**Re: Enbridge Gas Inc. (Enbridge Gas)
Ontario Energy Board (OEB) File No.: EB-2022-0248
Mohawks of the Bay of Quinte and Shannonville Community Expansion
Project (Project)**

Post-Construction Report

Mohawks of the Bay of Quinte and Shannonville Community
Expansion Project (EB-2022-0248)

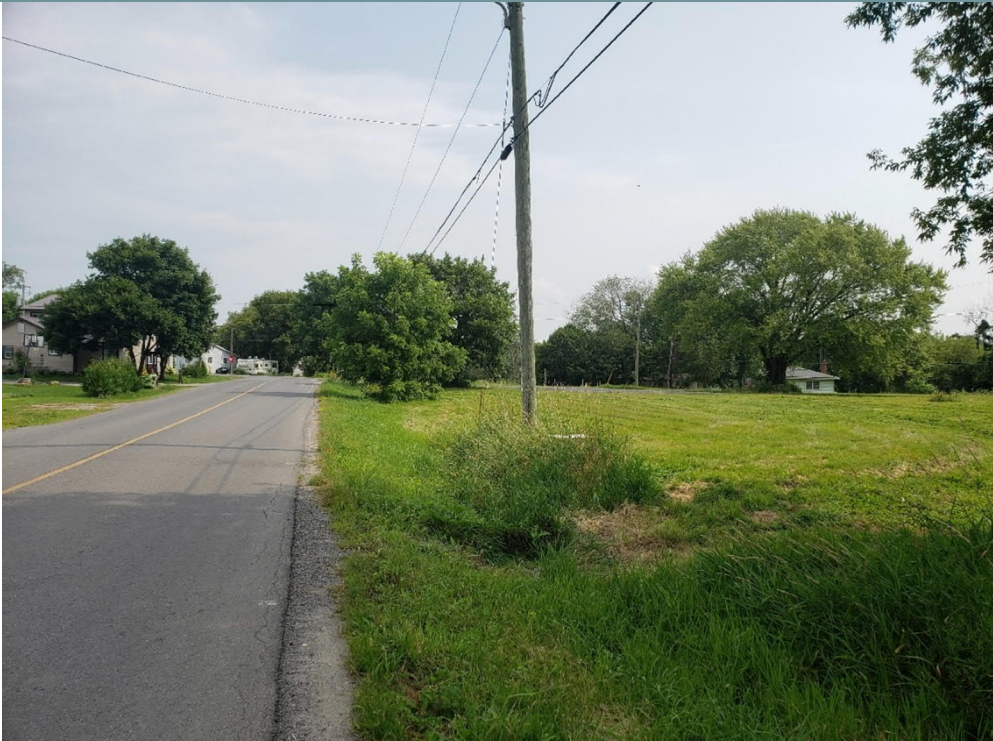
ID #	Location	Site Condition	Additional Work Recommended (Y/N)	Comments/Recommendations	Representative Photo (July 24, 2024)
1	Intersection of Beach Road and Yonge Street	Roadside is revegetated.	N	No issues to report at time of inspection.

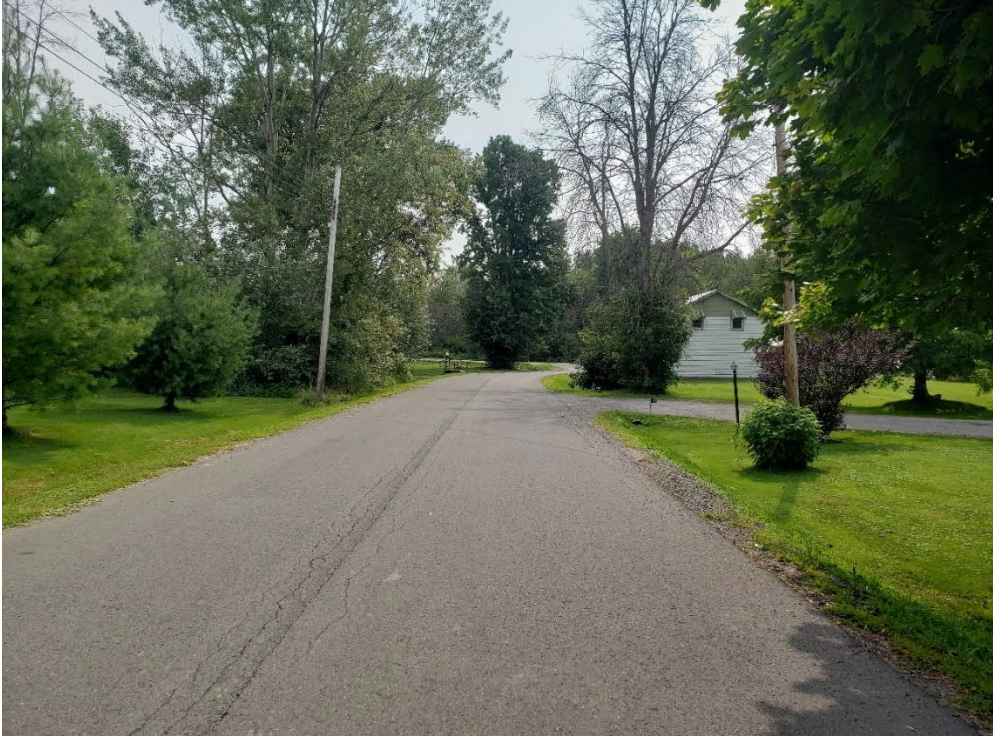
2	23 Young Street	Asphalt has been replaced; roadside is revegetated.	N	No issues to report at time of inspection.

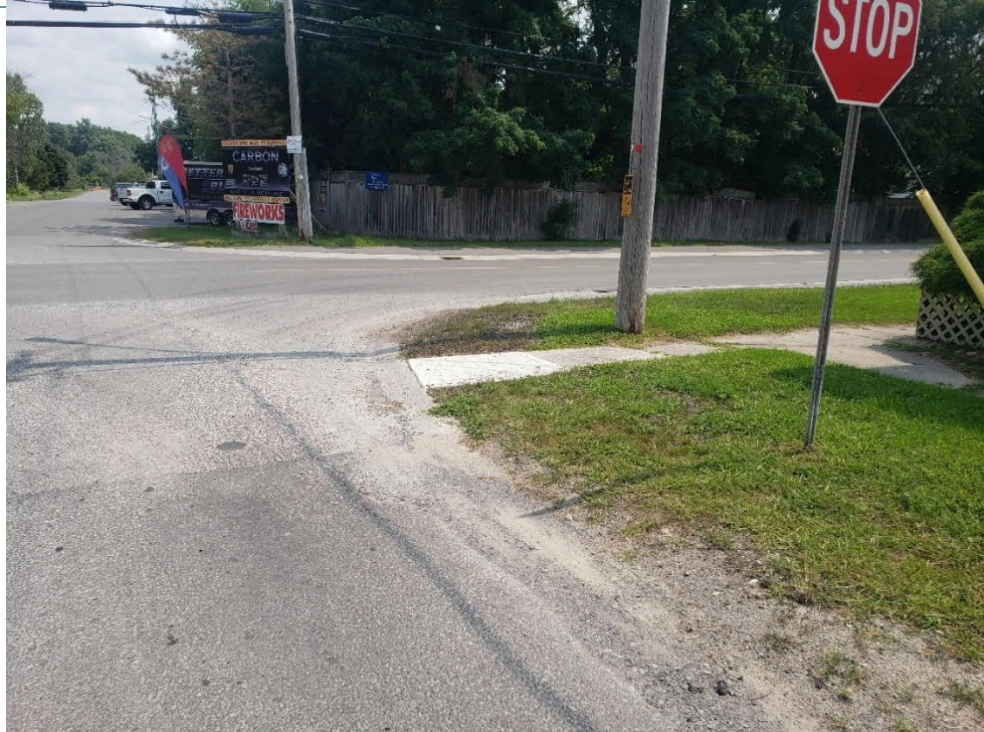
ID #	Location	Site Condition	Additional Work Recommended (Y/N)	Comments/Recommendations	Representative Photo (July 24, 2024)
5	Intersection of Queen Street and York Road	Asphalt has been replaced.	N	No issues to report at time of inspection.

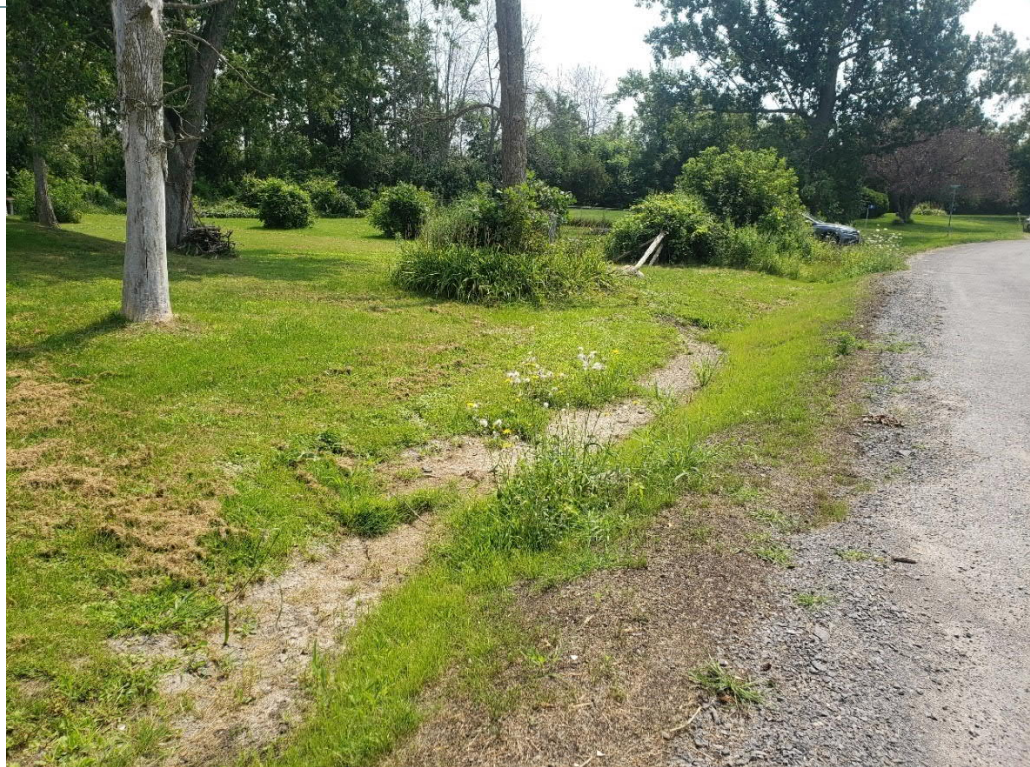
ID #	Location	Site Condition	Additional Work Recommended (Y/N)	Comments/Recommendations	Representative Photo (July 24, 2024)
7	13 Gore Street	Some areas of exposed soil and gravel. Evidence of lawn mowing.	Y	Monitor in following growing season. Reseed as needed.

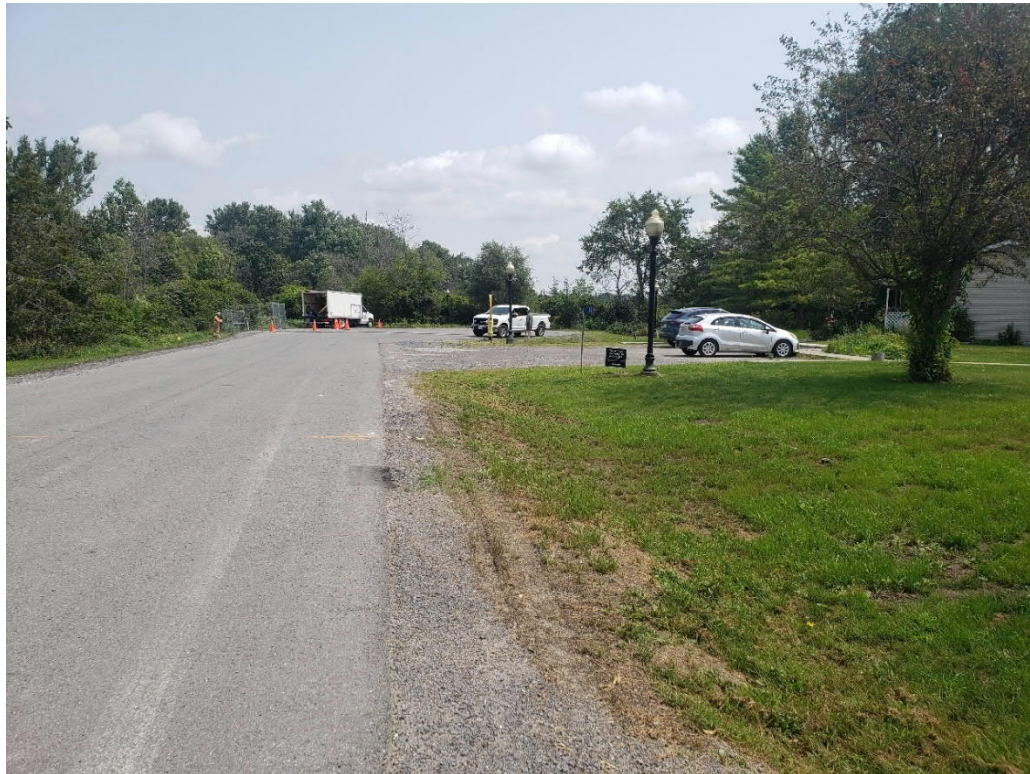
8	5 Atsia Court	Road/ asphalt in good condition. Some areas of exposed soil.	Y	Monitor in following growing season. Reseed as needed.

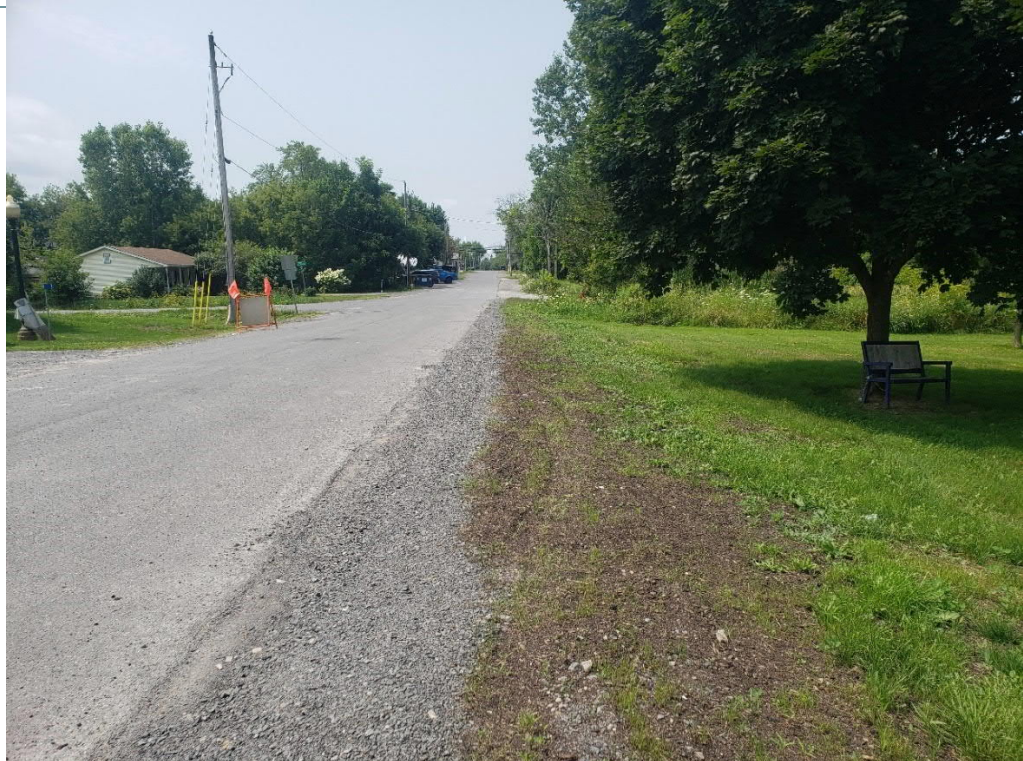
ID #	Location	Site Condition	Additional Work Recommended (Y/N)	Comments/Recommendations	Representative Photo (July 24, 2024)
9	Atsia Court (north side)	Road/asphalt in good condition. Some areas of bare soil.	Y	Monitor in following growing season. Reseed as needed.

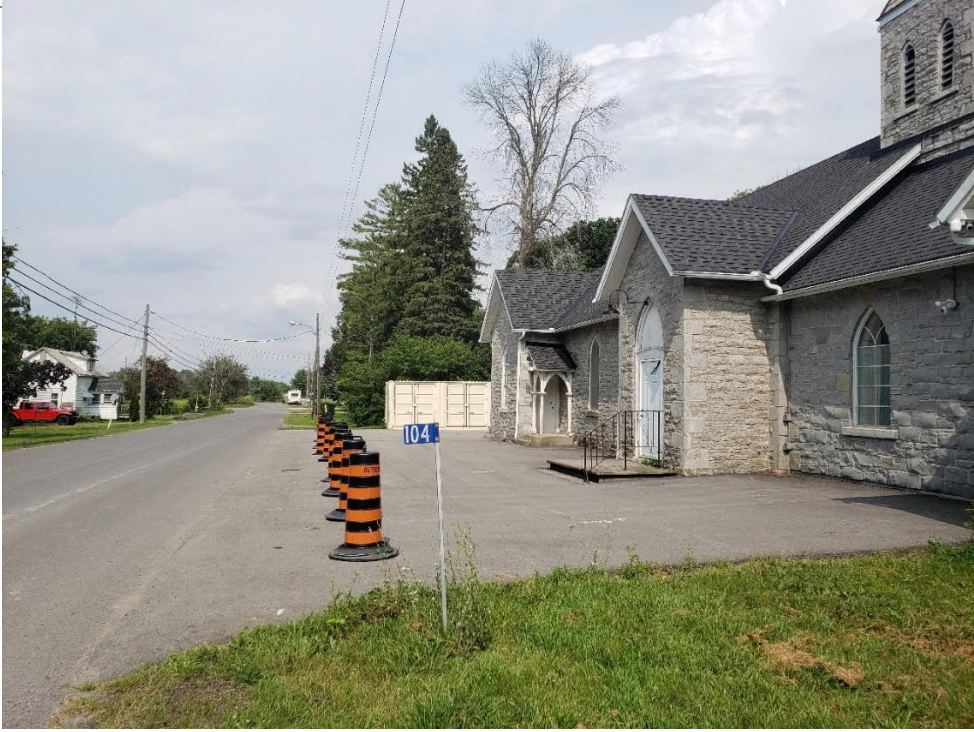
ID #	Location	Site Condition	Additional Work Recommended (Y/N)	Comments/Recommendations	Representative Photo (July 24, 2024)
11	104 Young Street	Road/asphalt in good condition.	N	No issues to report at time of inspection.

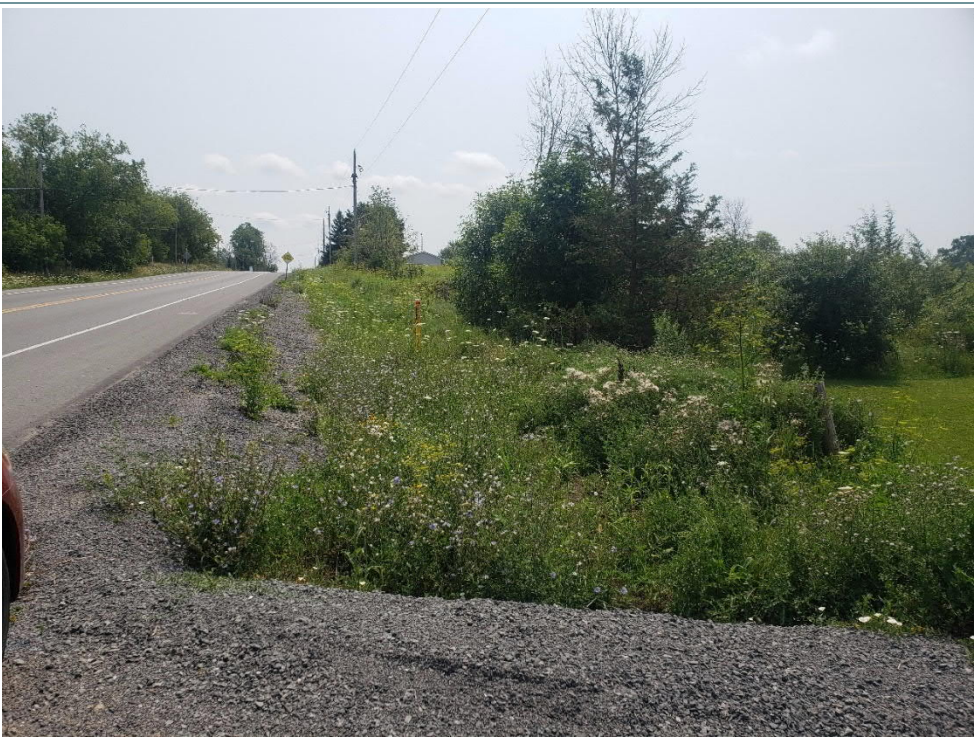
12	112 York Road	Road is in good condition; ROW is gravelled with some vegetation.	N	No issues to report at time of inspection.

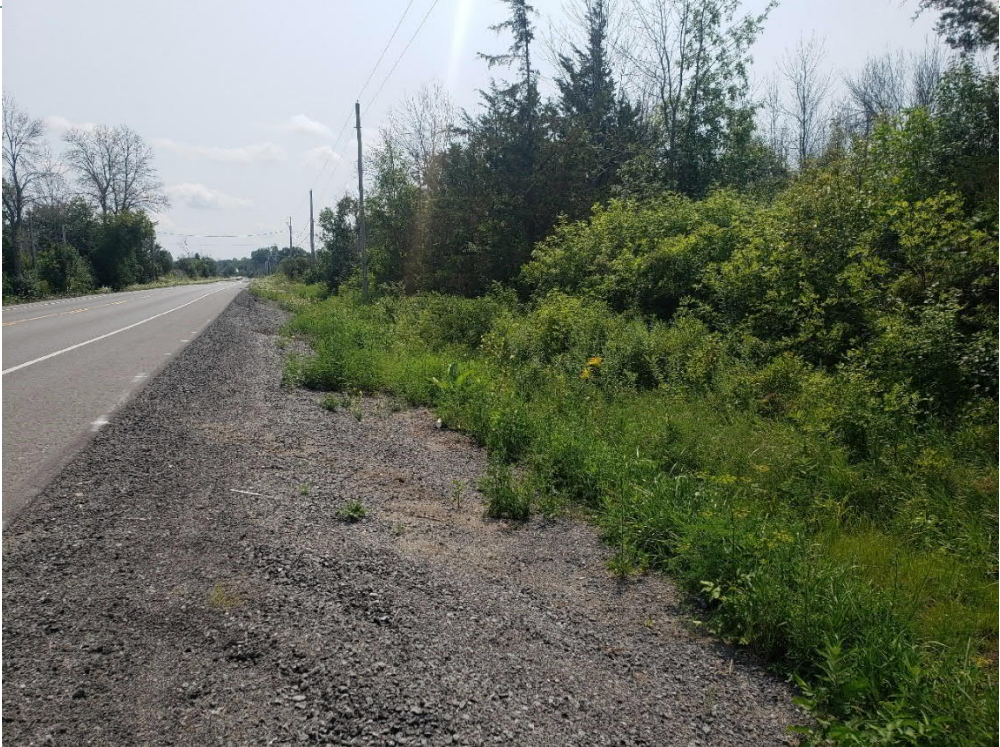
ID #	Location	Site Condition	Additional Work Recommended (Y/N)	Comments/Recommendations	Representative Photo (July 24, 2024)
13	192 York Road	ROW is gravelled with some vegetation.	N	No issues to report at time of inspection.

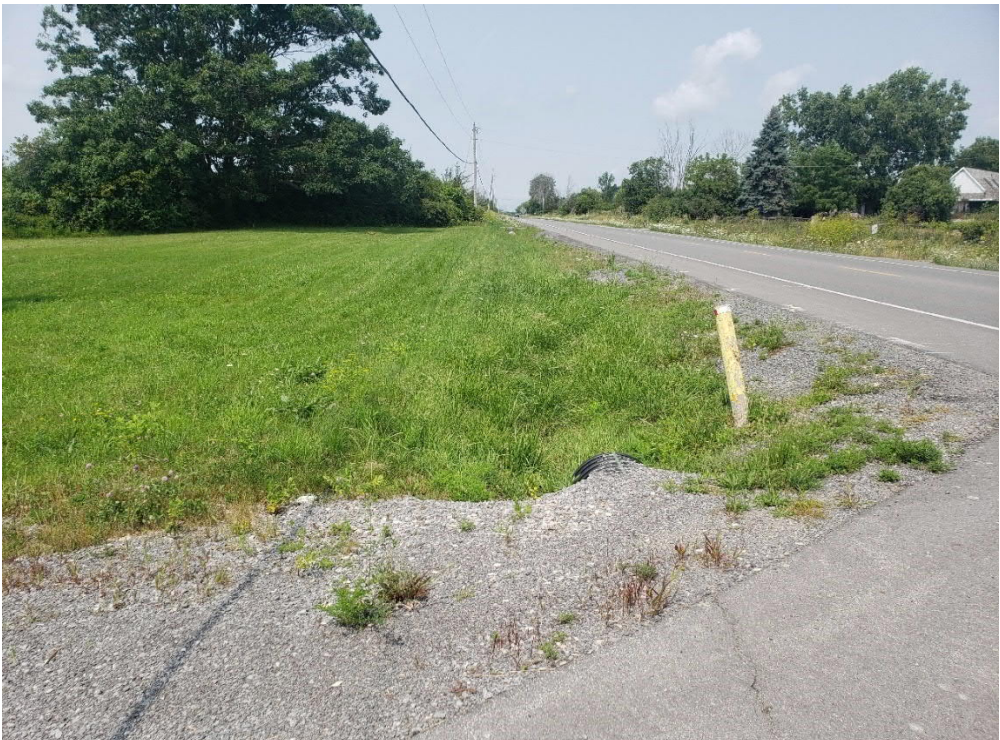
14	266 York Road	Driveway is in good condition. ROW is gravelled with some vegetation leading to manicured lawn.	N	No issues to report at time of inspection.

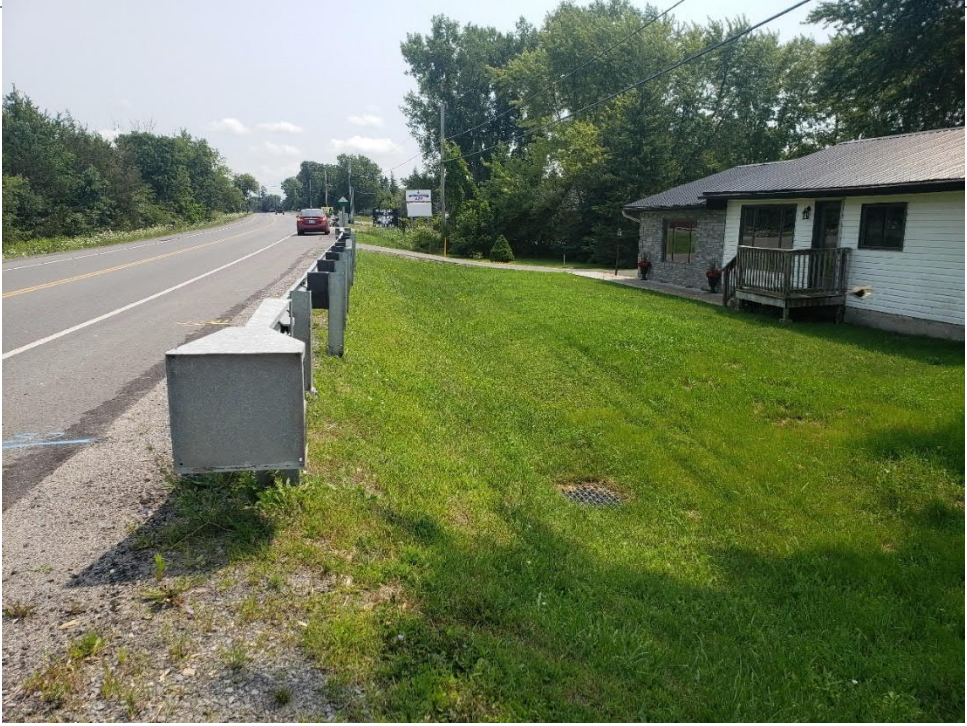
ID #	Location	Site Condition	Additional Work Recommended (Y/N)	Comments/Recommendations	Representative Photo (July 24, 2024)
17	346 York Road	ROW is gravelled with manicured lawn behind the guardrail.	N	No issues to report at time of inspection.

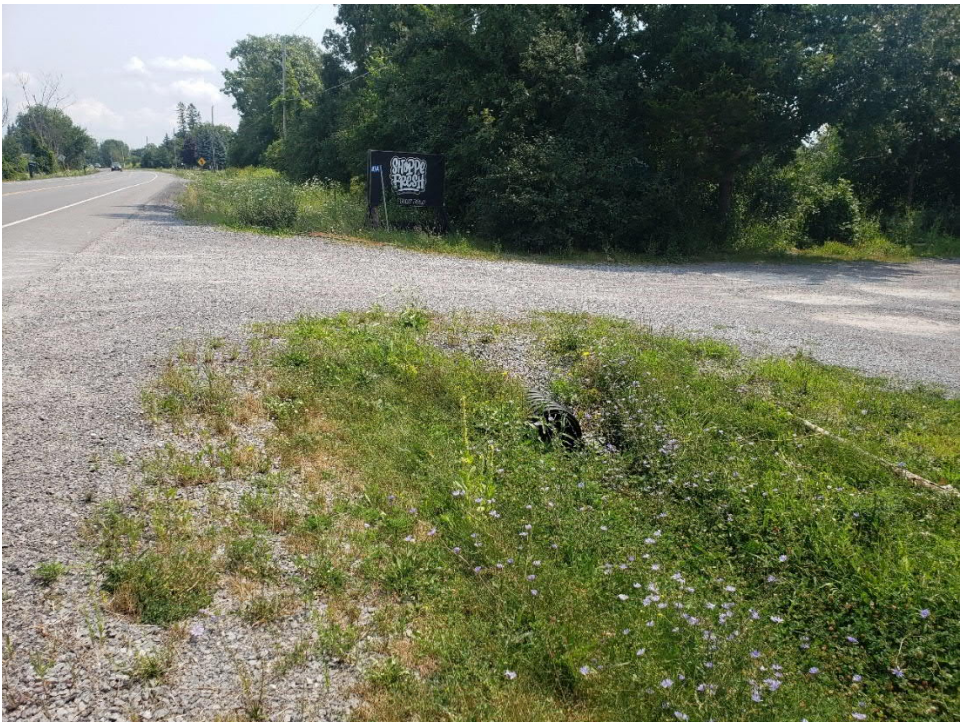
18	414 York Road	ROW is gravelled, vegetation present along the roadside and in the ditch. Culvert appears to be in good condition.	N	No issues to report at time of inspection.

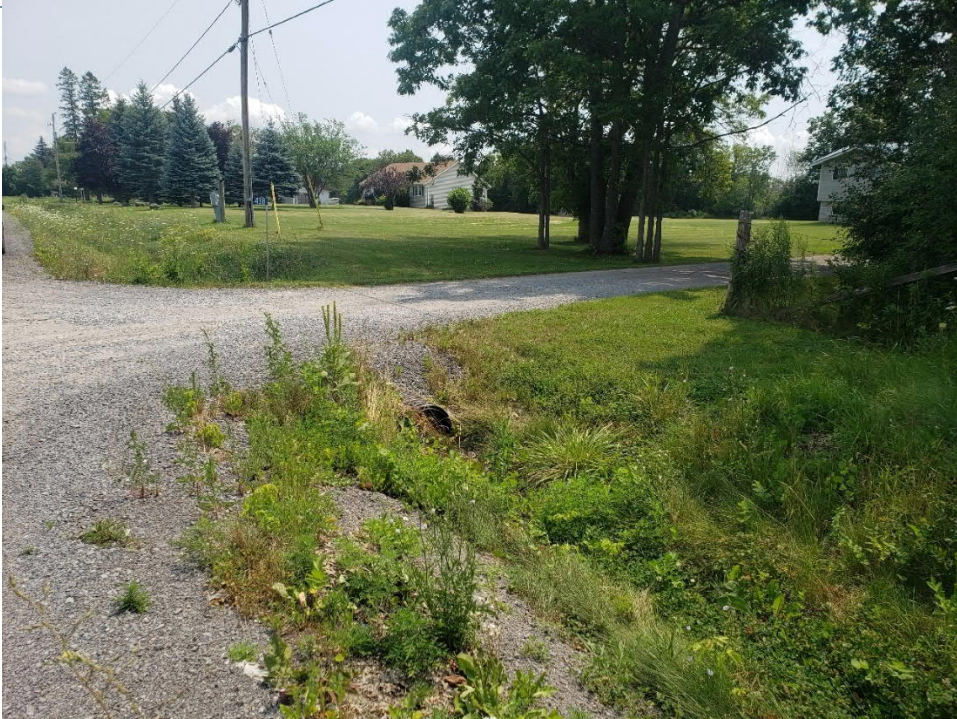
ID #	Location	Site Condition	Additional Work Recommended (Y/N)	Comments/Recommendations	Representative Photo (July 24, 2024)
19	438 York Road	ROW is gravelled, vegetation present along the roadside and in the ditch. Culvert appears to be in good condition.	N	No issues to report at time of inspection.

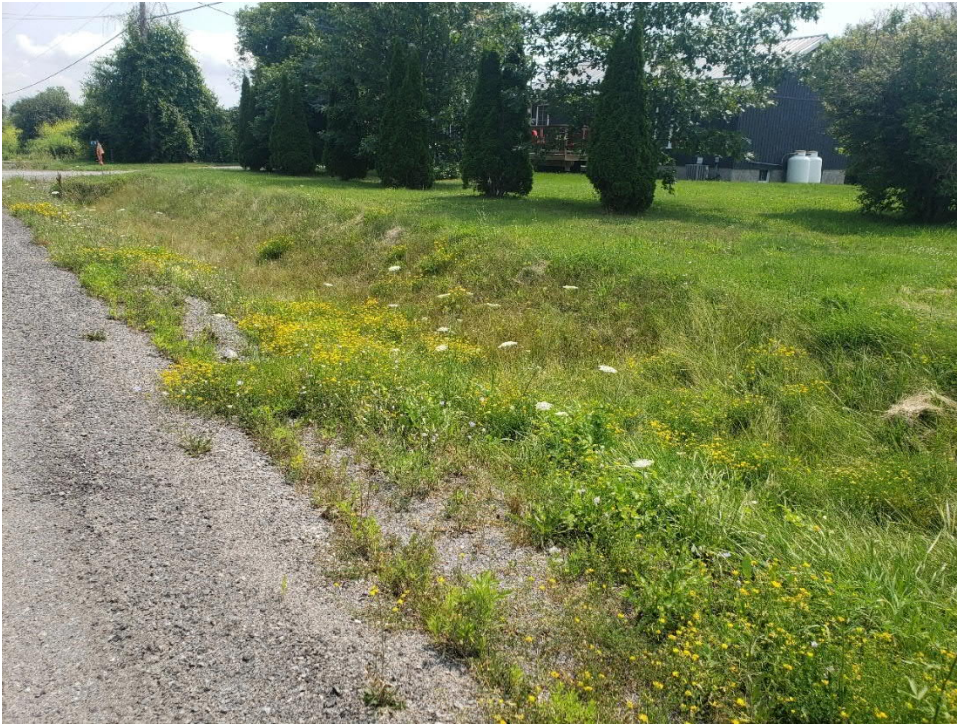
20	474 York Road	ROW is gravelled, vegetation present along the roadside and in the ditch.	N	No issues to report at time of inspection.

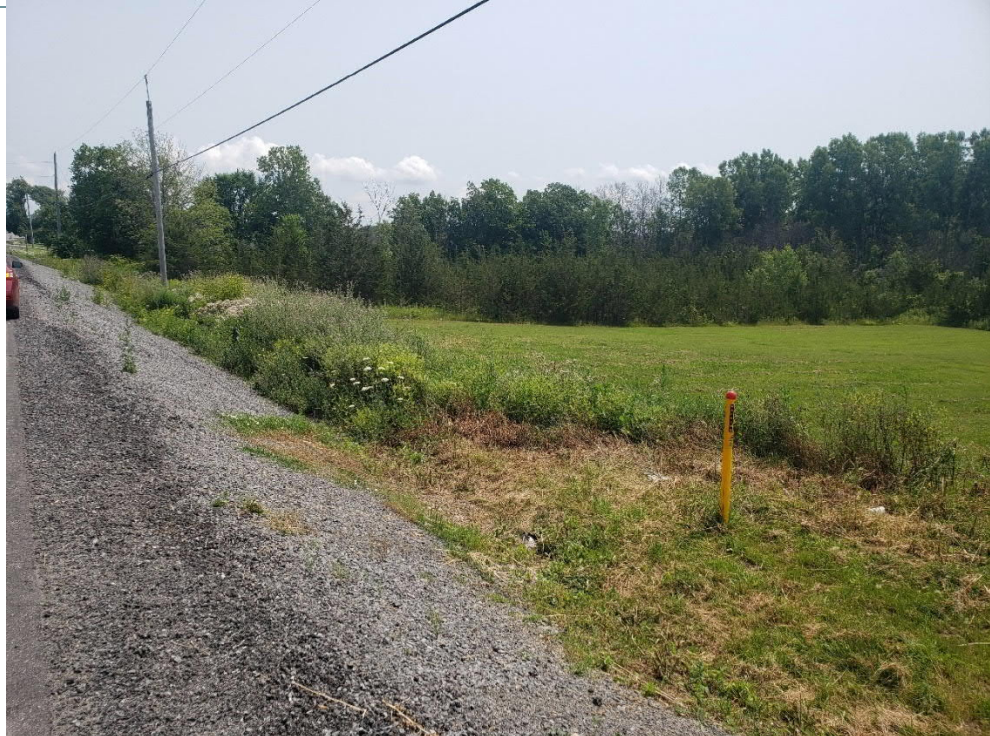
ID #	Location	Site Condition	Additional Work Recommended (Y/N)	Comments/Recommendations	Representative Photo (July 24, 2024)
21	490 York Road	ROW is gravelled, some vegetation regrowth present. Areas of dry grass.	N	No issues to report at time of inspection.

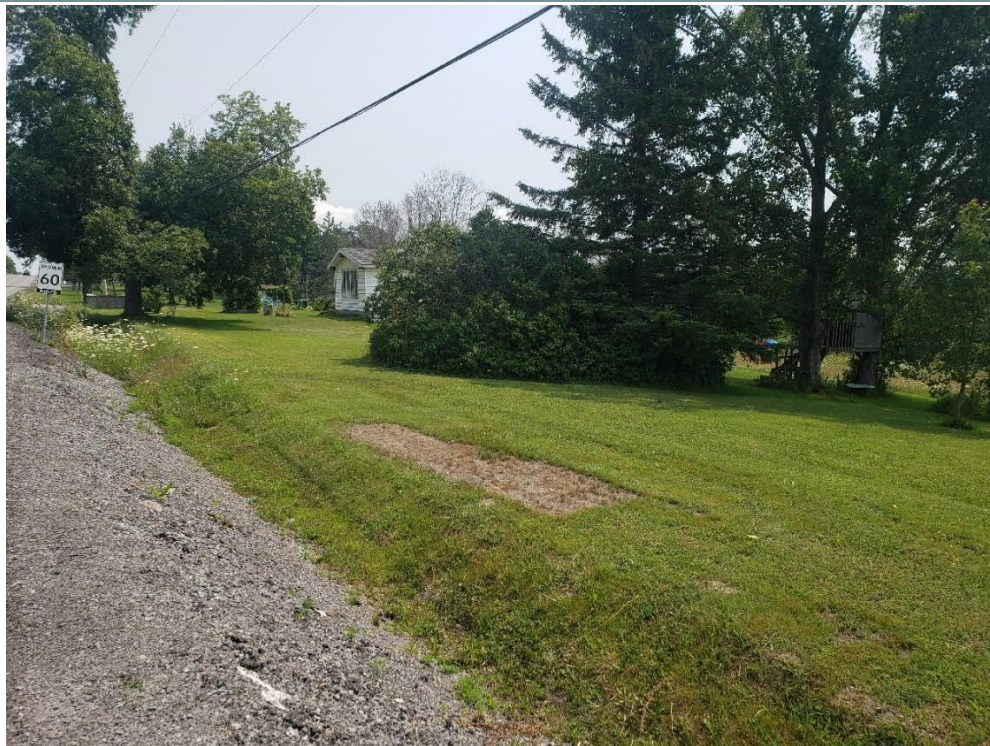
22	538 York Road	ROW is gravelled. One area of dead grass on lawn.	Y	Monitor in following growing season. Reseed as needed.

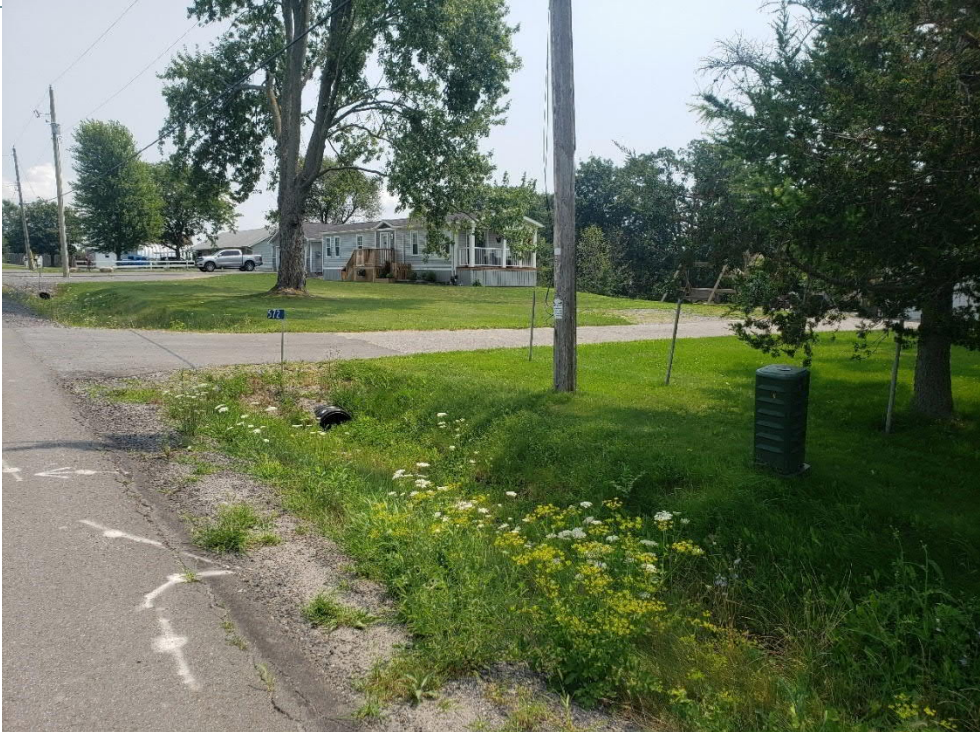
ID #	Location	Site Condition	Additional Work Recommended (Y/N)	Comments/Recommendations	Representative Photo (July 24, 2024)
23	572 York Road	ROW is gravelled and roadside ditch is vegetated. Culvert appears in good condition.	N	No issues to report at time of inspection.

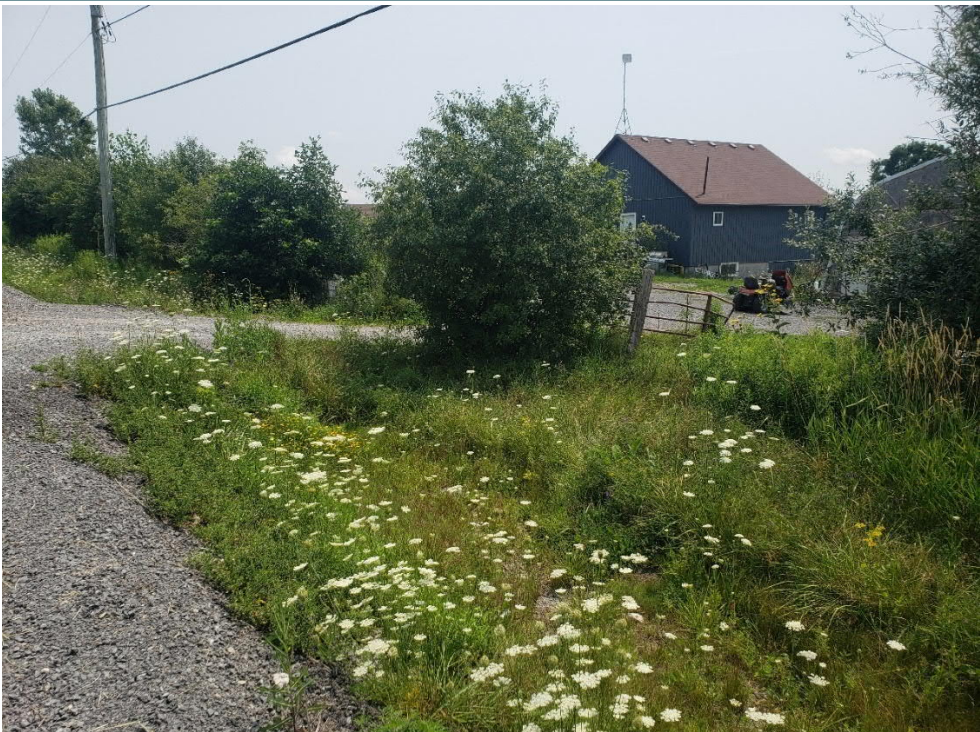
24	588 York Road	ROW is gravelled and roadside ditch is vegetated.	N	No issues to report at time of inspection.

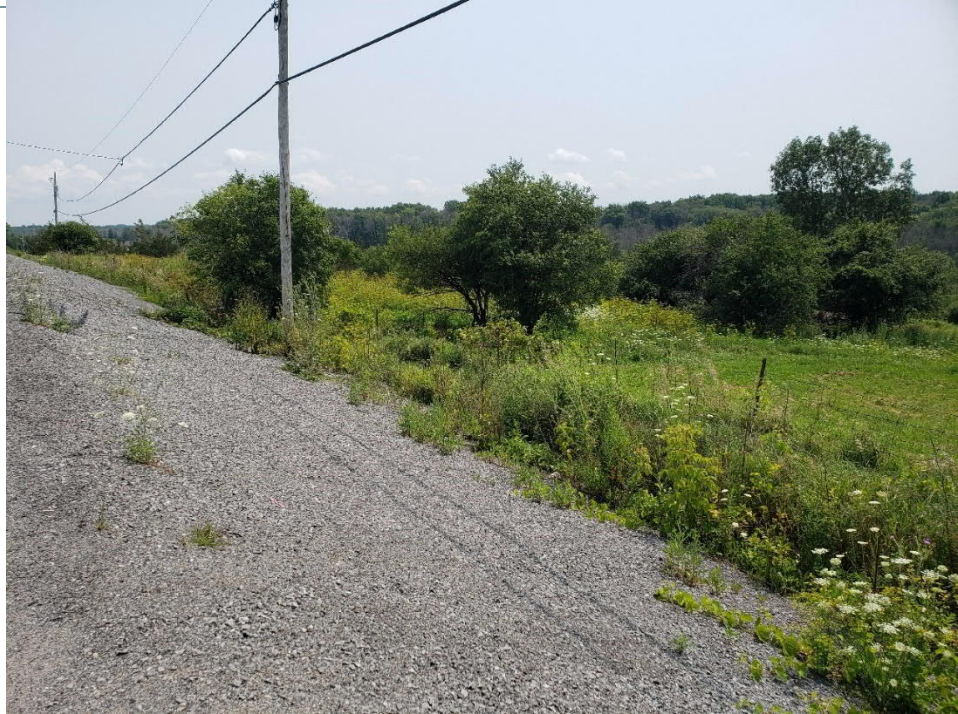
ID #	Location	Site Condition	Additional Work Recommended (Y/N)	Comments/Recommendations	Representative Photo (July 24, 2024)
25	Across from 621 York Road	ROW is gravelled with some vegetation beginning to grow at roadside.	N	No issues to report at time of inspection.

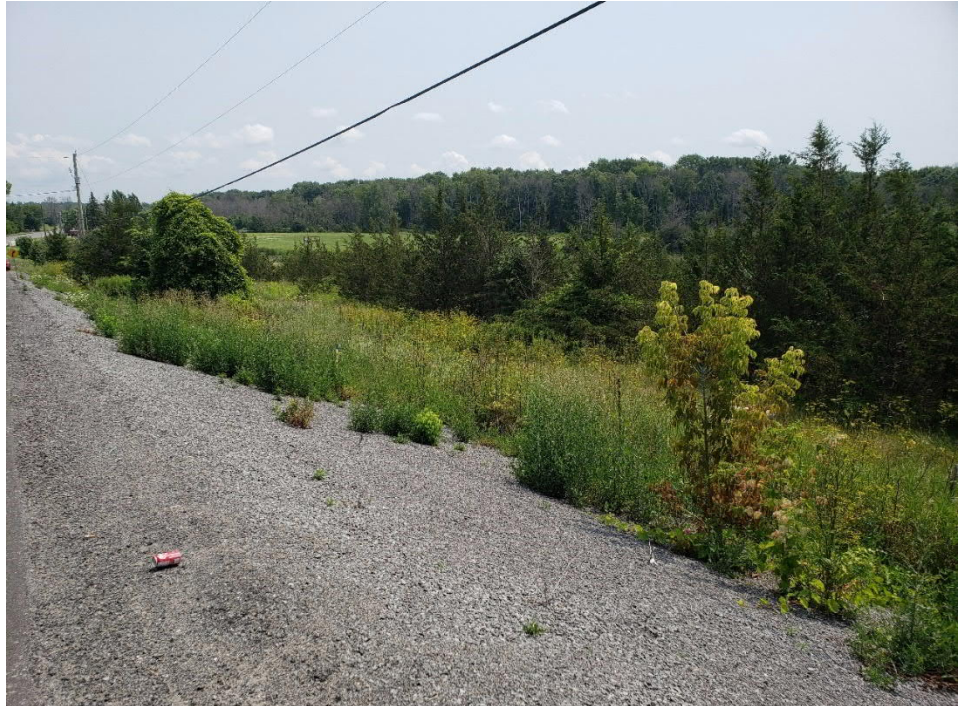
26	Between 621 and 683 York Road	ROW is gravelled with some vegetation beginning to grow at roadside.	N	No issues to report at time of inspection.

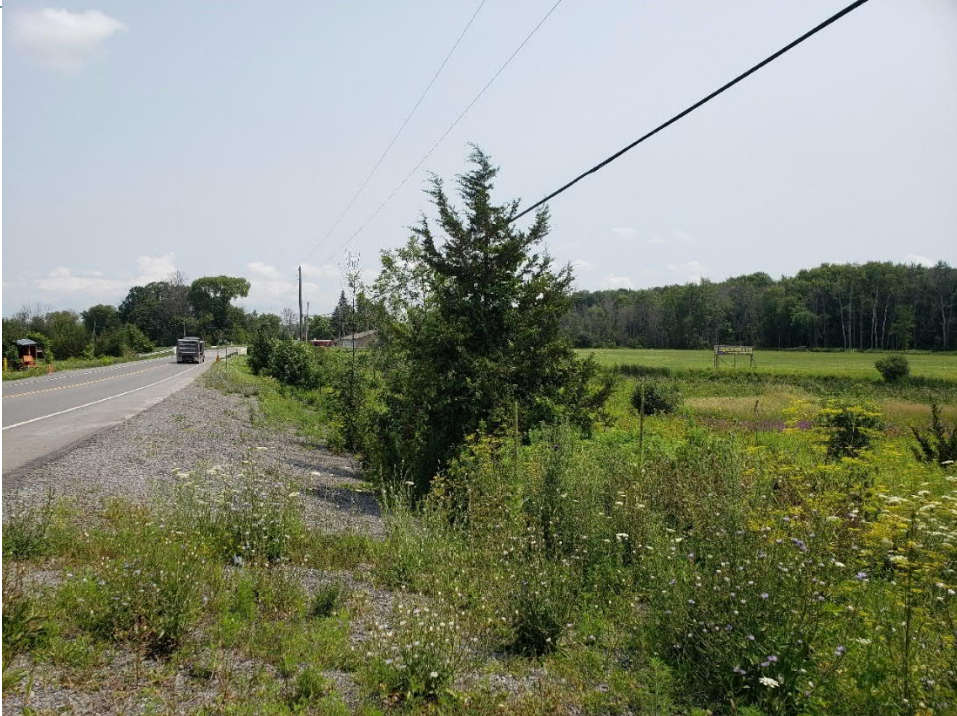
ID #	Location	Site Condition	Additional Work Recommended (Y/N)	Comments/Recommendations	Representative Photo (July 24, 2024)
27	Across from 683 York Road	ROW is gravelled with vegetation growing at roadside.	N	No issues to report at time of inspection.

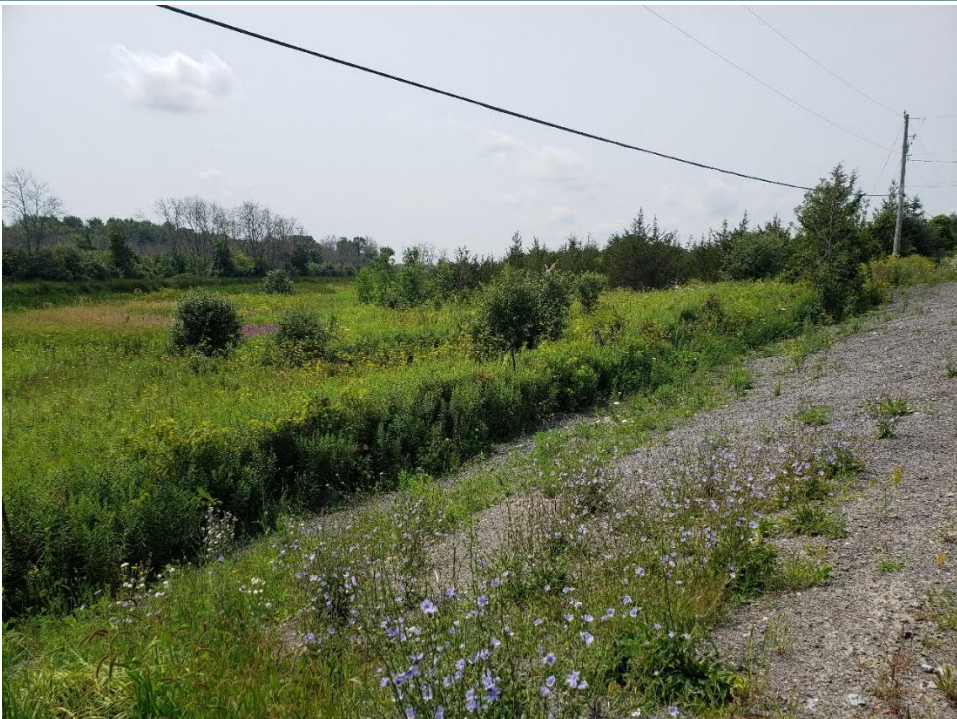
28	West of bridge at Marysville Creek	ROW and location of TWS is gravelled with some vegetation beginning to grow at roadside.	N	No issues to report at time of inspection.

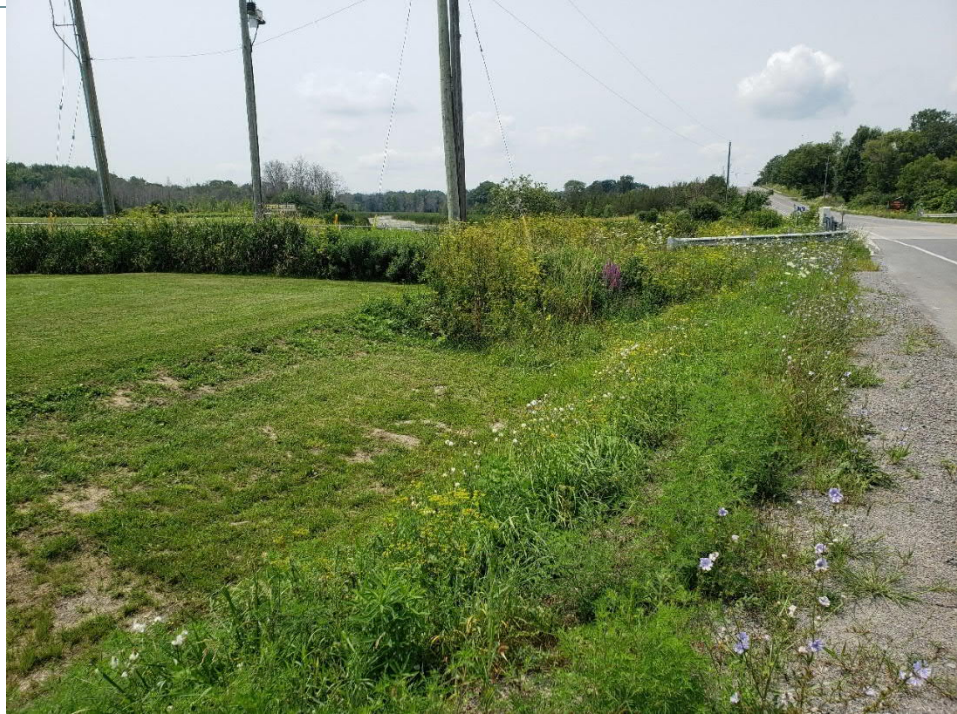
ID #	Location	Site Condition	Additional Work Recommended (Y/N)	Comments/Recommendations	Representative Photo (July 24, 2024)
29	East of bridge at Marysville Creek	ROW is gravelled and vegetation is growing at roadside and within ditch. Some areas of exposed soil.	Y	Monitor in following growing season. Reseed as needed.

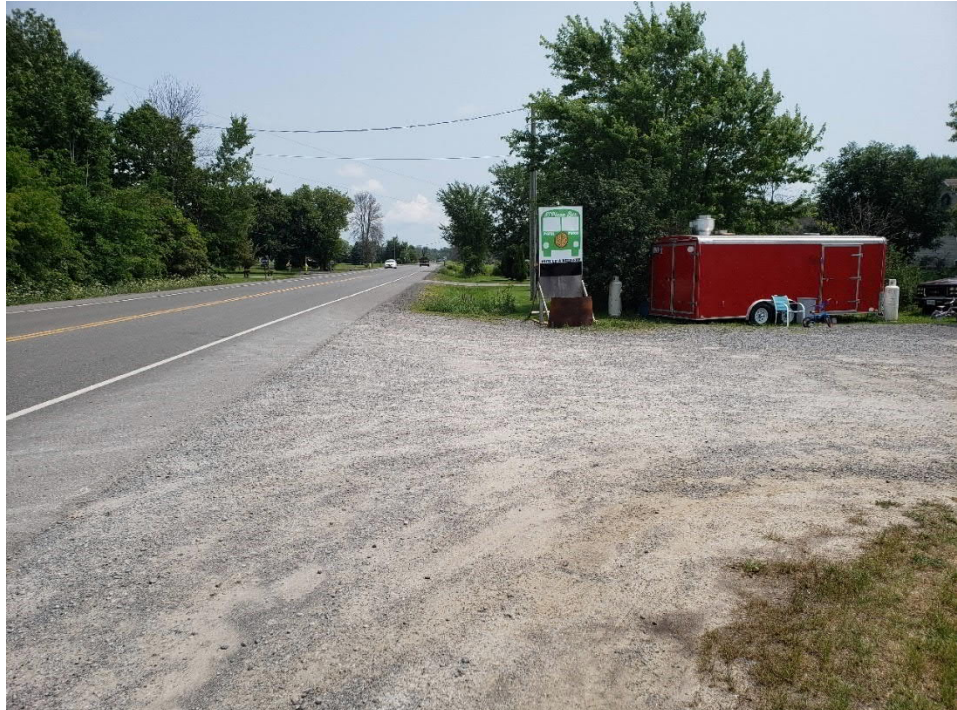
30	722 York Road	Driveway is gravelled and in good condition.	N	No issues to report at time of inspection.

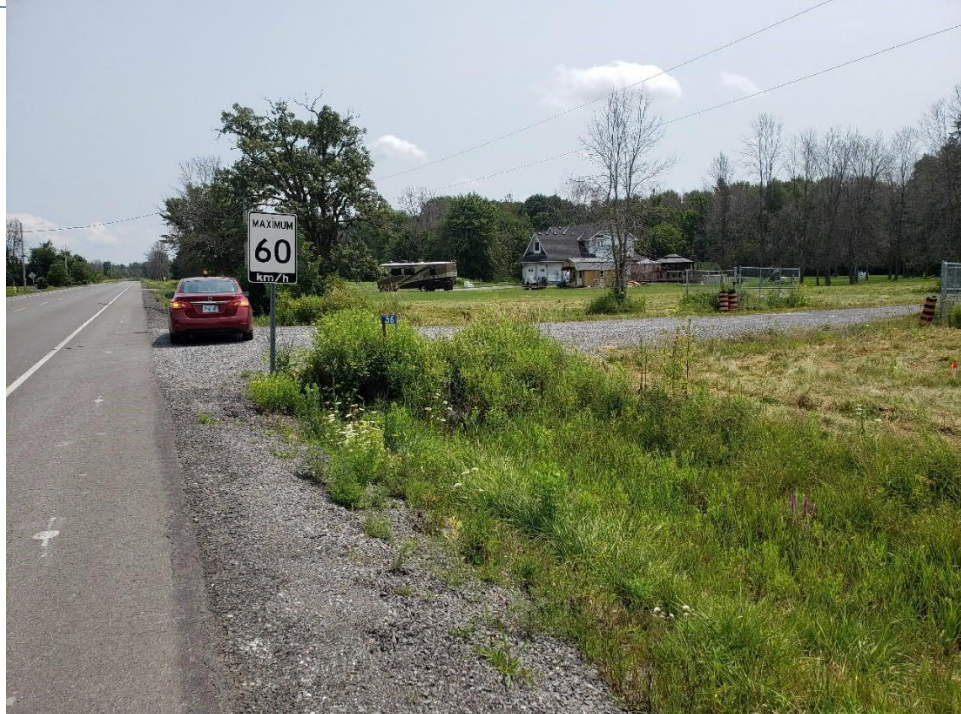
ID #	Location	Site Condition	Additional Work Recommended (Y/N)	Comments/Recommendations	Representative Photo (July 24, 2024)
31	756 York Road	ROW is gravelled and roadside ditch is vegetated. Culvert appears in good condition.	N	No issues to report at time of inspection.

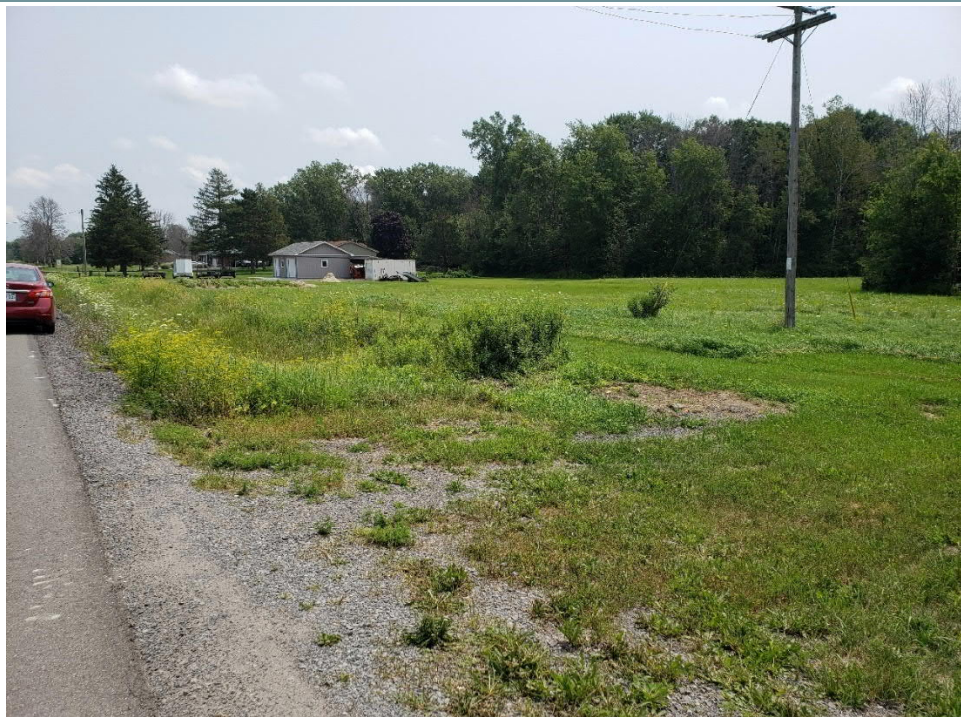
32	Across from 781 York Road	ROW is gravelled. Some areas of bare soil within manicured lawn.	Y	Monitor in following growing season. Reseed as needed.

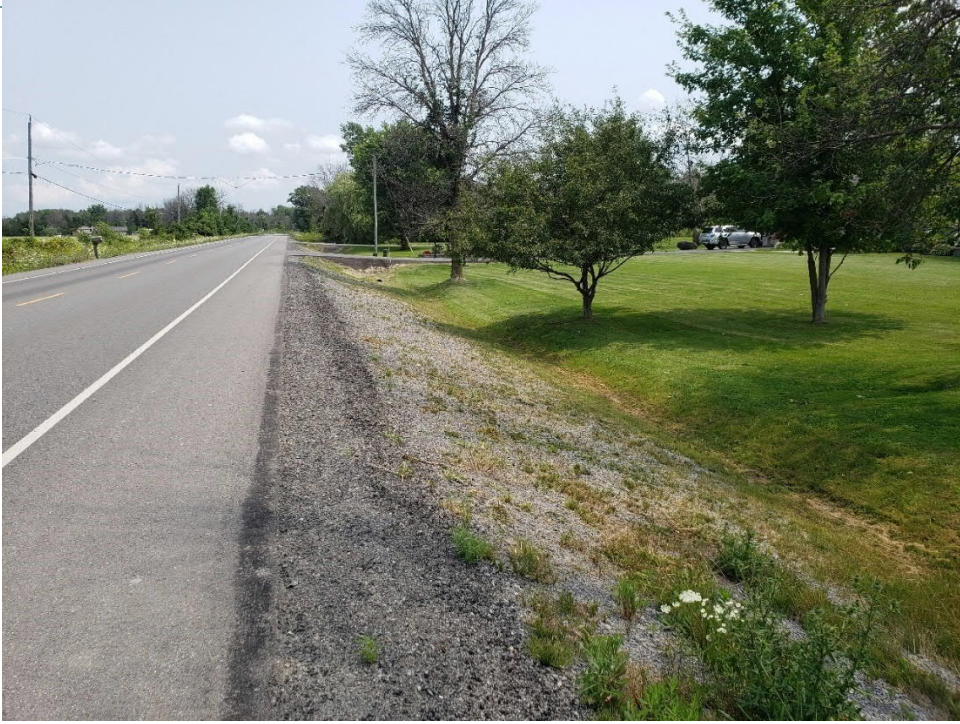
ID #	Location	Site Condition	Additional Work Recommended (Y/N)	Comments/Recommendations	Representative Photo (July 24, 2024)
35	836 York Road (east of driveway)	ROW is gravelled up to manicured lawn. Sparse revegetation.	N	No issues to report at time of inspection.

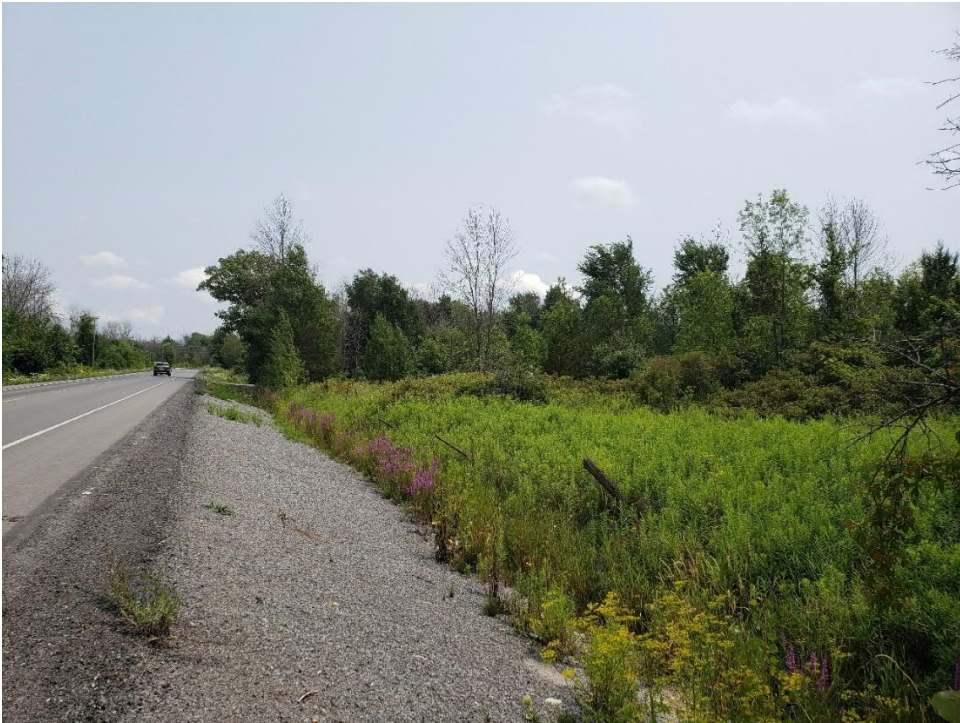
36	Between 860 and 888 York Road	ROW is gravelled. Sparse revegetation.	N	No issues to report at time of inspection.

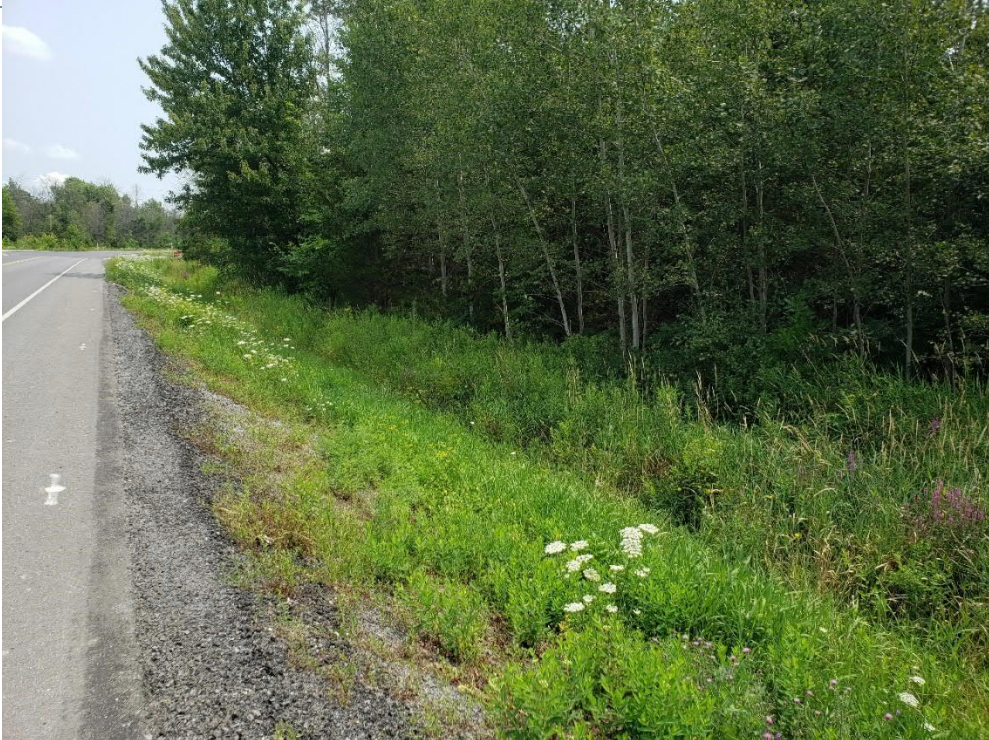
ID #	Location	Site Condition	Additional Work Recommended (Y/N)	Comments/Recommendations	Representative Photo (July 24, 2024)
37	East of 888 York Road	ROW is gravelled and beginning to revegetate.	N	No issues to report at time of inspection.

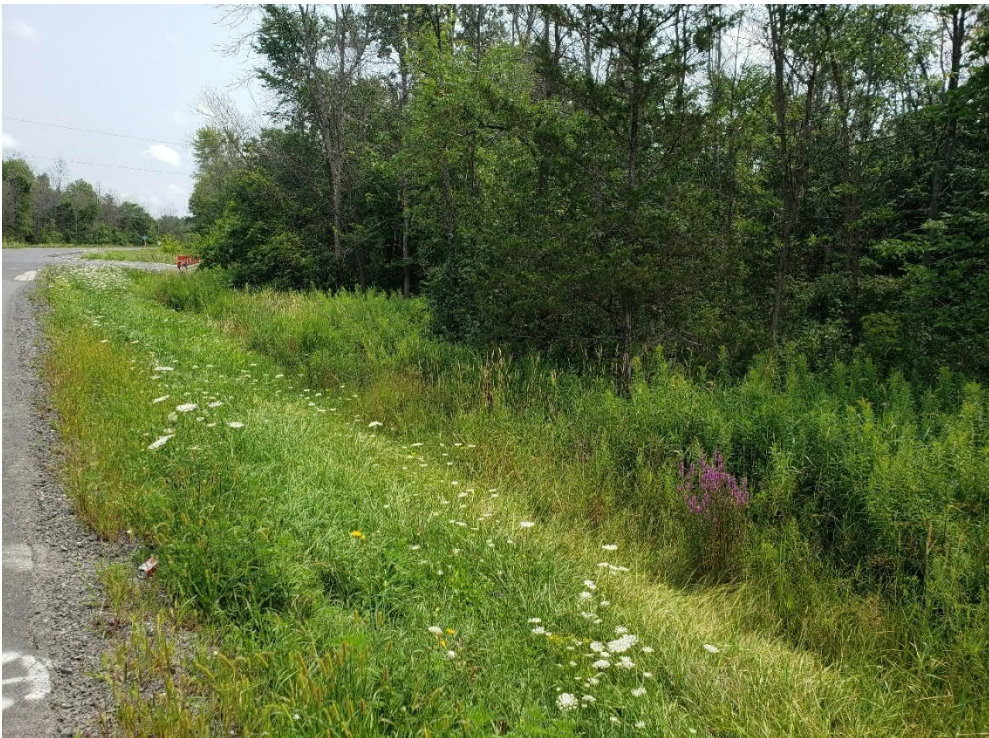
38	York Road, west of intersection with Norways Road	ROW is mostly vegetated. Small area of gravel present.	N	No issues to report at time of inspection.
