**Re: Enbridge Gas Inc. (Enbridge Gas)
Ontario Energy Board (OEB) File No.: EB-2022-0248
Mohawks of the Bay of Quinte and Shannonville Community Expansion
Project (Project)**

Post-Construction Report

Mohawks of the Bay of Quinte and Shannonville Community
Expansion Project (EB-2022-0248)

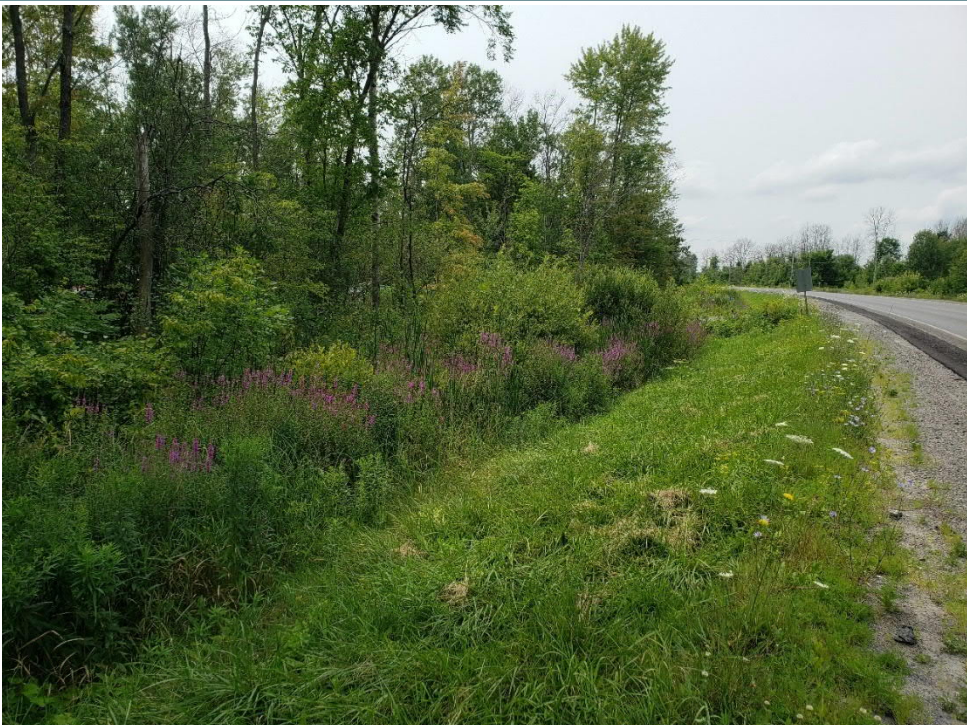
ID #	Location	Site Condition	Additional Work Recommended (Y/N)	Comments/Recommendations	Representative Photo (July 24, 2024)
39	York Road, east of intersection with Norways Road	Roadside is vegetated with some standing water in ditch.	N	No issues to report at time of inspection.	 
40	York Road, east of intersection with Norways Road	Small strip of gravel along ROW, roadside is vegetated.	N	No issues to report at time of inspection.

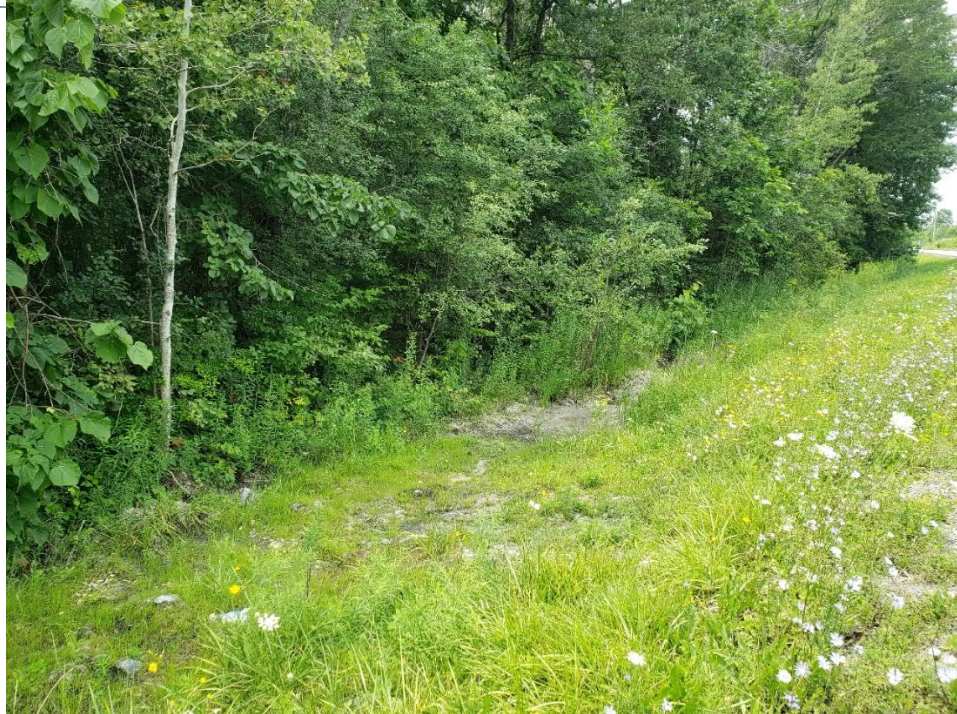
ID #	Location	Site Condition	Additional Work Recommended (Y/N)	Comments/Recommendations	Representative Photo (July 24, 2024)
41	York Road west of 1096 York Road	Roadside is mostly vegetated, some areas of exposed soil in roadside ditch.	N	No issues to report at time of inspection.

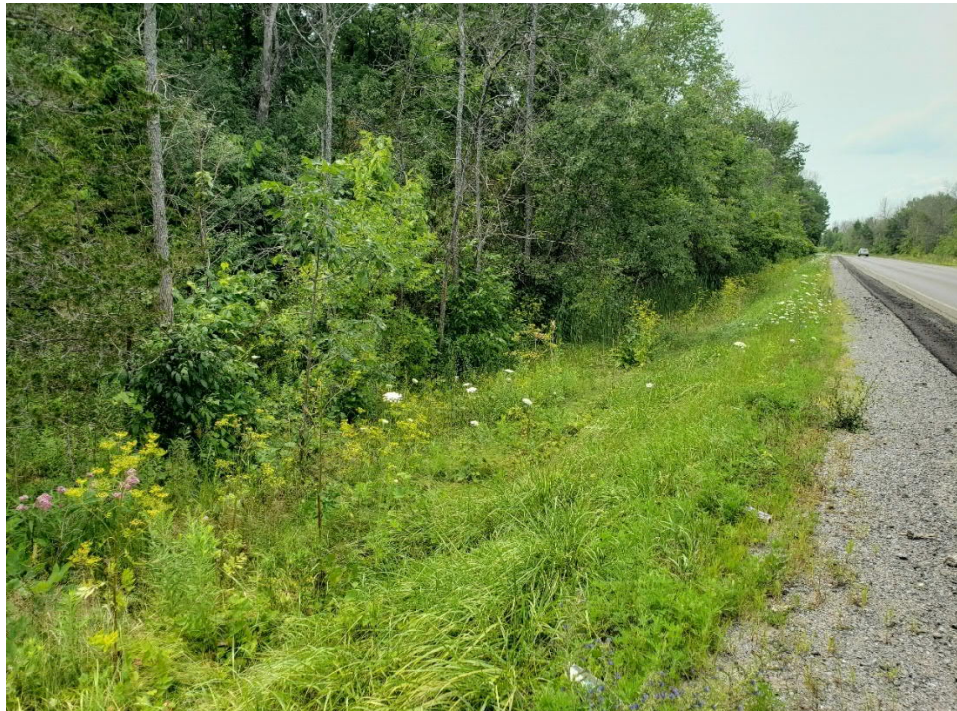
42	York Road, west of 1096 York Road	ROW is gravelled, roadside is well vegetated.	N	No issues to report at time of inspection.

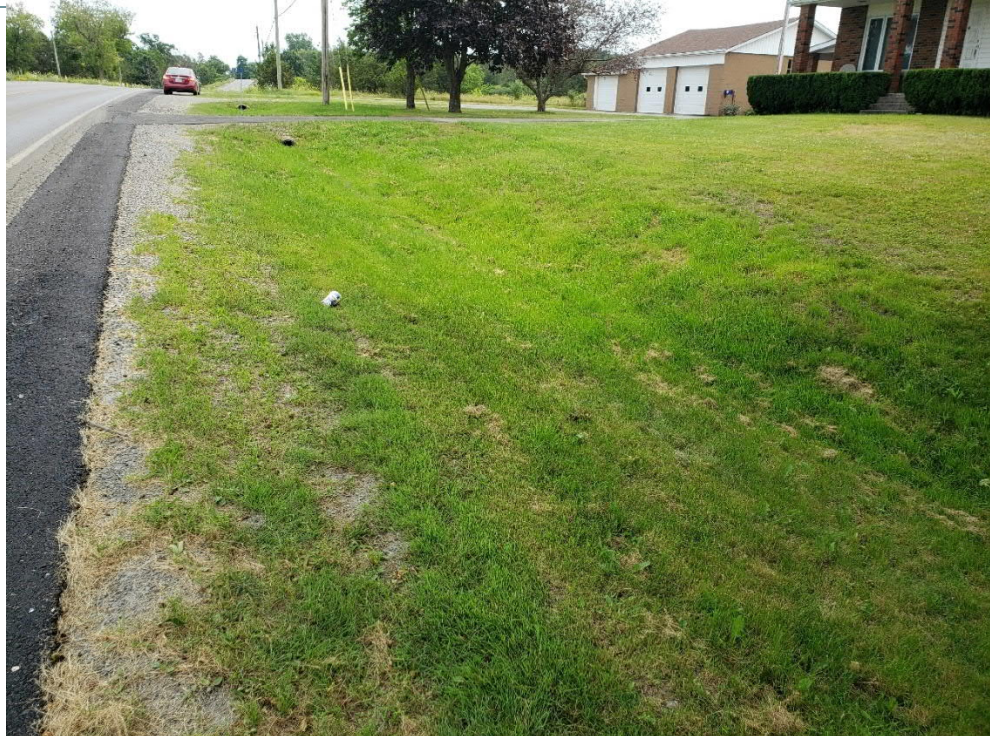
ID #	Location	Site Condition	Additional Work Recommended (Y/N)	Comments/Recommendations	Representative Photo (July 24, 2024)
43	1112 York Road	ROW has new strip of asphalt; roadside is beginning to revegetate adjacent to manicured lawn.	N	No issues to report at time of inspection.

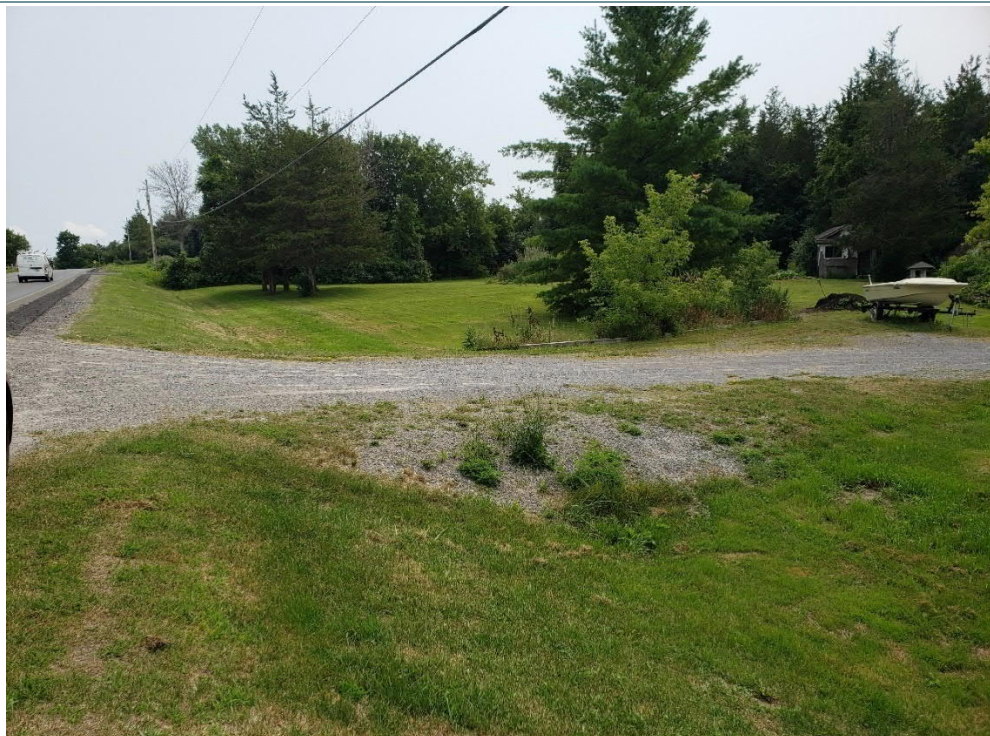
44	1154 York Road	ROW has new strip of asphalt; roadside is beginning to revegetate adjacent to manicured lawn.	N	No issues to report at time of inspection.

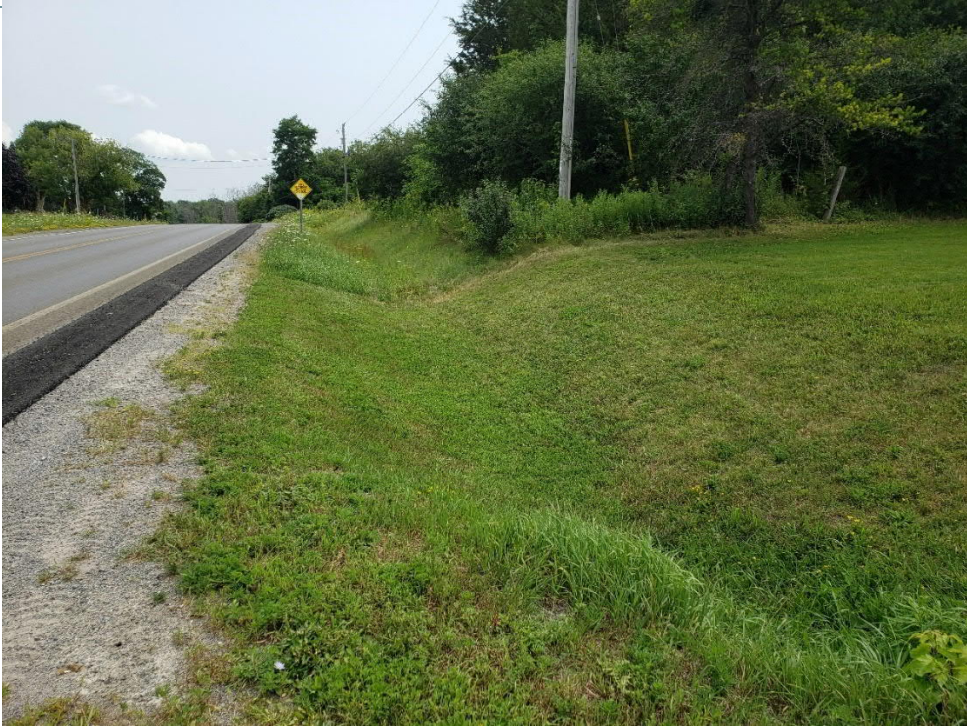
ID #	Location	Site Condition	Additional Work Recommended (Y/N)	Comments/Recommendations	Representative Photo (July 24, 2024)
45	1192 York Road	ROW has new strip of asphalt; roadside is beginning to revegetate adjacent to manicured lawn.	N	No issues to report at time of inspection.

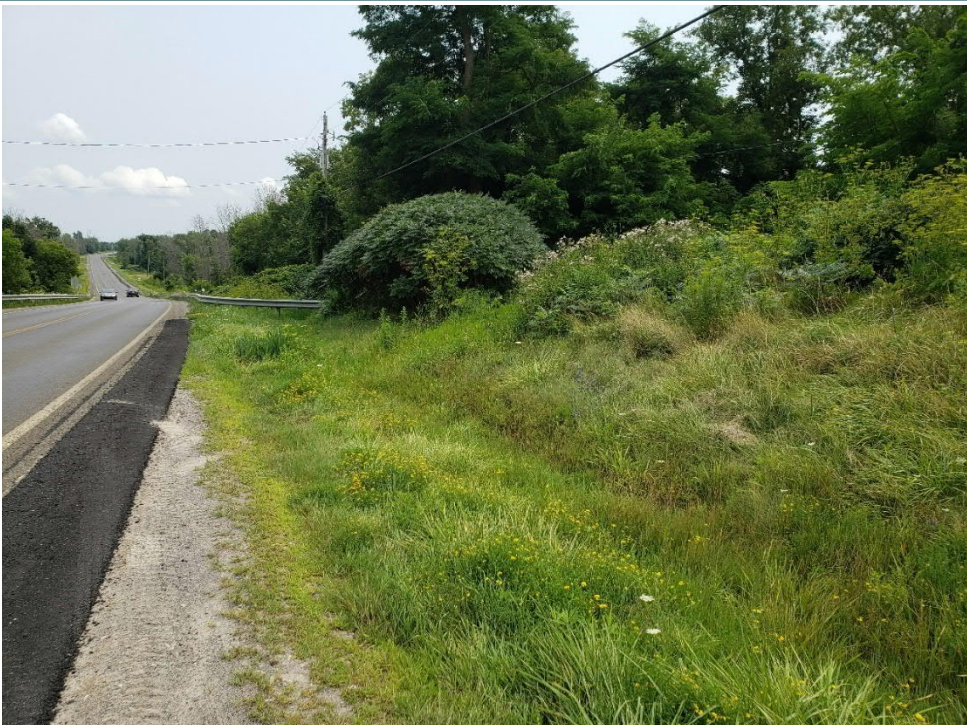
46	1214 York Road	ROW has new strip of asphalt; roadside is beginning to revegetate alongside ditch.	N	No issues to report at time of inspection.

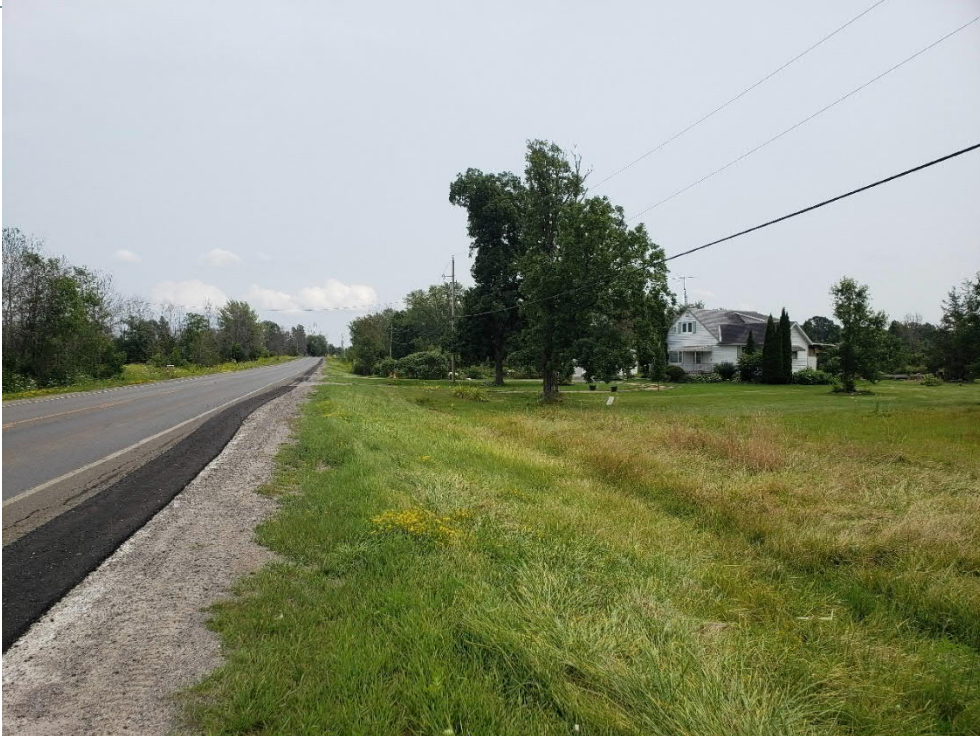
ID #	Location	Site Condition	Additional Work Recommended (Y/N)	Comments/Recommendations	Representative Photo (July 24, 2024)
47	East of 1286 York Road	ROW has new strip of asphalt; roadside is beginning to revegetate alongside ditch.	N	No issues to report at time of inspection.

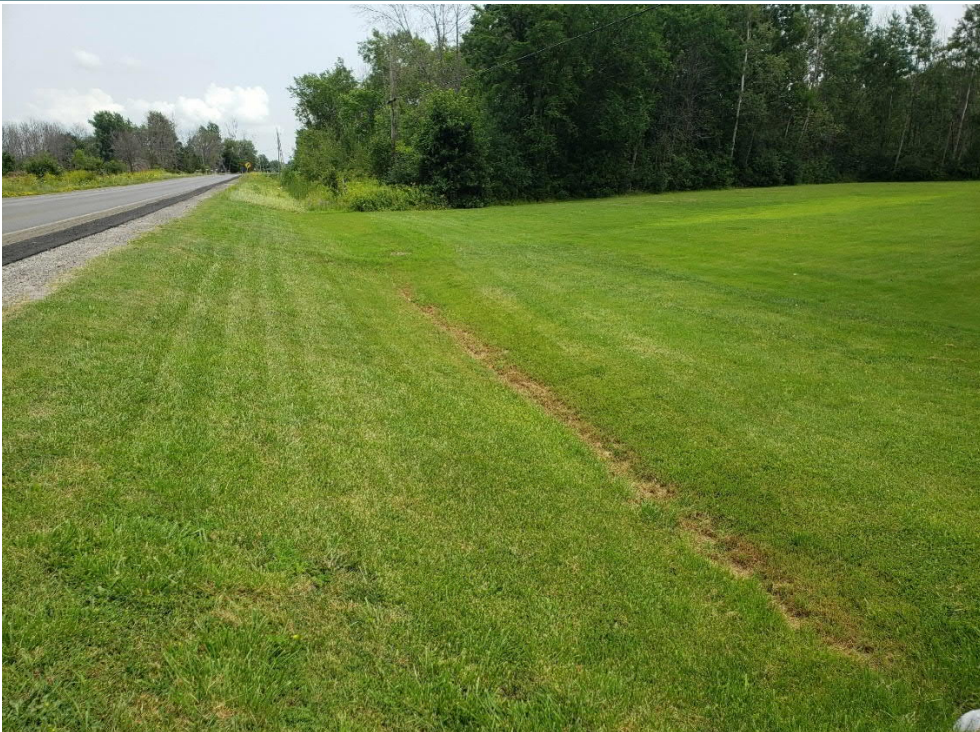
48	1306 York Road	ROW has new strip of asphalt. There is a small gravel strip adjacent to manicured lawn. Small area of dead grass within ditch, typical of roadside ditches.	N	No issues to report at time of inspection.

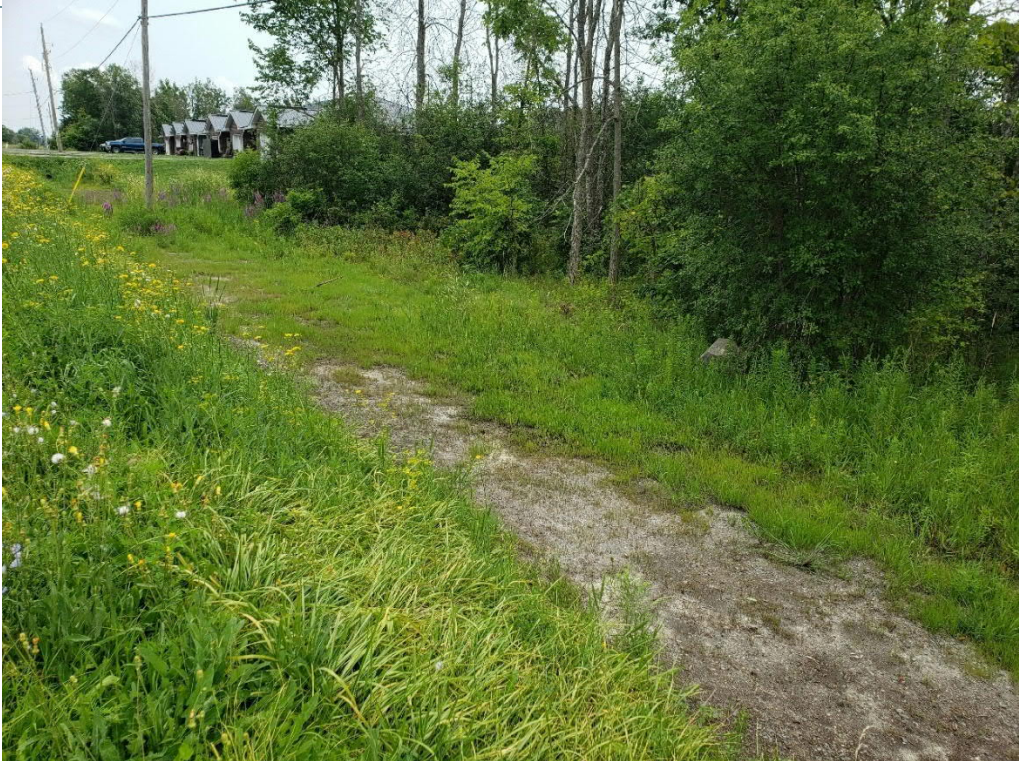
ID #	Location	Site Condition	Additional Work Recommended (Y/N)	Comments/Recommendations	Representative Photo (July 24, 2024)
49	East of 1306 York Road	Roadside is vegetated, some areas of exposed soil are present within ditch.	Y	Monitor in following growing season. Reseed as necessary.

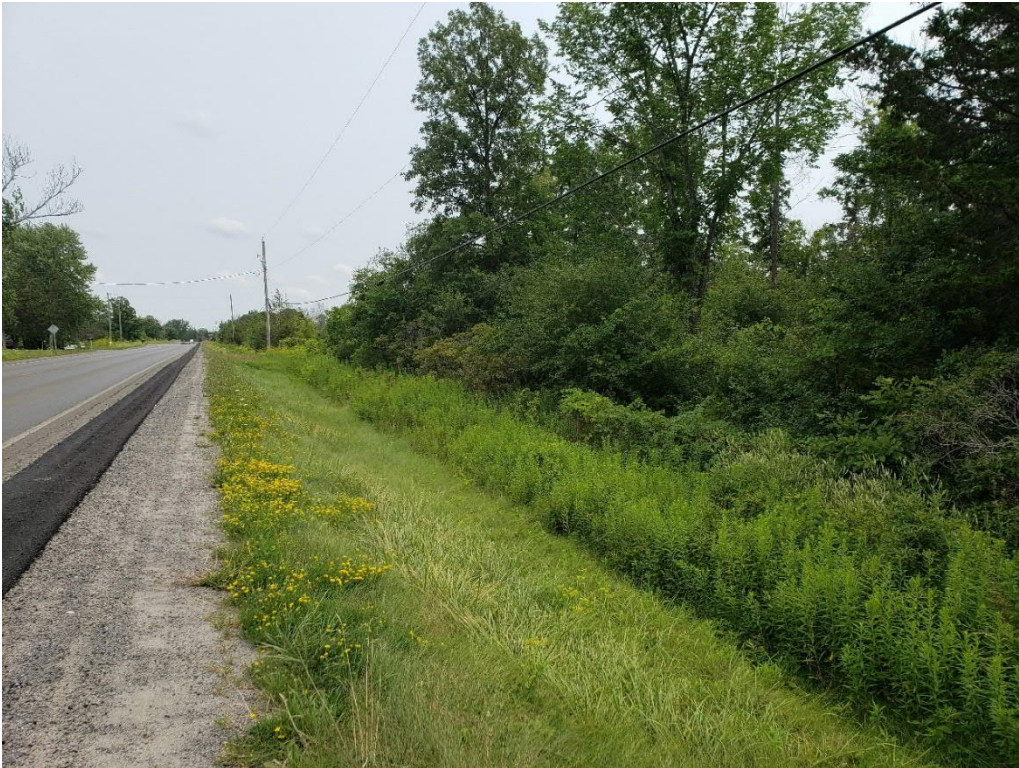
50	Across from 1365 York Road	ROW has new strip of asphalt. There is a small gravel strip adjacent to roadside vegetation.	N	No issues to report at time of inspection.

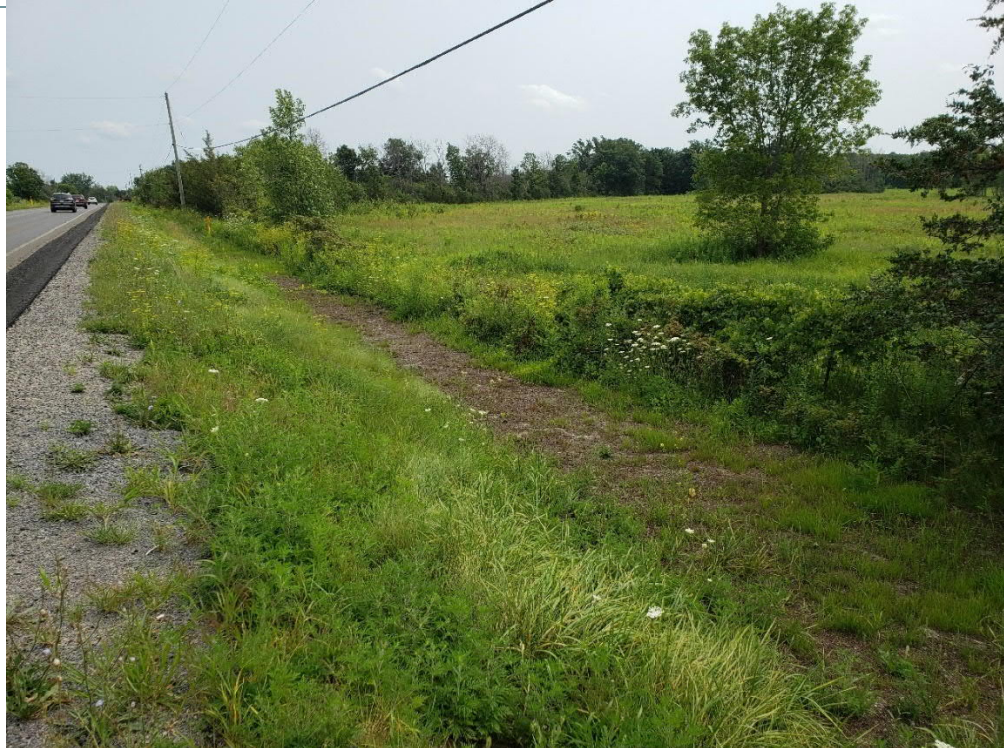
ID #	Location	Site Condition	Additional Work Recommended (Y/N)	Comments/Recommendations	Representative Photo (July 24, 2024)
51	Across from 1387 York Road	ROW has new strip of asphalt. There is a small gravel strip adjacent to roadside vegetation. Some areas of exposed soil within ditch.	Y	Monitor in following growing season. Reseed as necessary.

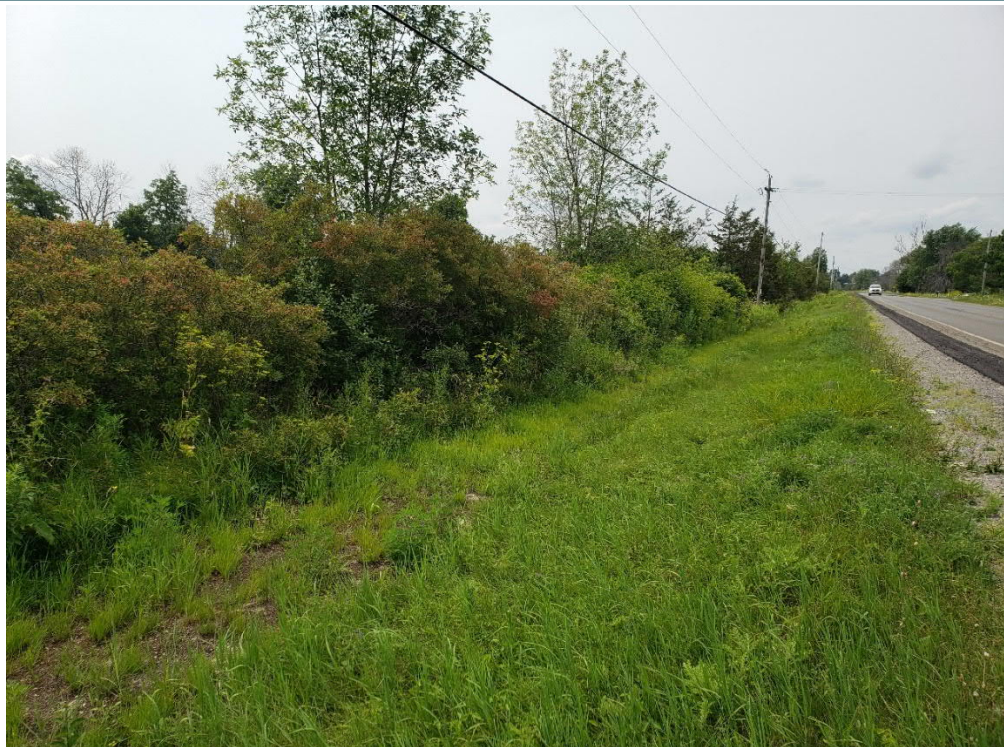
52	1462 York Road	ROW has new strip of asphalt. There is a small gravel strip adjacent to roadside vegetation. Some areas of exposed soil within ditch.	Y	Monitor in following growing season. Reseed as necessary

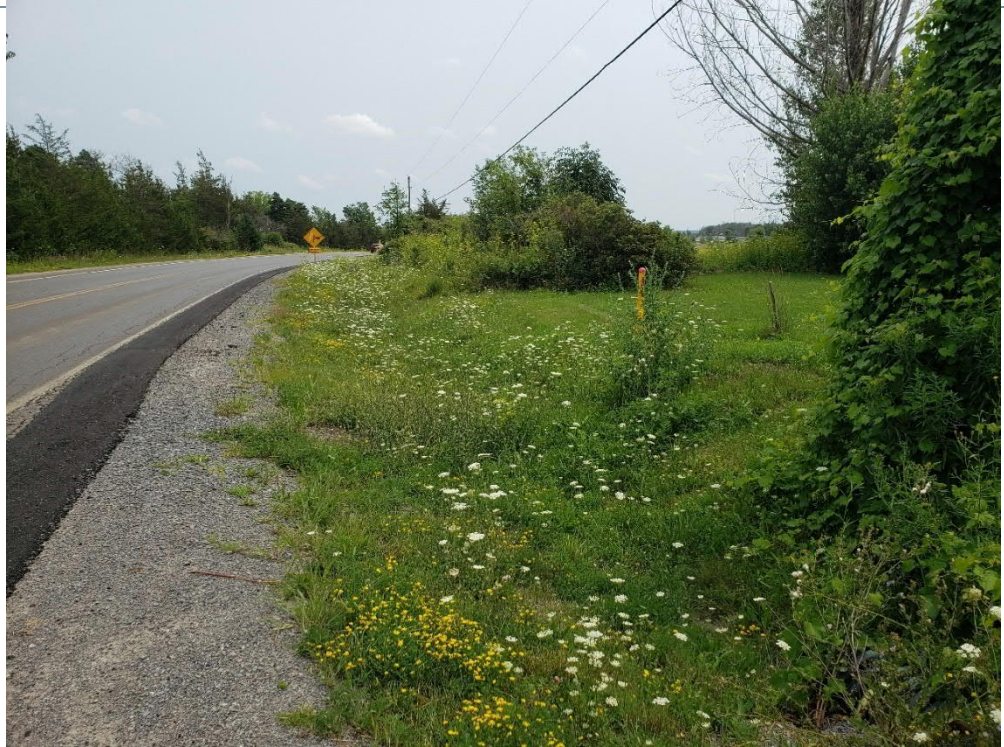
ID #	Location	Site Condition	Additional Work Recommended (Y/N)	Comments/Recommendations	Representative Photo (July 24, 2024)
53	1474 York Road	ROW has new strip of asphalt. There is a small gravel strip adjacent to roadside vegetation.	N	No issues to report at time of inspection.

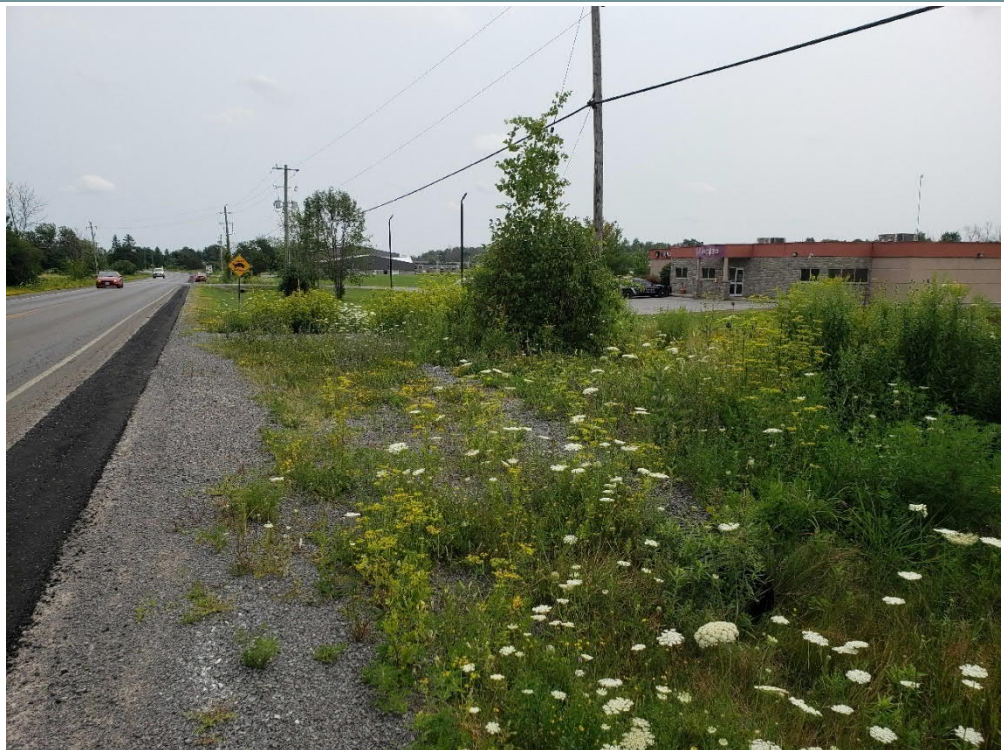
54	1508 York Road	ROW has new strip of asphalt. There is a small gravel strip adjacent to roadside vegetation.	N	No issues to report at time of inspection.

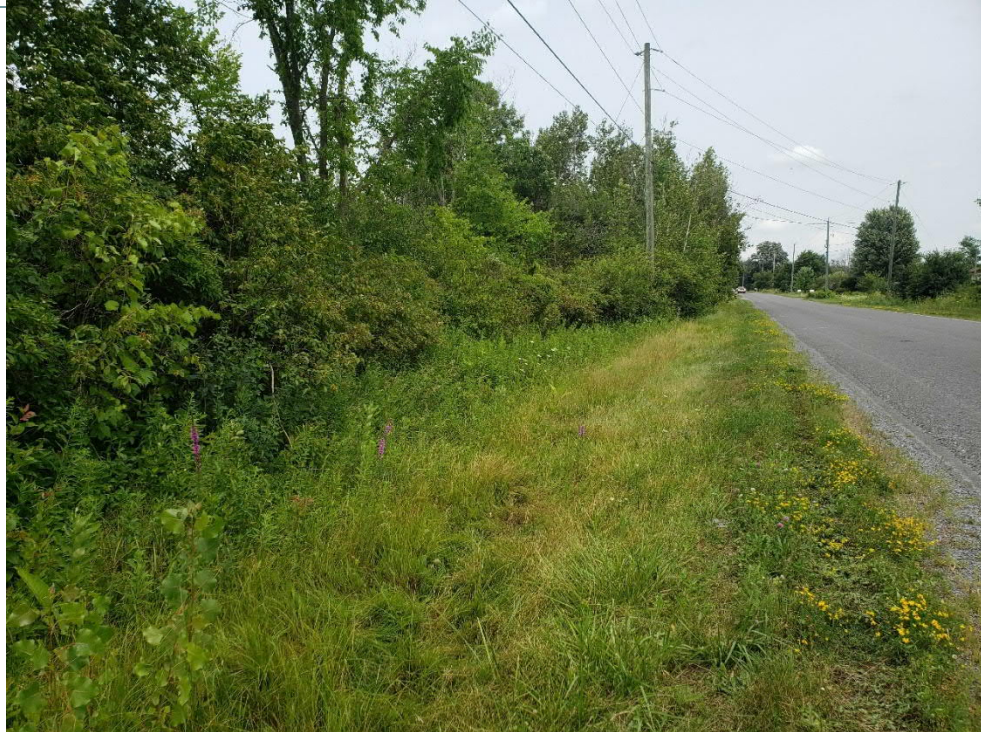
ID #	Location	Site Condition	Additional Work Recommended (Y/N)	Comments/Recommendations	Representative Photo (July 24, 2024)
55	East of 830 Ridge Road	ROW and roadside are vegetated.	N	No issues to report at time of inspection.

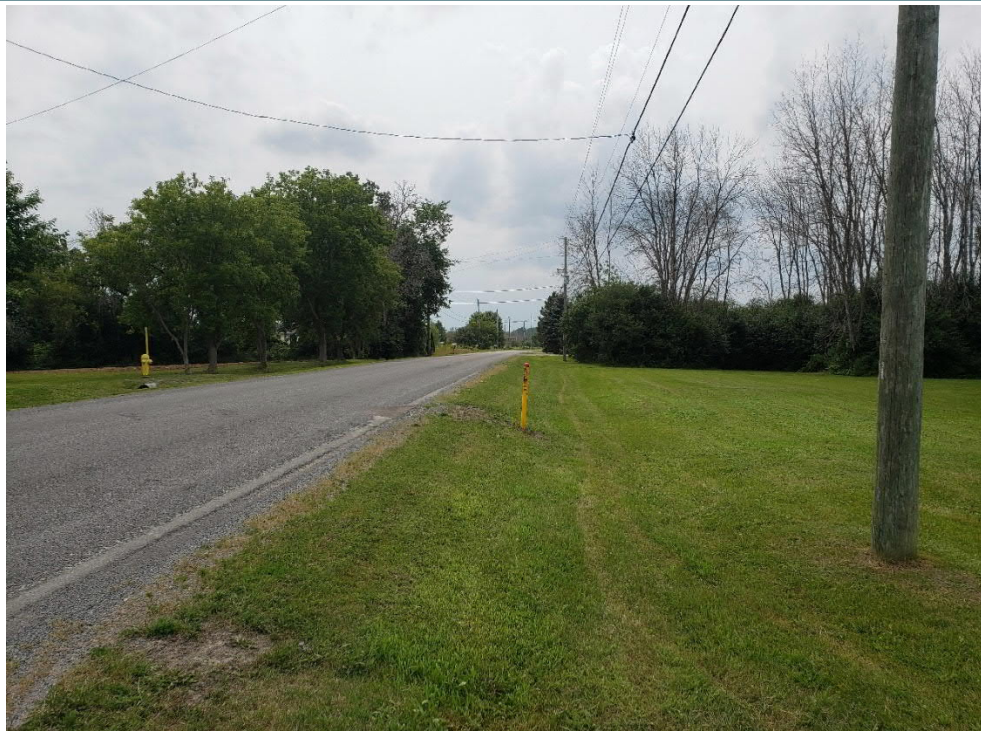
56	962 Ridge Road	ROW and roadside are vegetated.	N	No issues to report at time of inspection.

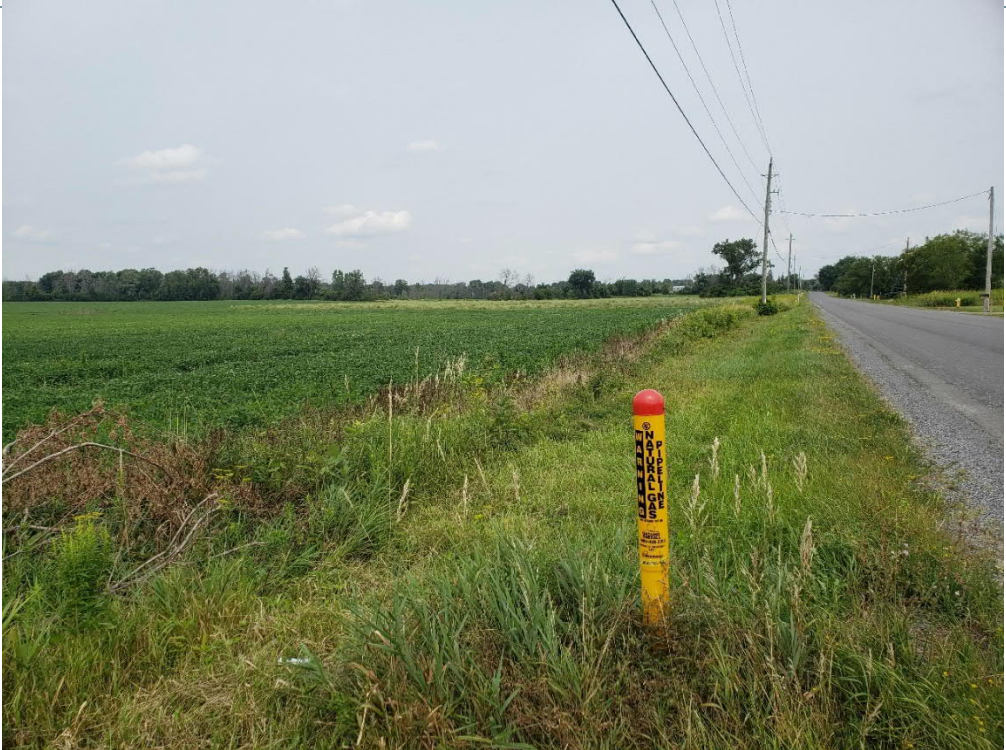
ID #	Location	Site Condition	Additional Work Recommended (Y/N)	Comments/Recommendations	Representative Photo (July 24, 2024)
57	1020 Ridge Road	ROW and roadside are vegetated.	N	No issues to report at time of inspection.

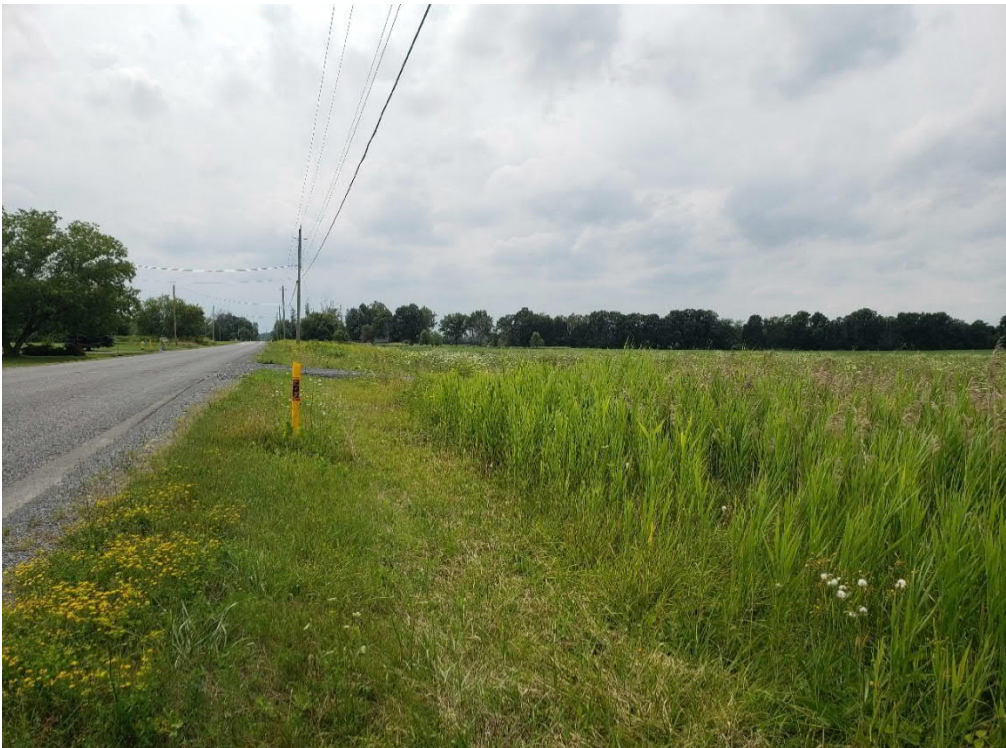
58	1068 Ridge Road	ROW and roadside are vegetated.	N	No issues to report at time of inspection.

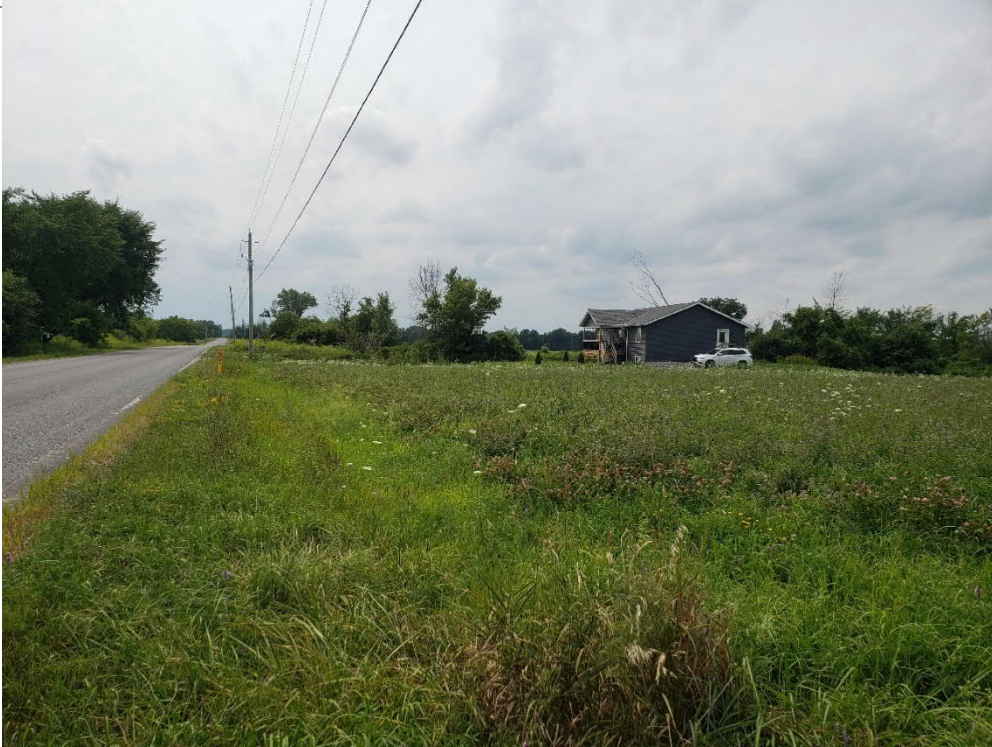
ID #	Location	Site Condition	Additional Work Recommended (Y/N)	Comments/Recommendations	Representative Photo (July 24, 2024)
59	1148 Ridge Road	ROW and roadside are vegetated.	N	No issues to report at time of inspection.

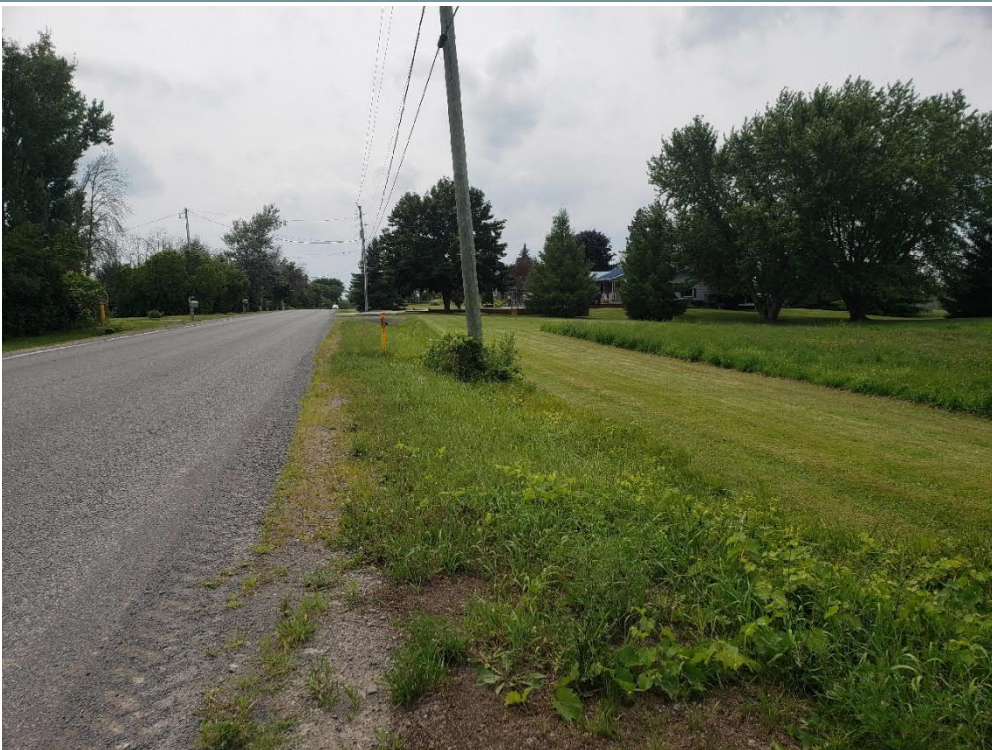
60	1208 Ridge Road	ROW and roadside are vegetated with very small patches of exposed soil.	N	No issues to report at time of inspection.

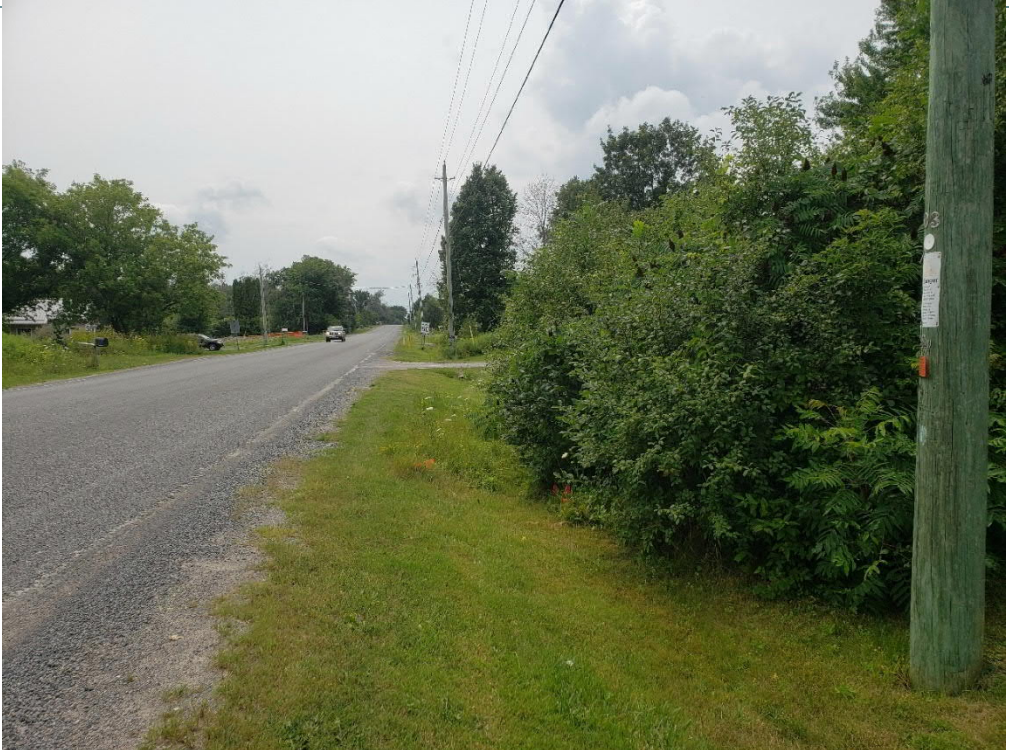
ID #	Location	Site Condition	Additional Work Recommended (Y/N)	Comments/Recommendations	Representative Photo (July 24, 2024)
61	1253 Ridge Road	ROW is gravelled and roadside is vegetated with grass alongside manicured lawn.	N	No issues to report at time of inspection.

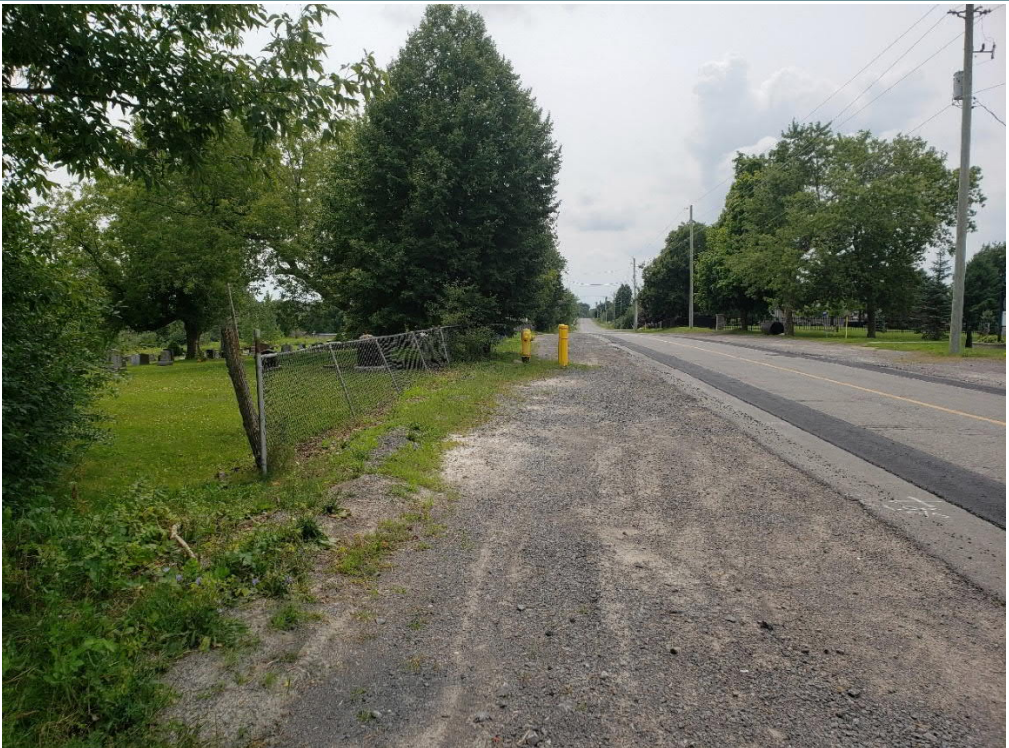
62	West of 1310 Ridge Road	New strip of asphalt in ROW and roadside is gravelled with some vegetation adjacent to cemetery fence.	N	No issues to report at time of inspection.

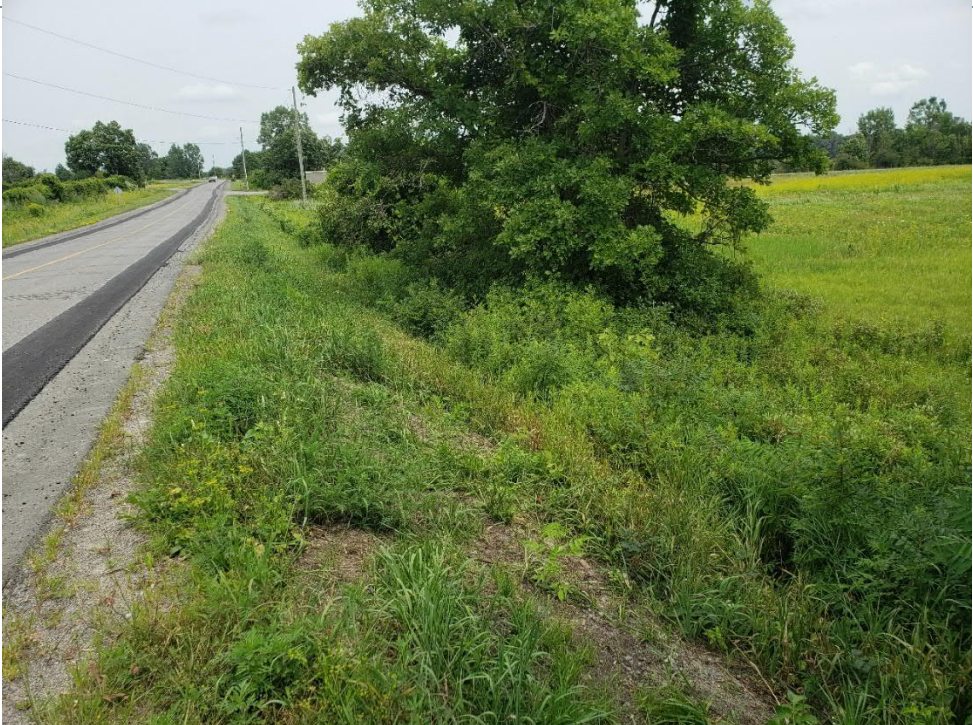
ID #	Location	Site Condition	Additional Work Recommended (Y/N)	Comments/Recommendations	Representative Photo (July 24, 2024)
63	Ridge Road east of intersection with Sadies Lane	New strip of asphalt in ROW. Roadside is vegetated.	N	No issues to report at time of inspection.

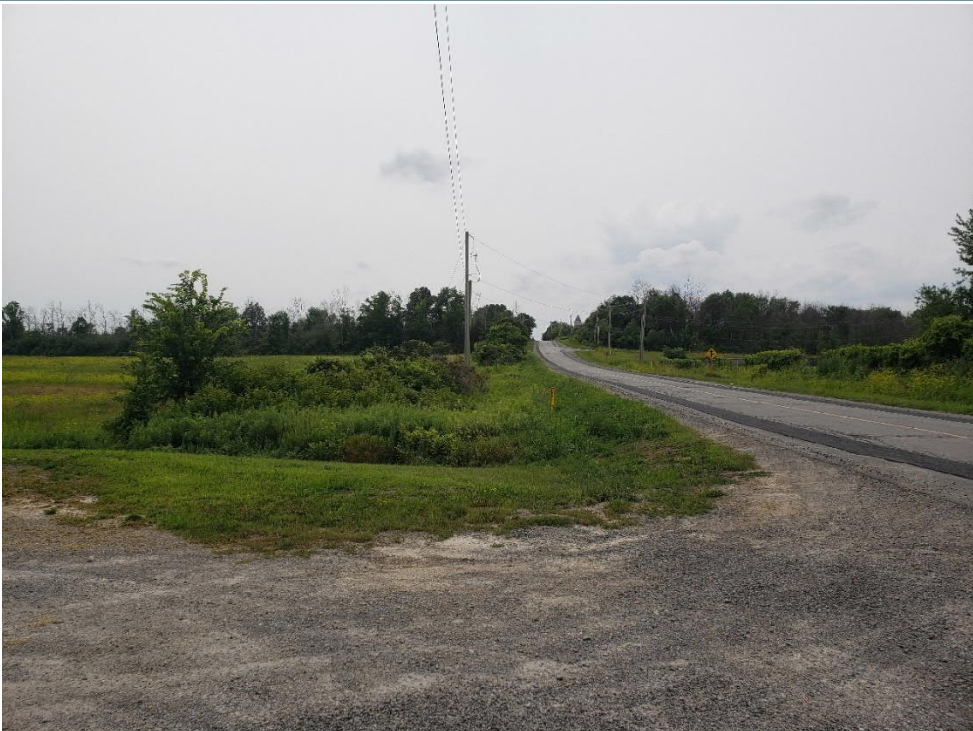
64	1384 Ridge Road	Gravelled driveway, roadside is vegetated.	N	No issues to report at time of inspection.

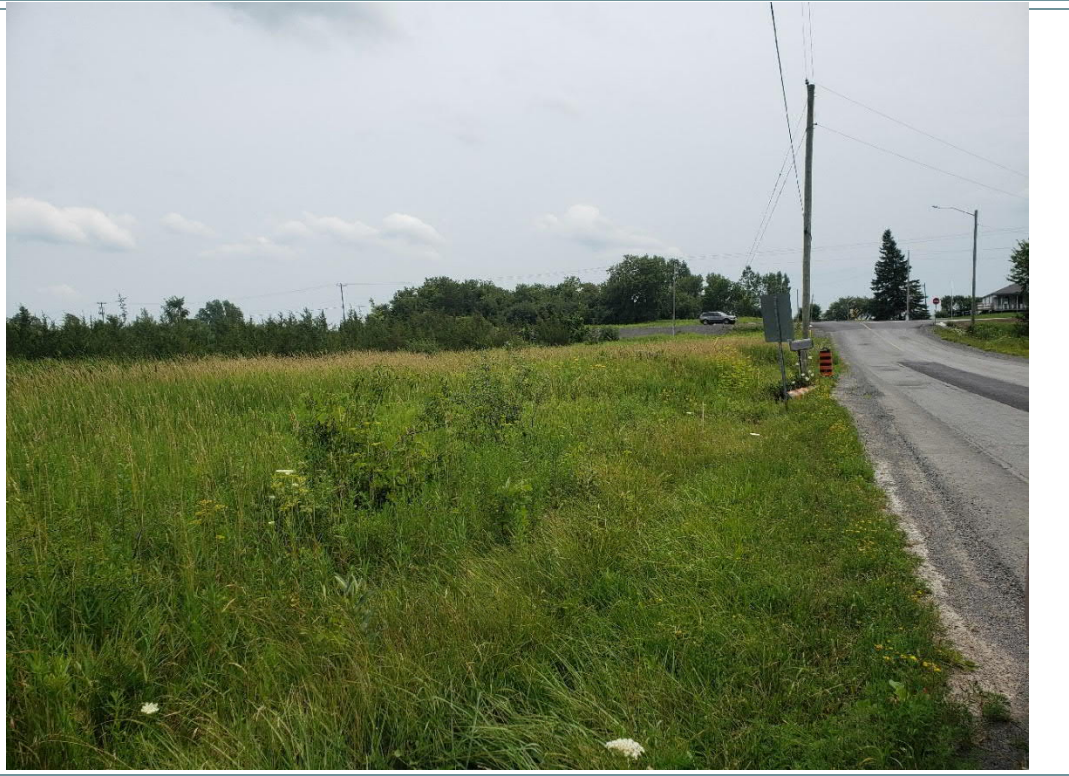
ID #	Location	Site Condition	Additional Work Recommended (Y/N)	Comments/Recommendations	Representative Photo (July 24, 2024)
65	15 Wyman Road	Gravelled ROW, roadside is vegetated. Two pylons on side of road.	Y	Confirmed that pylons do not belong to NPL. No issues to report at time of inspection.

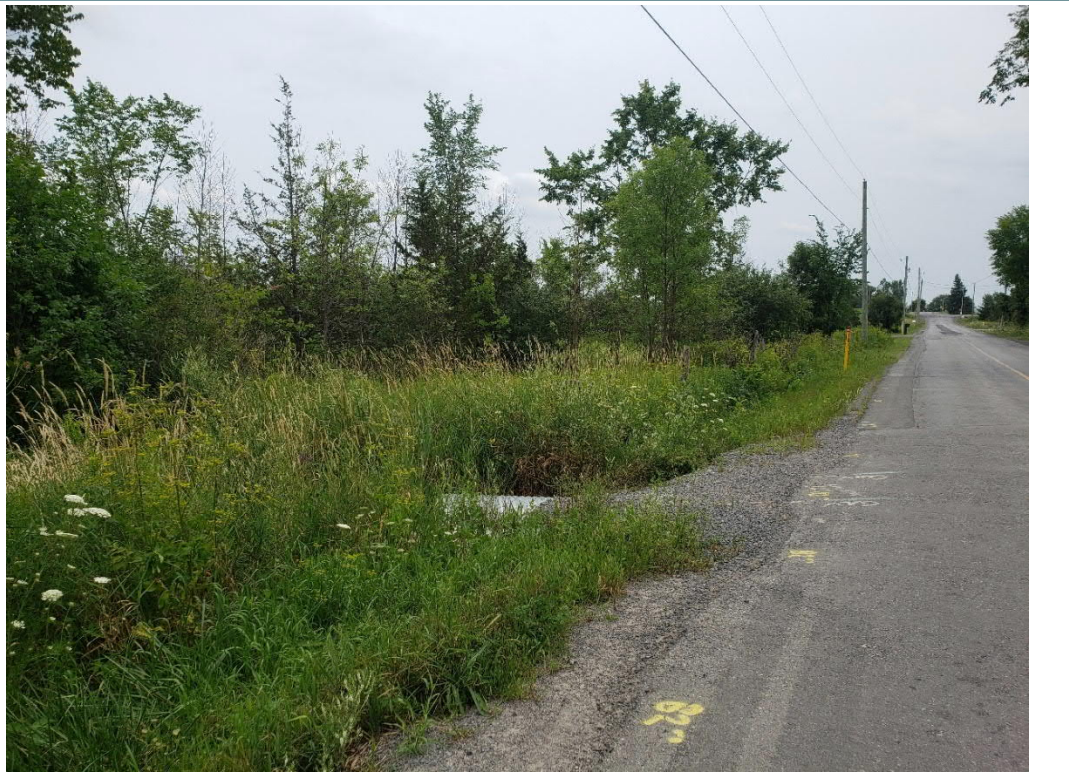
66	North of 27 Wyman Road	ROW is gravelled and roadside is vegetated.	N	No issues to report at time of inspection.

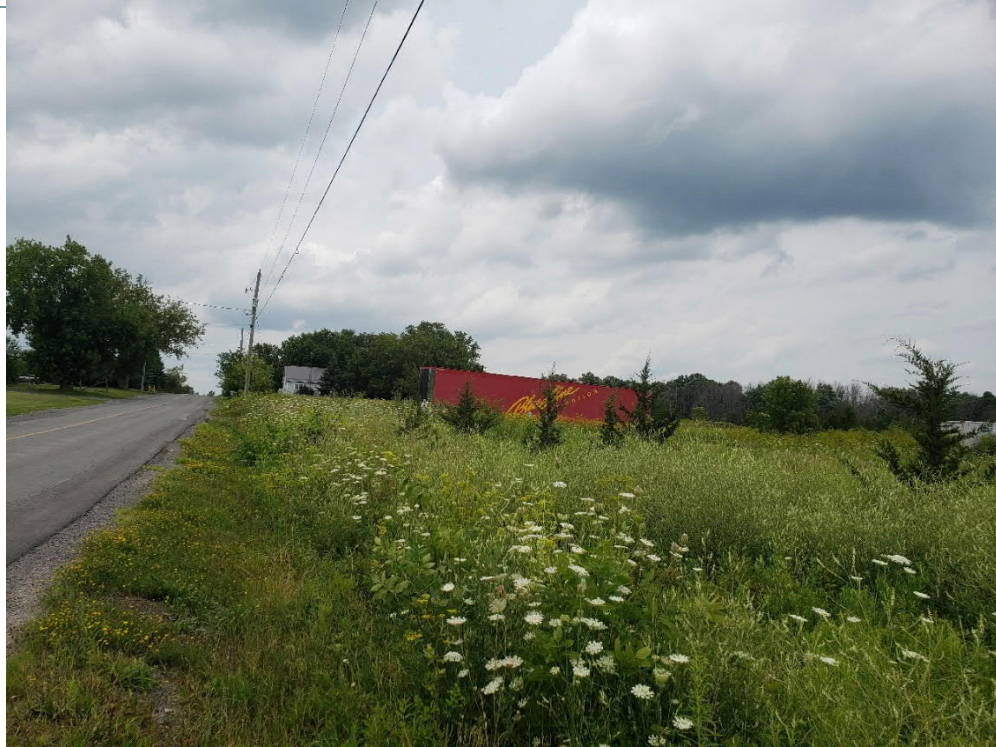
ID #	Location	Site Condition	Additional Work Recommended (Y/N)	Comments/Recommendations	Representative Photo (July 24, 2024)
67	South of 121 Wyman Road	ROW is gravelled and roadside is vegetated.	N	No issues to report at time of inspection.

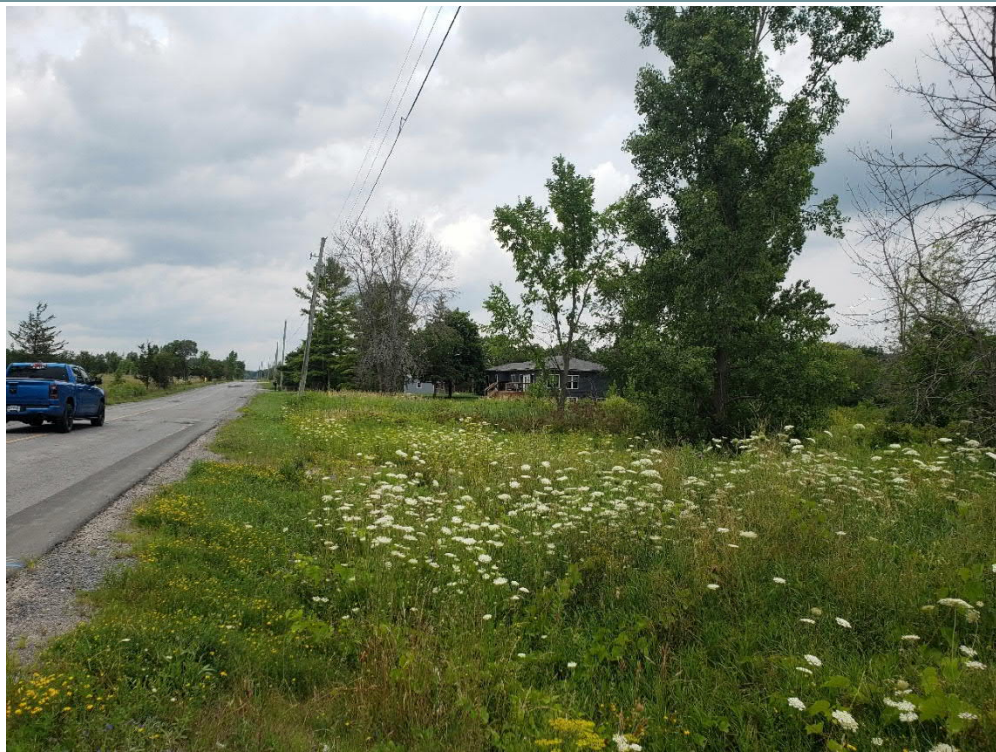
68	North of 134 Wyman Road	ROW is gravelled and roadside is vegetated.	N	No issues to report at time of inspection.
