**Re: Enbridge Gas Inc. (Enbridge Gas)
Ontario Energy Board (OEB) File No.: EB-2022-0248
Mohawks of the Bay of Quinte and Shannonville Community Expansion
Project (Project)**

Post-Construction Report

Mohawks of the Bay of Quinte and Shannonville Community
Expansion Project (EB-2022-0248)

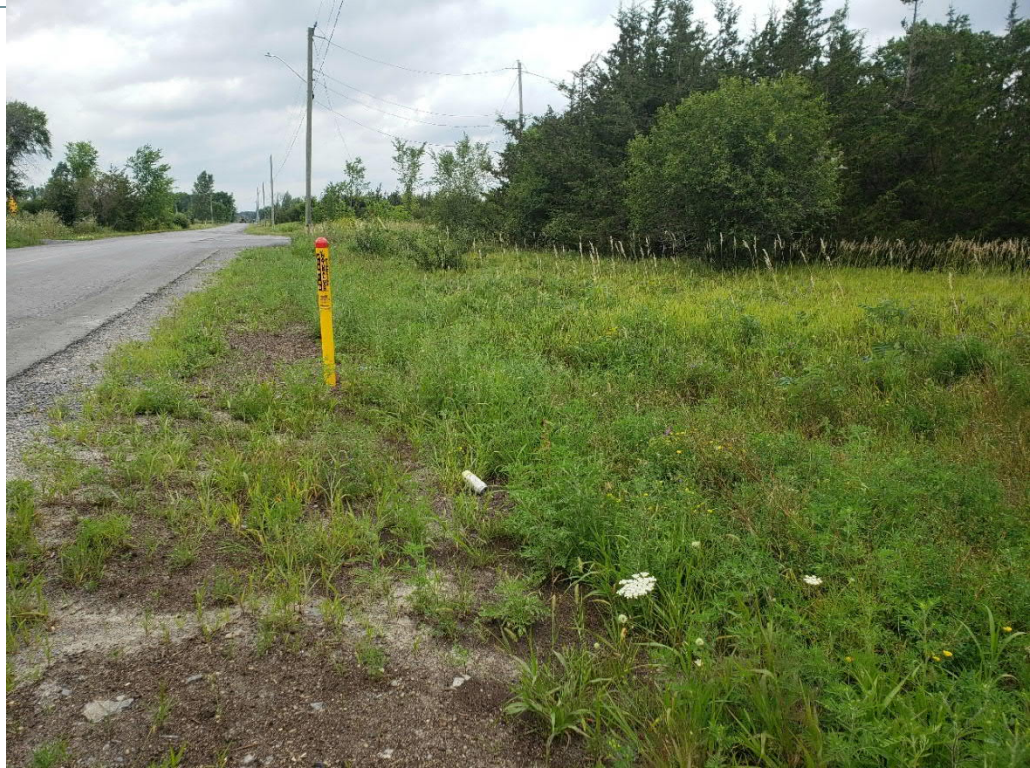
ID #	Location	Site Condition	Additional Work Recommended (Y/N)	Comments/Recommendations	Representative Photo (July 24, 2024)
69	Wyman Road, south of the intersection of Wyman Road and Lower Slash Road	ROW is gravelled and roadside is vegetated with some small areas of exposed soil.	Y	Monitor in following growing season. Reseed as needed.

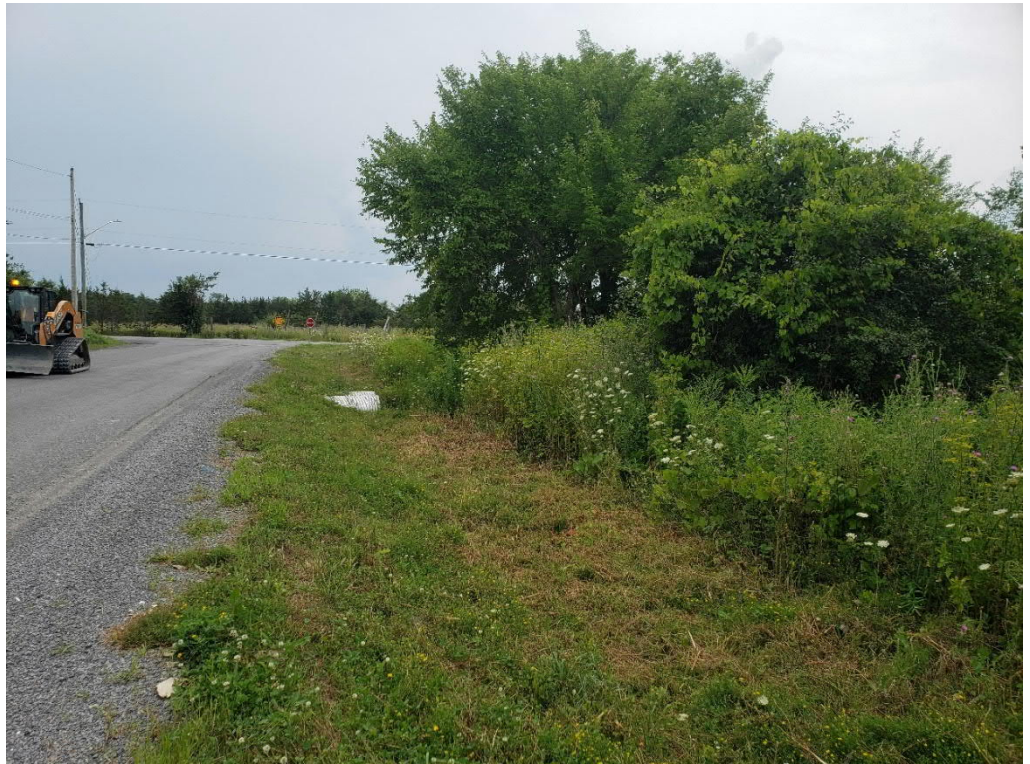
70	Lower Slash Road east of the intersection of Lower Slash Road and Wyman Road	ROW is gravelled and roadside is vegetated.	N	No issues to report at time of inspection.

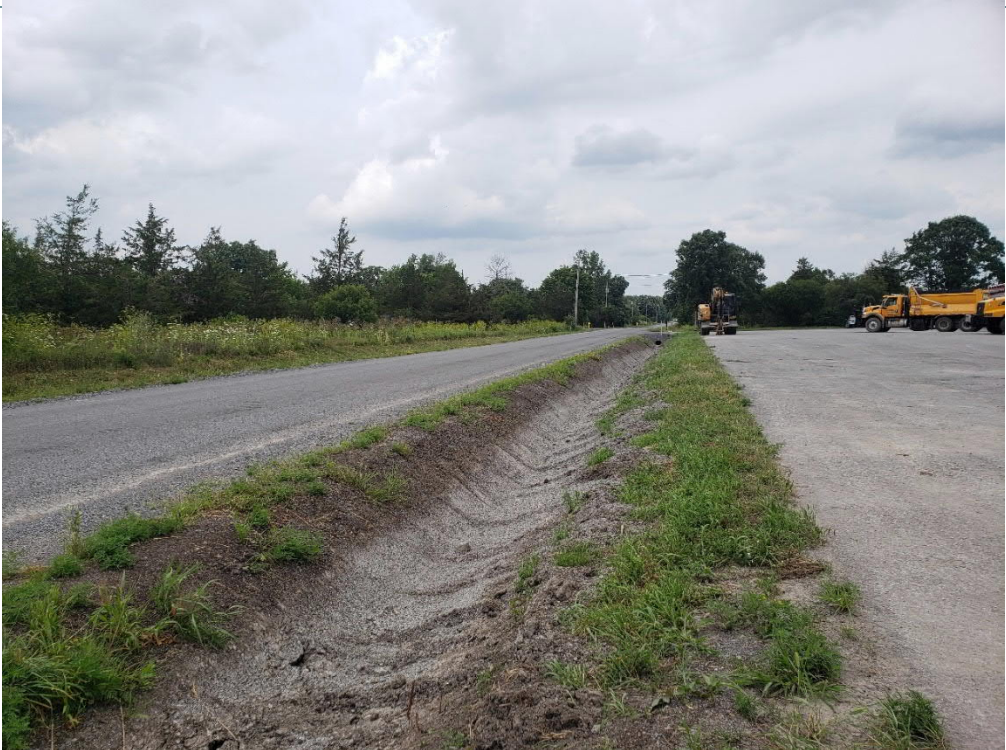
ID #	Location	Site Condition	Additional Work Recommended (Y/N)	Comments/Recommendations	Representative Photo (July 24, 2024)
71	38 Lower Slash Road	ROW is gravelled with some vegetation. Areas of exposed soil along drainage ditch.	N	No issues to report at time of inspection.

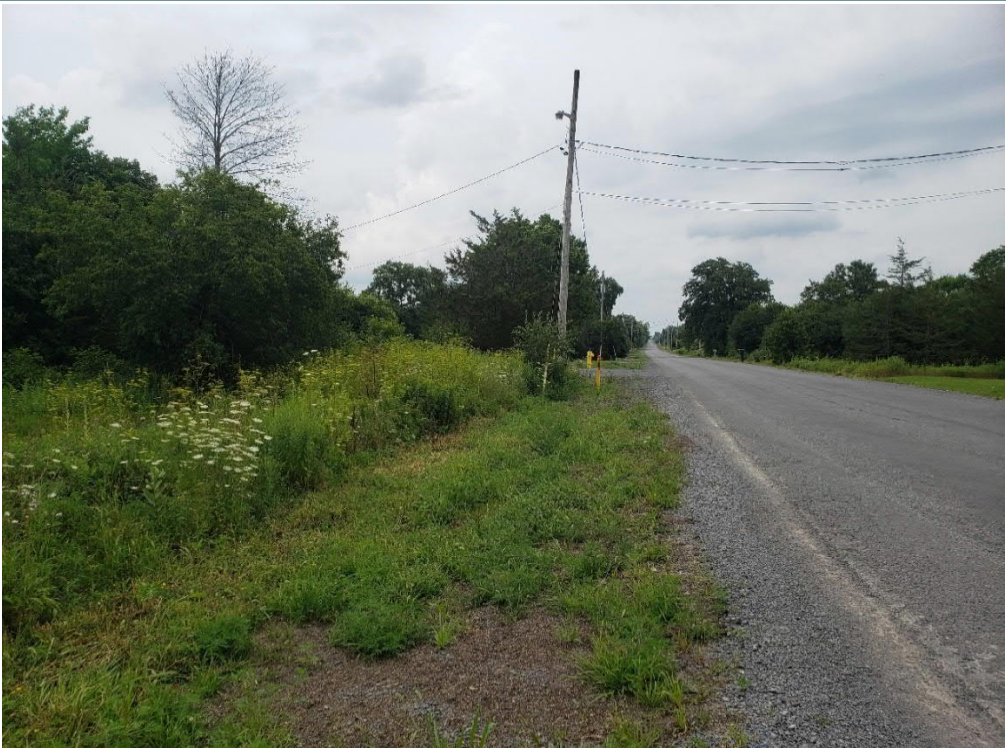
72	38 Lower Slash Road	ROW is gravelled with some roadside vegetation. Some minor areas of exposed soil.	Y	Monitor in following growing season. Reseed as needed.

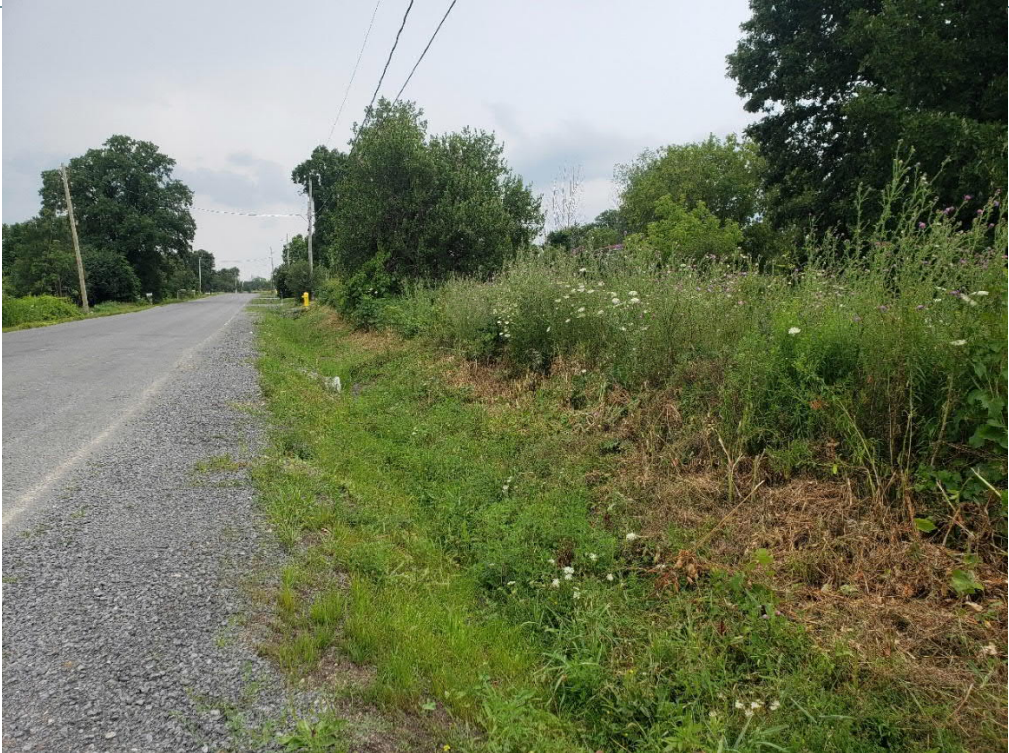
ID #	Location	Site Condition	Additional Work Recommended (Y/N)	Comments/Recommendations	Representative Photo (July 24, 2024)
73	Across from 110 Lower Slash Road	ROW is gravelled and roadside is vegetated.	N	No issues to report at time of inspection.
