### AIRD & BERLIS LLP

Re: Application by Toronto Hydro-Electric System Limited; EB-2012-

0064

ICM Visual Support Booklet

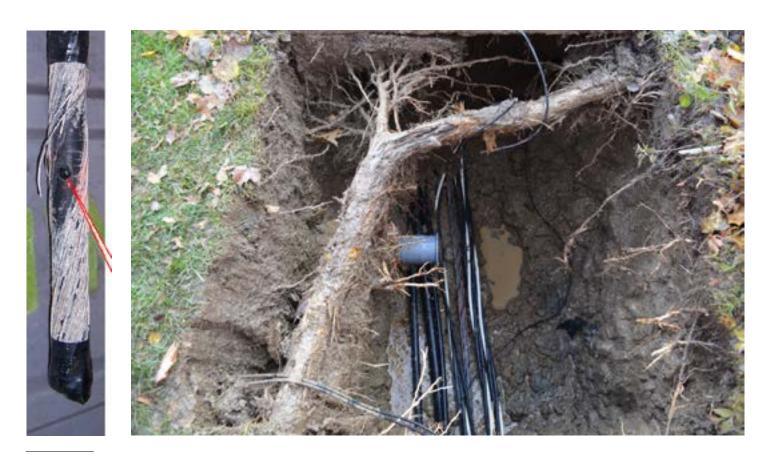
B1 - Fig 40

### **DIRECT BURIED CABLES** - Failed cables

Fault due to insulation failure

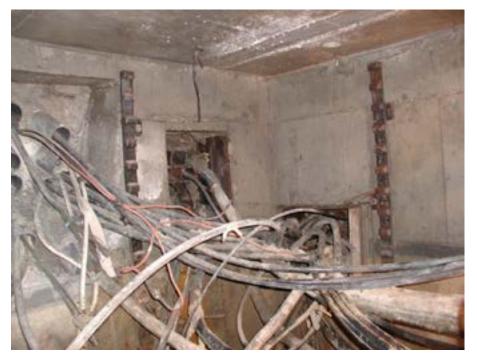
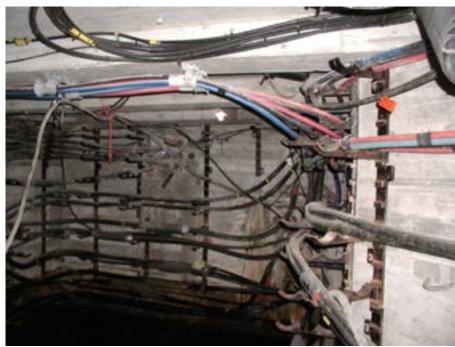
### **PILC CABLES** - Before and after piece out

Not Pieced Out (Before)

Pieced Out (After)

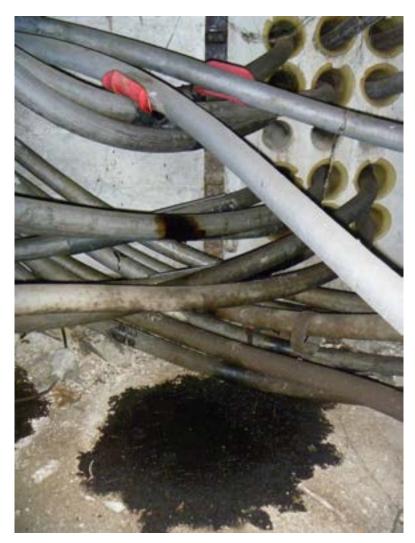
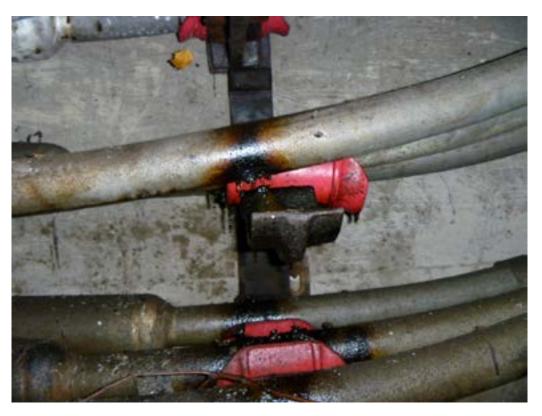
B2 - Fig 3

# **PILC CABLES** – Leaking oil from PILC cables Schedule B2

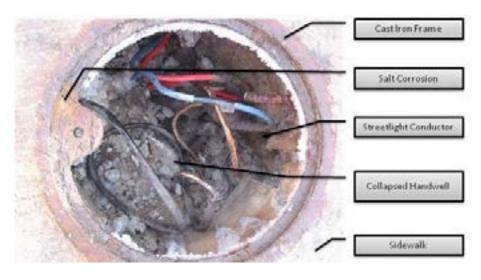
B3 - Fig 1 Open handwell photographed during inspections

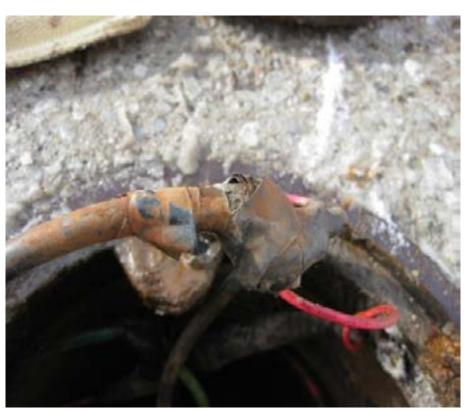
B3 - Fig 3
Degraded conditions of split bolt connectors in handwells

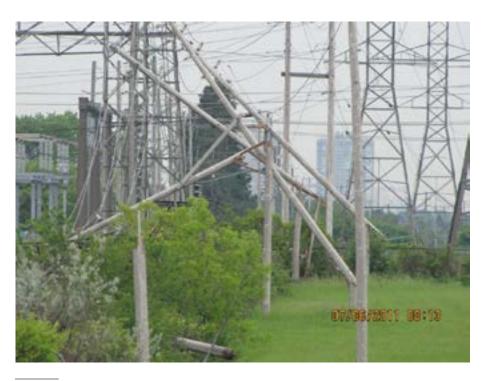
**B4 - Fig 8** Multiple pole failure

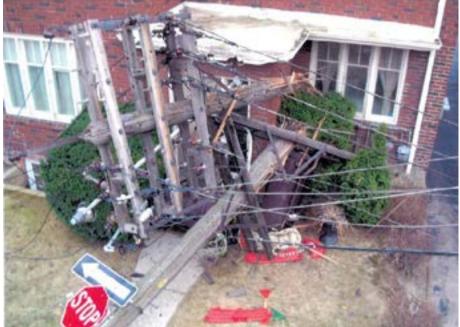
**B4 - Fig 13** Broken pole on home - Acacia Rd.

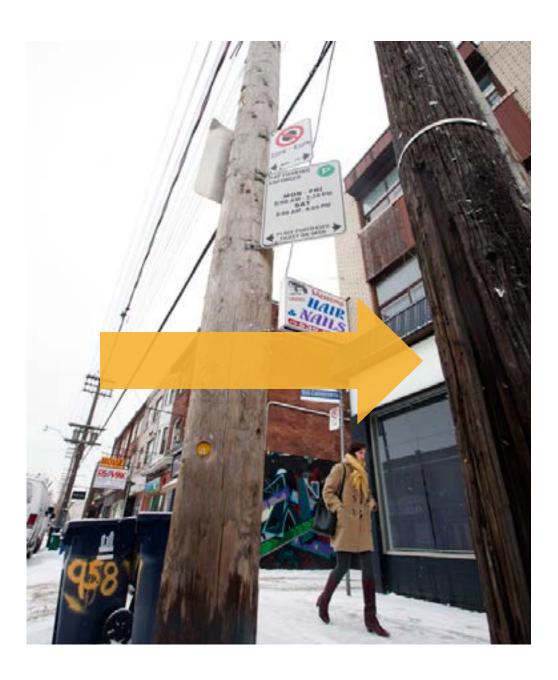
# **POOR CONDITION** – Wooden poles

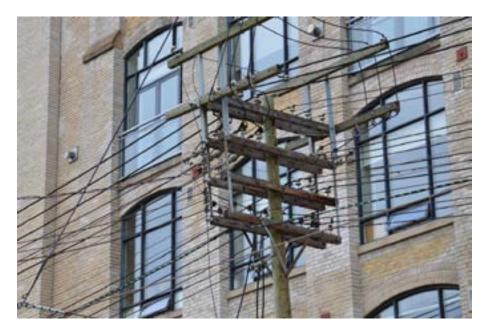
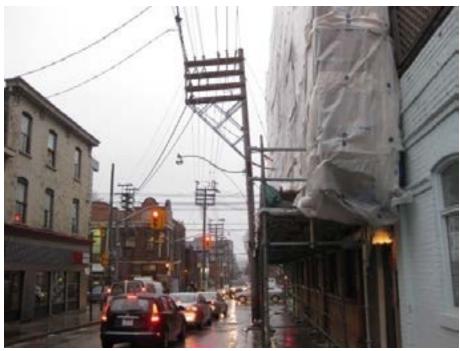
B5 - Fig 6

**POOR CONDITION** – New development/load on existing infrastructure and in close proximity to homes Schedule B5

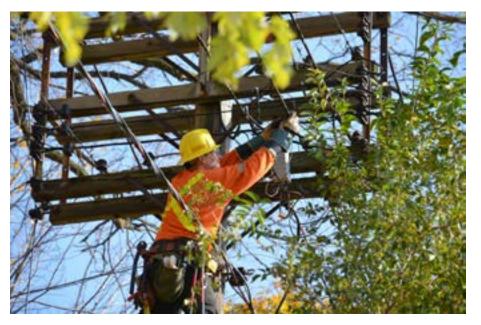
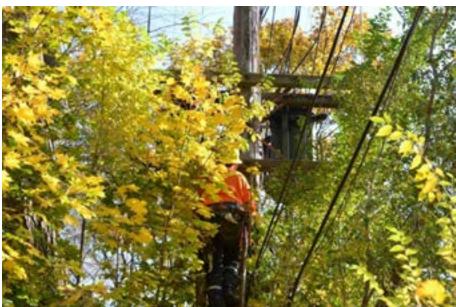
### **REAR LOT CONVERSION** - Before

Difficult to access and make repairs (need to climb poles as trucks can't access backyards)

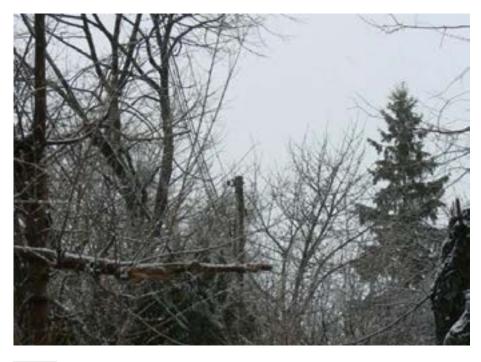
B6 - Fig 10

## **REAR LOT CONVERSION** - Access and safety issues

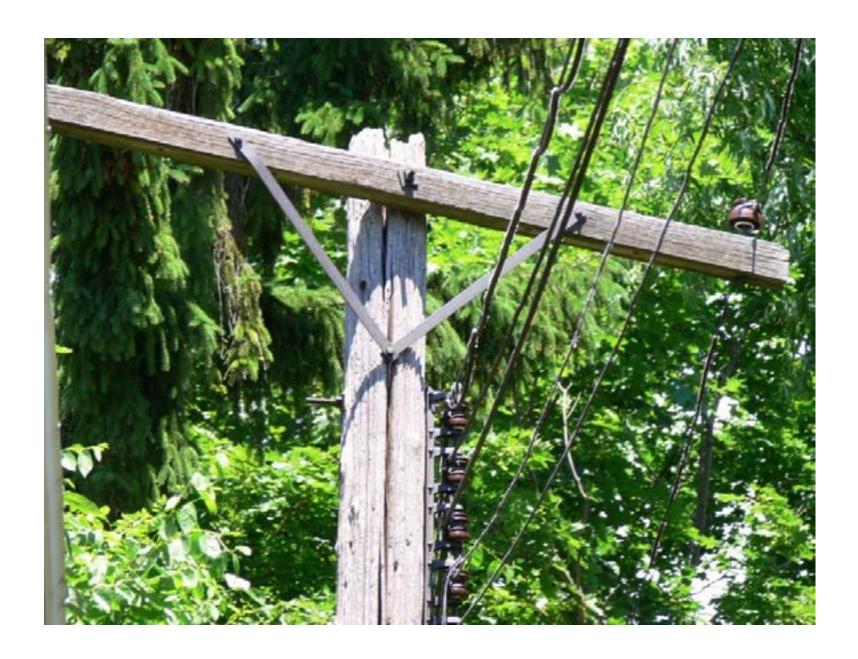
### **REAR LOT CONVERSION** - Poor condition

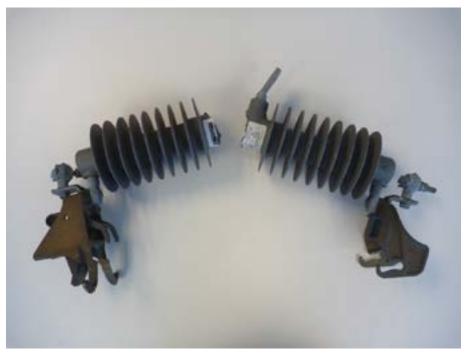
B7 - Fig 3

### **SMD 20 SWITCHES** - Broken switch

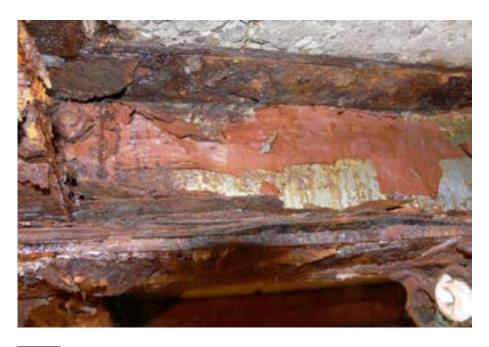
B9 - Fig 7

### **NETWORK VAULTS AND ROOFS** - Poor condition

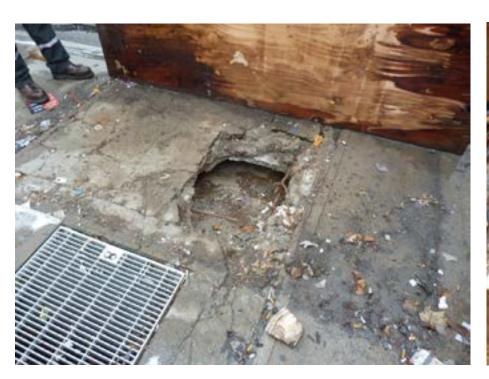
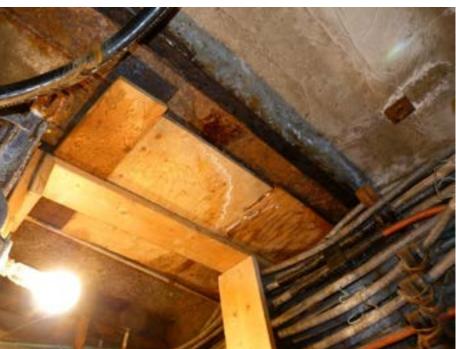
### **NETWORK VAULTS AND ROOFS** - Poor condition

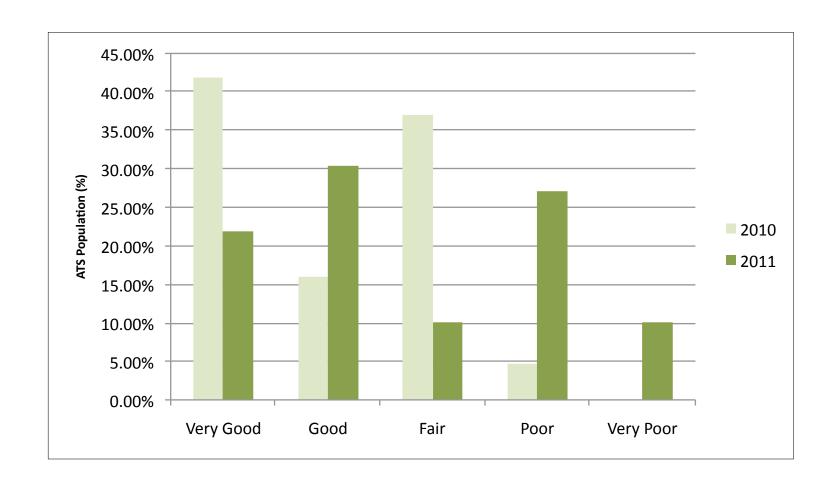
B11 - Fig 2

## **AUTOMATIC TRANSFER SWITCHES AND REVERSE POWER BREAKERS** – Poor condition Schedule B11

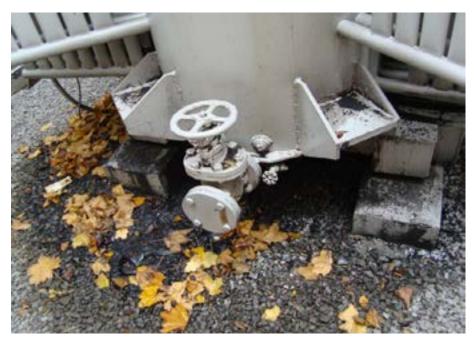
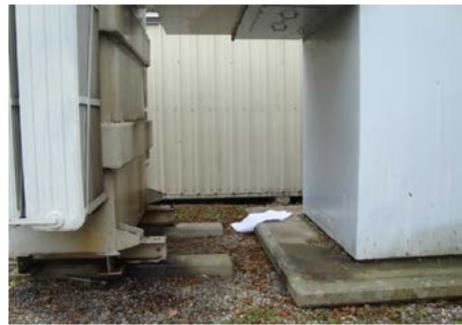
B12 - Fig 1 B12 - Fig 2

### **STATION POWER TRANSFORMERS** - Oil leaks

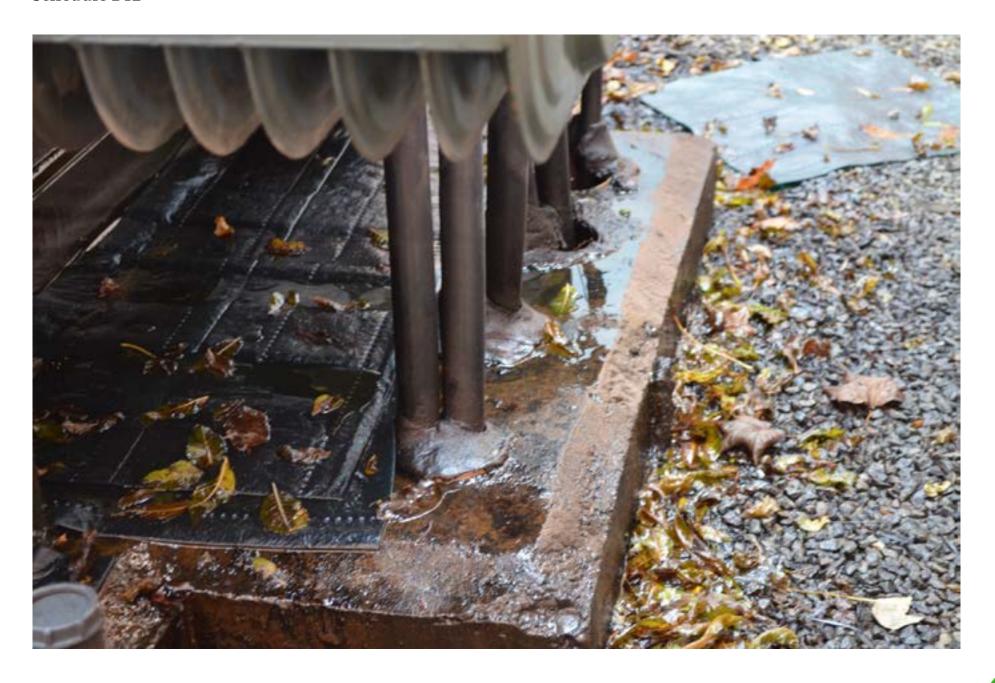
### **STATION POWER TRANSFORMERS** - Oil leaks

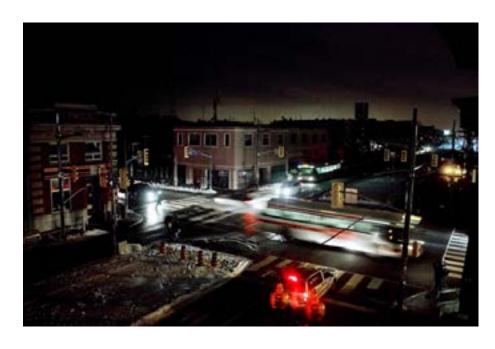
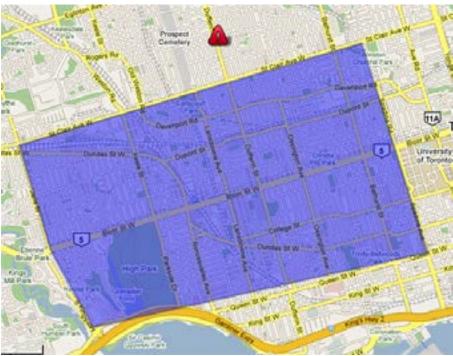
# **DOWNTOWN STATION LOAD TRANSFER** – Dufferin station flooding Schedule B19
