Toronto Hydro-Electric System Limited
EB-2012-0064
Tab 4
Schedule B9
ORIGINAL
(26 pages)

ICM Project – Network Infrastructure and Equipment

Network Vaults and Roofs Segment

Toronto Hydro-Electric System Limited (THESL)

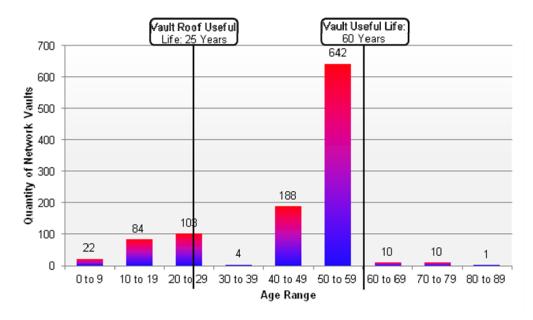
Figure 1: Distribution of Network Vaults

Currently, THESL has 1,064 network vaults in the downtown core supplying the network system. 13

Figure 1 below shows the age distribution of all network vaults and comparison to the useful life 14

of both the overall vault and the roof. While a vast majority of vaults have reached or are 15

quickly approaching their expected end-of-life (60% will have reached end-of-life within the next

ten years or less), a majority (81%) of network vault roofs are already well past the vault roof

expected life of 25 years. 18

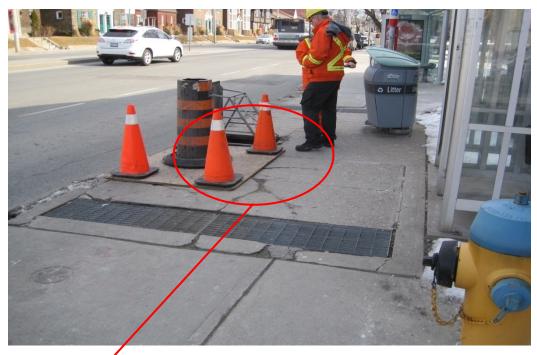
Figure B: Structural failure of vault located near Lawrence/Yonge Street front of a bus shelter, with plywood temporarily covering the hole in sidewalk.

The degradation of network vaults contributes to safety risks for both THESL crew workers and 7 the public. THESL crews routinely enter vaults for routine maintenance on equipment, and are 8 at risk of falling concrete and debris. Similarly, the public is subject to tripping hazards and 9 other personal injuries, as most network vaults are located in heavy pedestrian areas (below 10 sidewalks) in Toronto's downtown core (See Section III, 3). Figure B shows a vault where a 11

portion of the roof has collapsed. 12

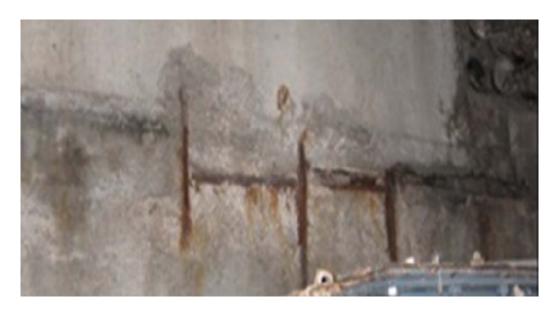
Figure 6: Network Vault Wall with Exposed Rebar

The walls within a network vault are critical to the load bearing capability of the entire vault. Corrosion of the rebar within these walls significantly weakens the structural integrity of the vault as a whole. Over time, corrosion will result in the collapse of the vault walls and may damage the electrical assets contained within, causing a power outage to customers and requiring costly repairs for power restoration. Figure 6 illustrates an example of a network vault wall with exposed rebar.

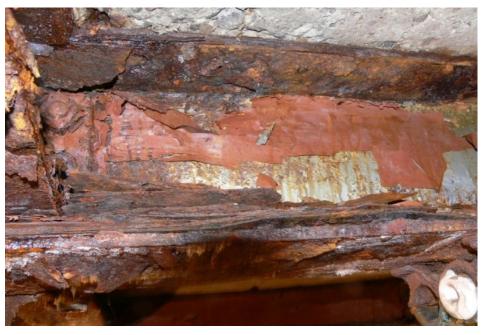
Figure 7: Corroded I-Beams

The I-Beam represents the major support structure for the vault roof. The failure of the I-

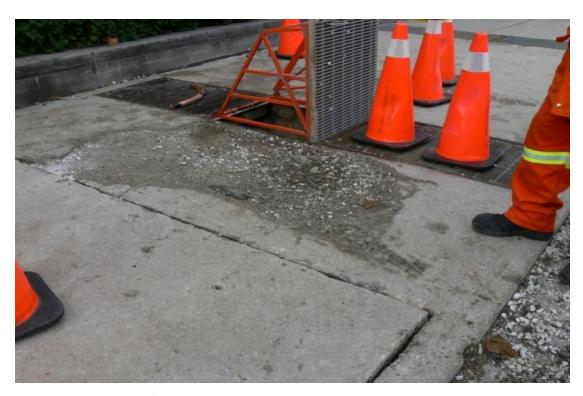
Figure 8: Cracked Roof

- A cracked roof will result in water leaking into the vault. This will accelerate the degradation of 2
- rebar and I-beams and may also lead to rusting, contamination, and degradation of the electrical 3
- assets inside. Leaking water will also increase the risk of a catastrophic failure of critical 4
- electrical assets such as Network Units. In addition, pedestrians may trip and fall due to the 5
- 6 uneven surface caused by the cracks. See Figure 8 below.

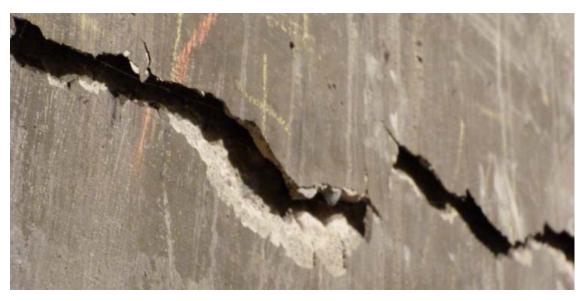
Figure 9: Cracked Wall

When a network vault wall develops cracks it increases the likelihood of water entering the vault, which may ultimately result in vault flooding, thus potentially causing a short circuit and overall outage to the secondary network system. Figure 9 illustrates a typical crack found inside a THESL vault.

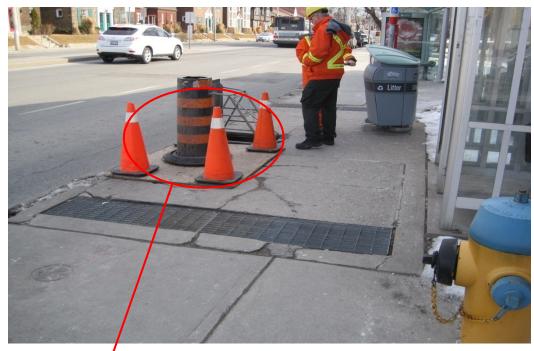
Figure 10: Structural failure of vault located near Lawrence/Yonge St front of a bus shelter,

with plywood temporarily covering the hole in sidewalk. 17

Figures 10 and 11 below illustrate a structural failure of a vault located near Lawrence and Yonge Streets (during March 2010) in front of a bus shelter. The hole in the vault roof is covered temporarily by a piece of plywood, and surrounded by pylons. This failure resulted in disruption to the daily commuter traffic in the vicinity of the station, and had the potential to cause serious

personal injury to pedestrian traffic until it was isolated. 15

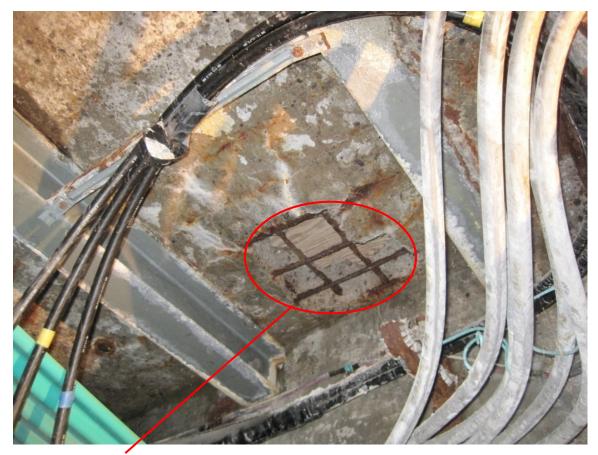
Figure 11: Structural failure of vault located near Lawrence/Yonge Street, as seen from within the vault chamber.

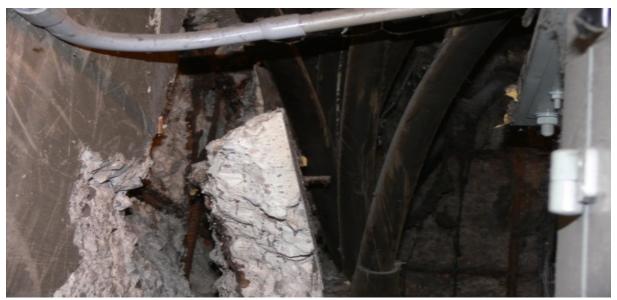
Figure 12: Photo of a large portion of concrete detached from vault wall King/Yonge St

- Figure 12 below illustrates a network vault at the intersection of King and Yonge Streets (during 4
- April 2010) where a large piece of concrete has fallen off the vault wall. This was caused by a 5
- structural deficiency as a result of old age, as well as salt and water entering the vault through 6
- cracks in the vault roof and side walls. The falling concrete had the potential to cause injuries to 7
- THESL crews if they had been present inside the vault performing switching operations at the
- time of the failure.

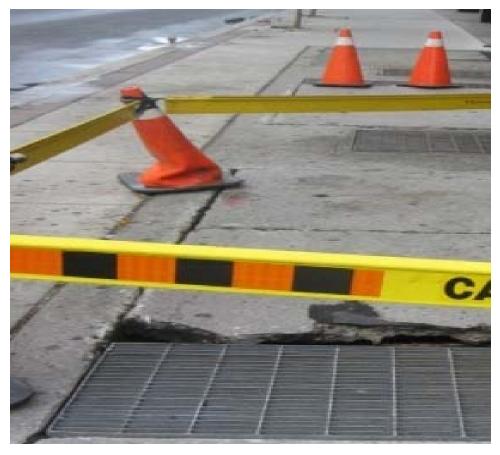
Figure 13: Photo of a vault roof collapsed due to failed supporting beam

- Figure 13 below illustrates the failure of a vault roof located in a busy downtown area. The 2
- edges of the concrete roof have cracked and fallen into the vault. As this is a busy area with a 3
- large amount of pedestrian traffic, this failure posed a potential safety risk to the public. It was 4
- determined that both the beams and roof slabs had deteriorated due to old age and salt usage 5
- on the sidewalk during winter.

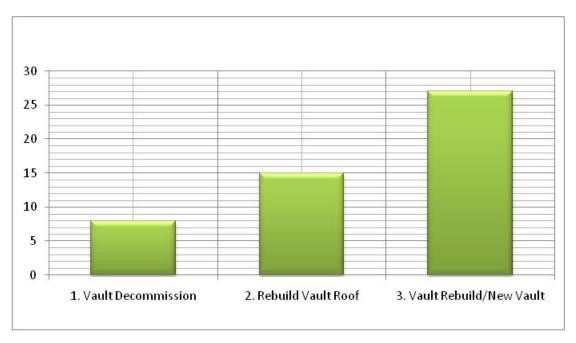
Figure 14: Vault Inspection Results and Civil Work Recommendations

- THESL submits that given the current circumstances and the options available, the most 14
- reasonable and cost effective approach is to undertake the option most suitable to the 15
- circumstances and conditions affecting any particular poor condition vault. This would involve 16
- decommissioning a vault in circumstances where the capacity is no longer required, rebuilding 17
- only the vault roof where the remaining structure is in an acceptable condition, and rebuilding 18
- the entire vault only where absolutely necessary. Figure 14 below shows a breakdown of vaults 19
- identified by the ACA as being in a condition requiring repair. Based on THESL's analysis, 8 20
- vaults in "poor" or "very poor" condition can be decommissioned, 15 of the vaults will only 21
- 22 require a roof rebuild, and 27 will required a complete vault rebuild.

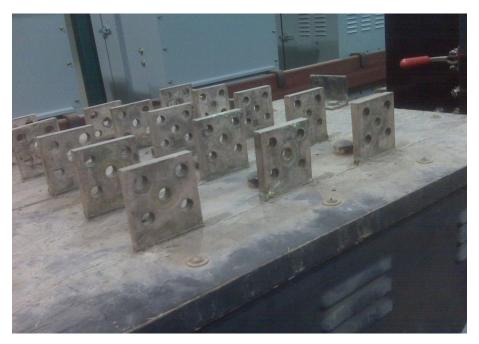
Figure 2: Top of Fibertop Network Unit. Photo Taken September 4, 2009

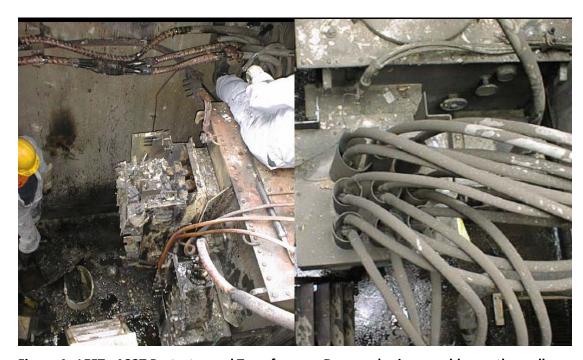
- Figure 4 LEFT: A23T Protector and Transformer. Damaged primary cables on the wall near 8
- the network protector. RIGHT: A26T Protector and Transformer Undamaged. This unit also 9
- has a fibre top network protector. (June 22, 2001) 10

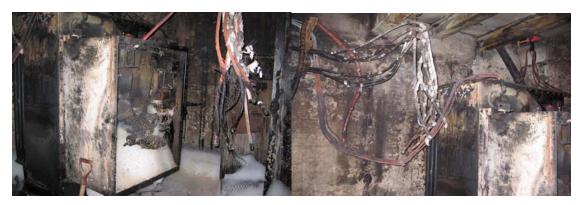
Figure 6 - LEFT: Failed Protector. RIGHT: Burnt AILC cables. (March 24, 2007)

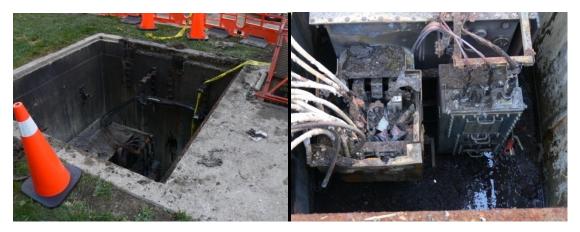
- Figure 7 LEFT: Vault 4557 with roof slabs off, signs of heavy smoke apparent in vault. RIGHT: 1
- 2 damaged Fibertop Network Unit. (June 1, 2010)

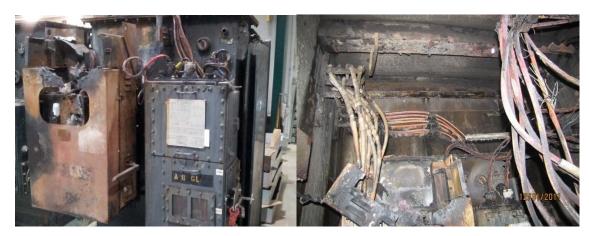
- Figure 9 LEFT: Fire damaged Fibertop Network Unit, Incident #4. RIGHT: Damaged vault
- from fire, Incident #4. (January 3, 2012) 6

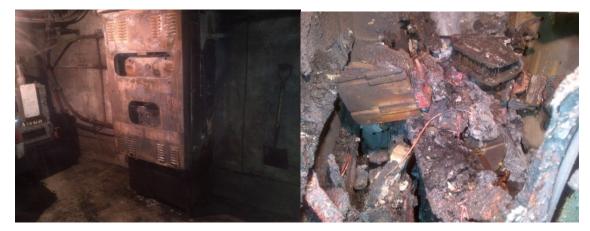
- 6 Figure 4: The figures above show the damaged equipment from the failure at 33 Princess
- Street. The fire destroyed the ATS unit (right). PHOTO TAKEN January 17, 2012

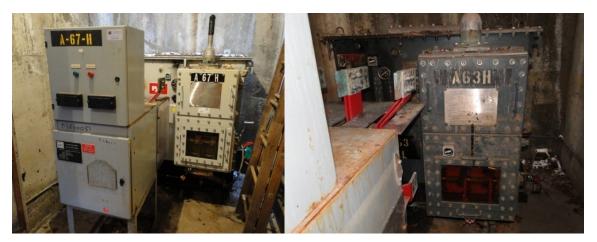
Figure 6: RPB units following failure at 50 Marlborough. PHOTOS from January 10, 2010

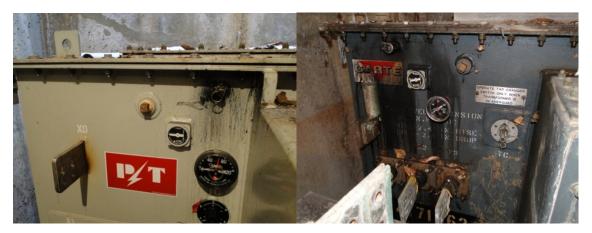
Figure 7: Damaged transformers at 50 Marlborough. PHOTOS from January 10, 2010

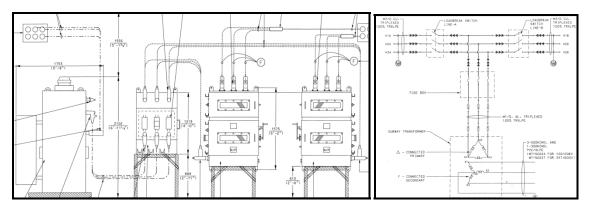
Figure 11: Modular switchgear (submersible equipment)

- Option (c) is to replace the ATS with modular switchgear equipment and retain one existing 1
- distribution transformer (as shown in Figure 11 below). This design replaces the secondary ATS 2
- with primary switching equipment, and as such is applicable at 120/208V, 240/416V and 3
- 347/600V (i.e., all three ATS voltages). Customers could be expected to experience inferior 4
- operating characteristics with this option, as restoration of service is delayed following 5
- unplanned feeder interruptions, due to the requirement to send crews to manually operate the 6
- switches. The time required to perform switching would typically take between one to 4.5 7
- hours. Modular switching equipment also requires unusually large vaults, and would therefore 8
- only be applicable to a small percentage of ATS locations. It is not applicable to RPB locations. 9

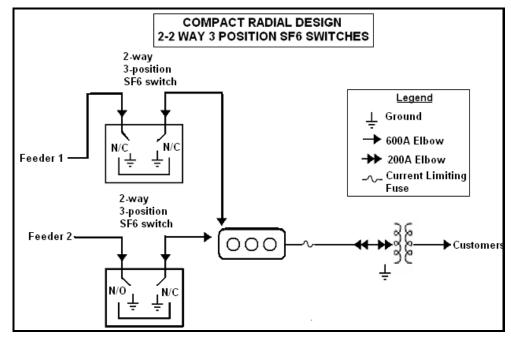
Figure 12: Compact radial (submersible equipment)

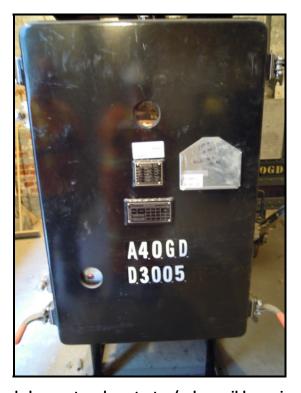
Figure 14: Stand alone network protector (submersible equipment)

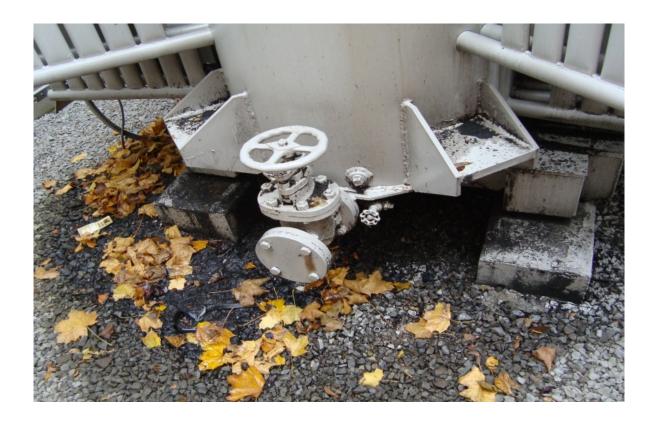
- Figure 1: Station Transformer, TR1, leakage at Ellesmere White Abbey MS (November 16, 1
- 2011) 2

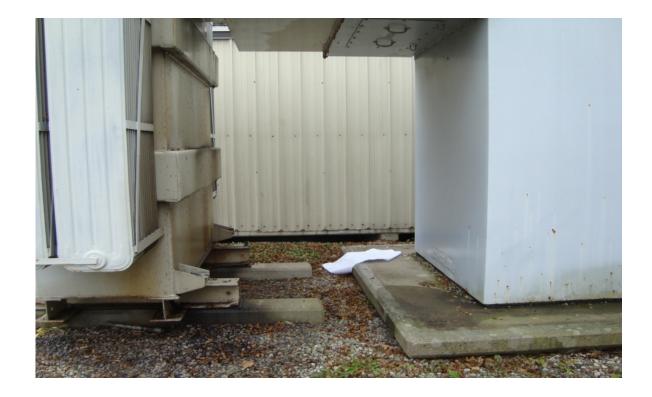
Figure 2: Station Transformer, TR1, leakage at Scarborough Golf Club MS (November 16, 2011)

- 4. Scarborough Golf Club MS
- **Transformer: TR1** 15
- **Age:** 59 16
- Transformer Leakage: Yes 17
- **DGA Results:** Condition 1 (Refer to Appendix 2) 18

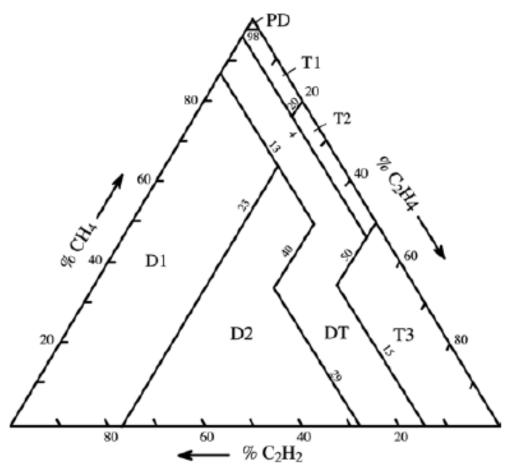
Figure 4: Duval Triangle Method

T >700 °C	coloration
		(800 °C) or metal fusion (> 1000 °C).
DT	Mixtures of electrical	
	and thermal faults in	
	the transformer

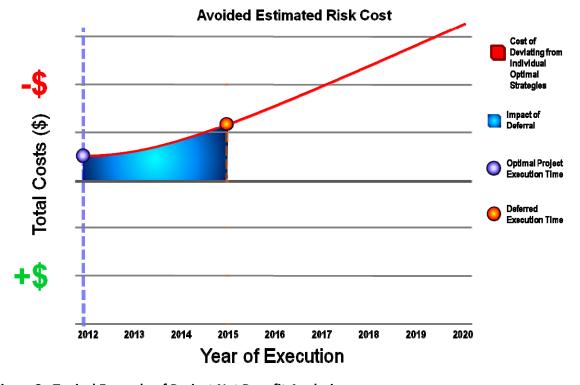
Figure 3: Typical Example of Project Net Benefit Analysis

Note that the Project Net Cost in Figure 3 is plotted with time, in years, as the abscissa and the 10 total costs as the ordinate. As such, the minimum point of this curve provides the highest Net 11 Project Benefit and defines the optimal year to execute the specific project.

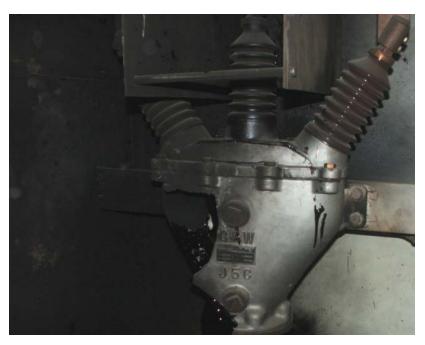
Figure 1: [2007] Pothead failed inside Terauley TS switchgear 1

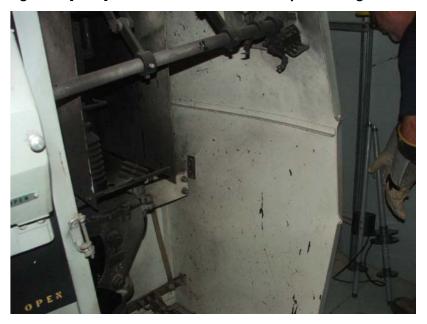
Figure 2: [2007] Impact of internal arc fault in a switchgear

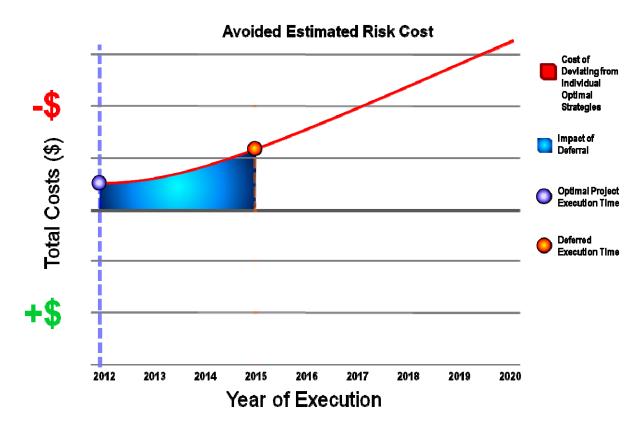
Figure 3: Typical Example of Project Net Benefit Analysis

Note that the Project Net Cost in Figure 3 is plotted with time, in years, as the abscissa and the total costs as the ordinate. As such, the minimum point of this curve provides the highest Net Project Benefit and defines the optimal year to execute the specific project.
