**Re: Enbridge Gas Inc. (Enbridge Gas)
Ontario Energy Board (OEB) File No.: EB-2022-0248
Mohawks of the Bay of Quinte and Shannonville Community Expansion
Project (Project)**

Post-Construction Report

Mohawks of the Bay of Quinte and Shannonville Community
Expansion Project (EB-2022-0248)

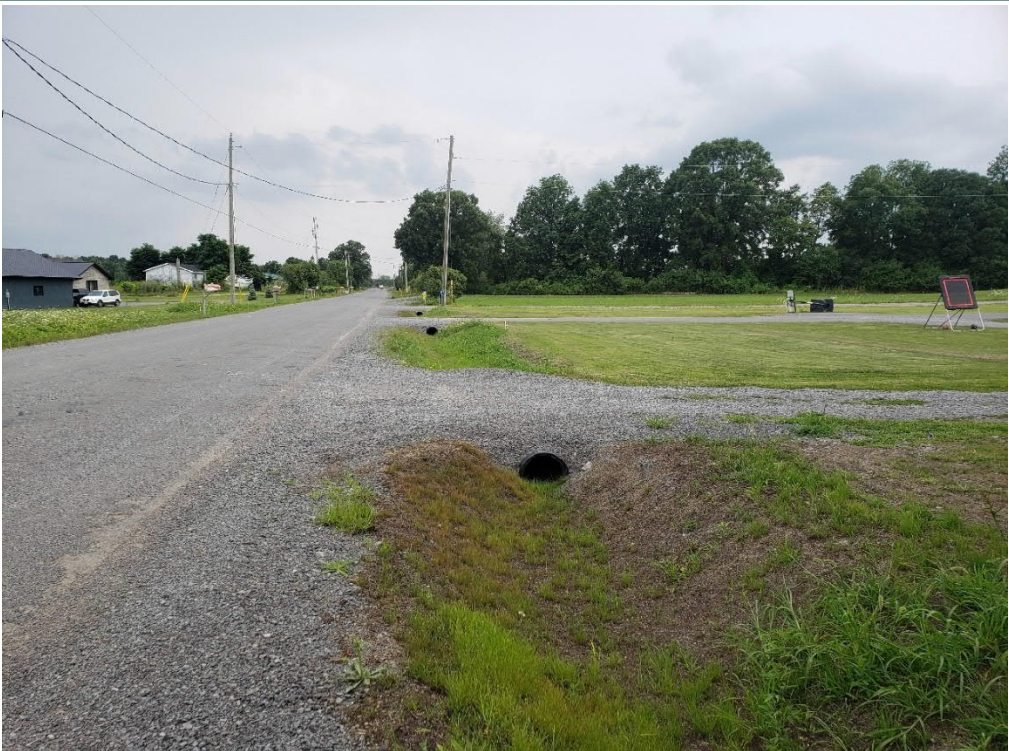
74	West of 169 Lower Slash Road	ROW is gravelled with some vegetation in roadside ditch adjacent to manicured lawn. Culvert appears in good condition.	N	No issues to report at time of inspection.

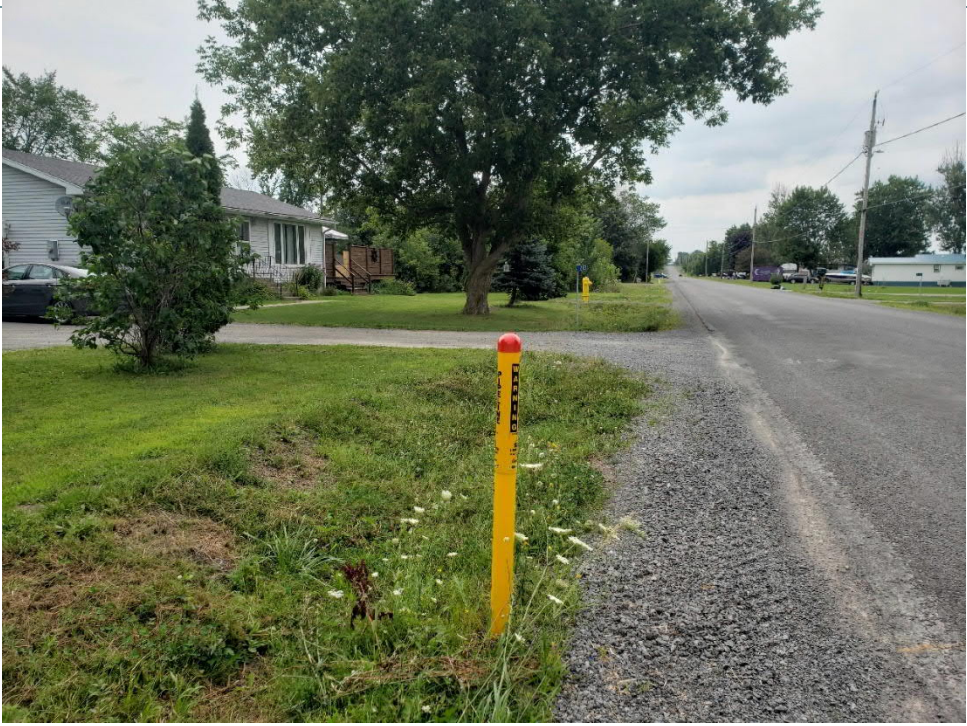
ID #	Location	Site Condition	Additional Work Recommended (Y/N)	Comments/Recommendations	Representative Photo (July 24, 2024)
75	East of 201 Lower Slash Road	ROW is gravelled and roadside ditch is vegetated.	N	No issues to report at time of inspection.

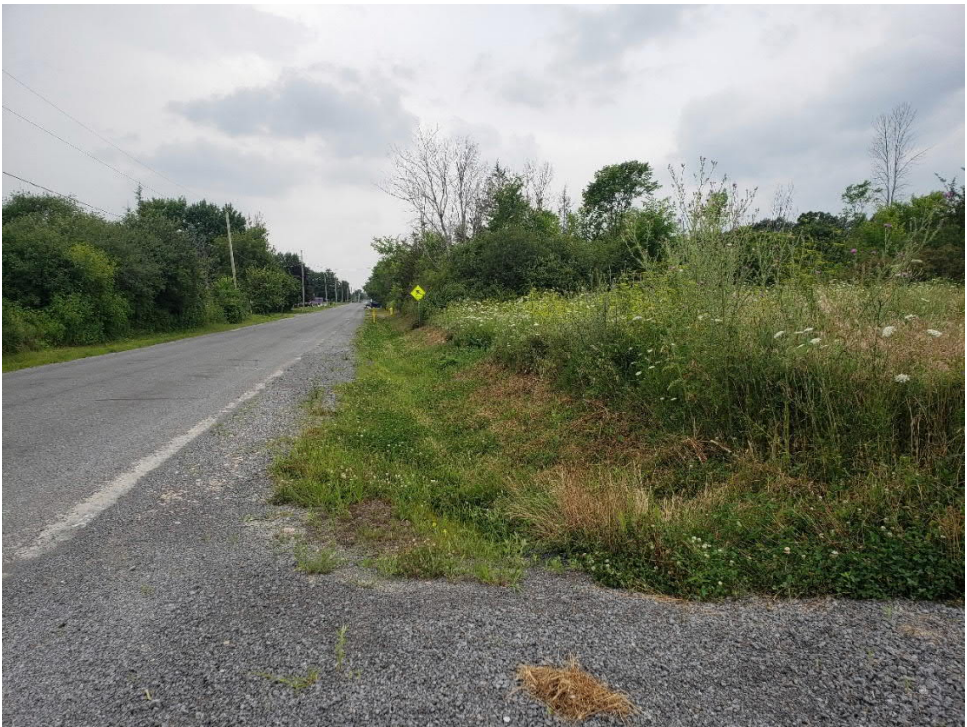
76	West of 307 Lower Slash Road	ROW is gravelled and roadside is vegetated.	N	No issues to report at time of inspection.

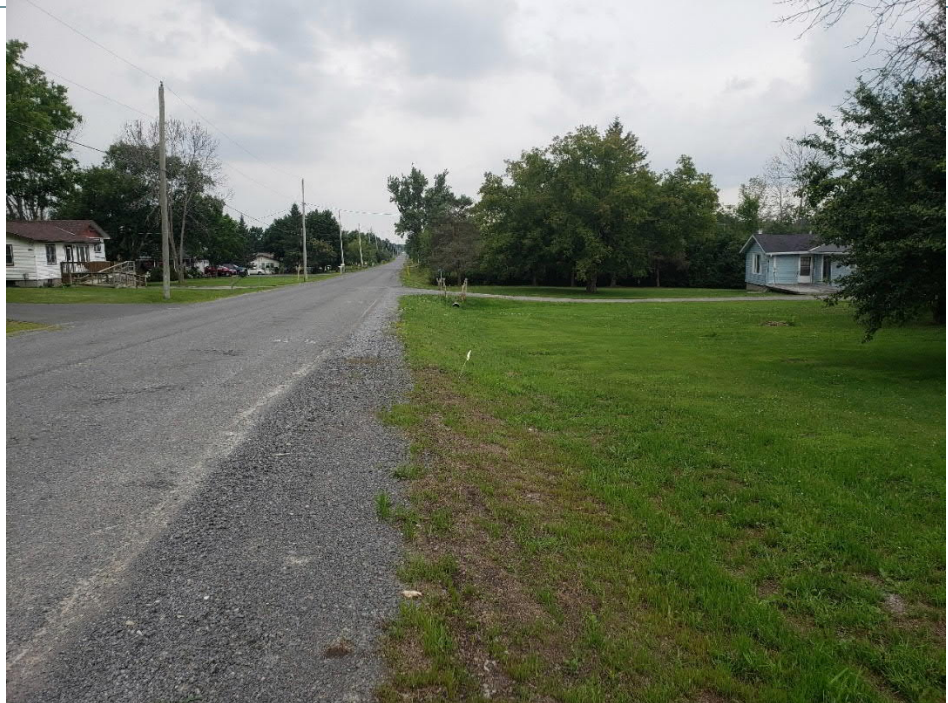
ID #	Location	Site Condition	Additional Work Recommended (Y/N)	Comments/Recommendations	Representative Photo (July 24, 2024)
77	375 Lower Slash Road	ROW is gravelled with some areas of exposed soil adjacent to manicured lawn.	Y	Monitor in following growing season. Reseed as necessary.

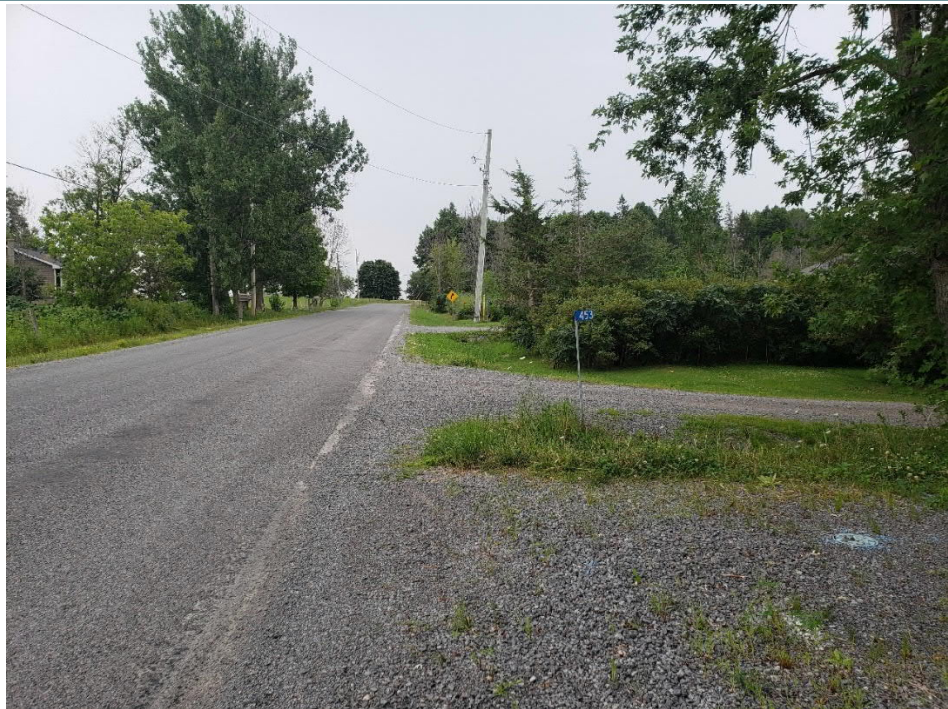
78	453 Lower Slash Road	ROW is gravelled and roadside is partially vegetated. There are gravel driveways in this area.	N	No issues to report at time of inspection.

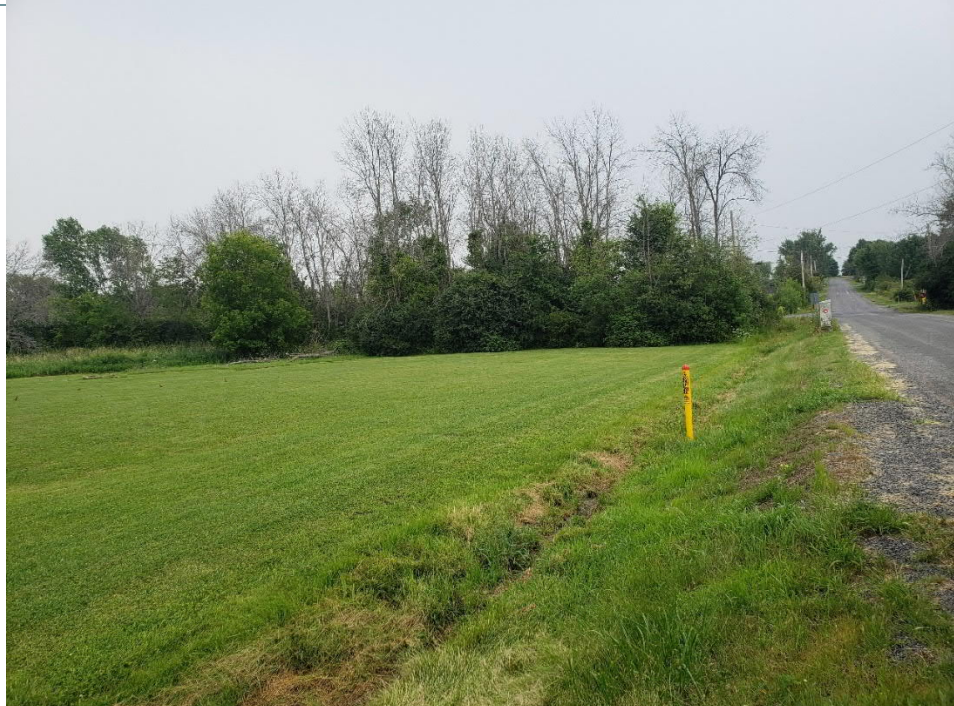
ID #	Location	Site Condition	Additional Work Recommended (Y/N)	Comments/Recommendations	Representative Photo (July 24, 2024)
79	22 Homeland Drive	ROW is gravelled and roadside is partially vegetated with some areas of dead grass along ditch adjacent to manicured lawn.	N	No issues to report at time of inspection.

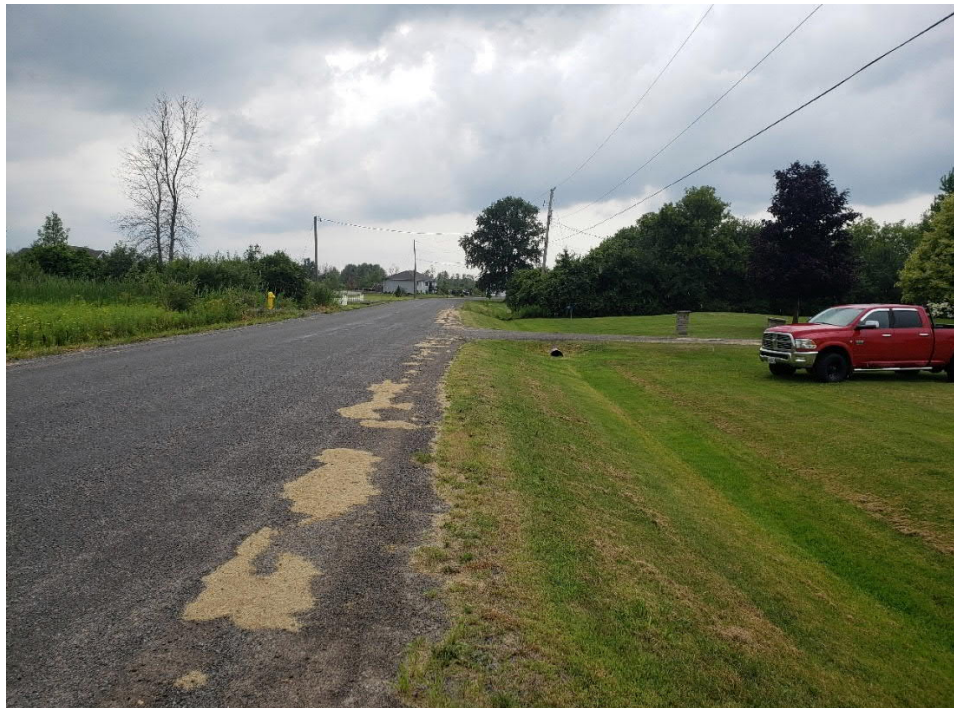
80	82 Homeland Drive	ROW is gravelled up to areas of manicured lawn.	N	No issues to report at time of inspection.

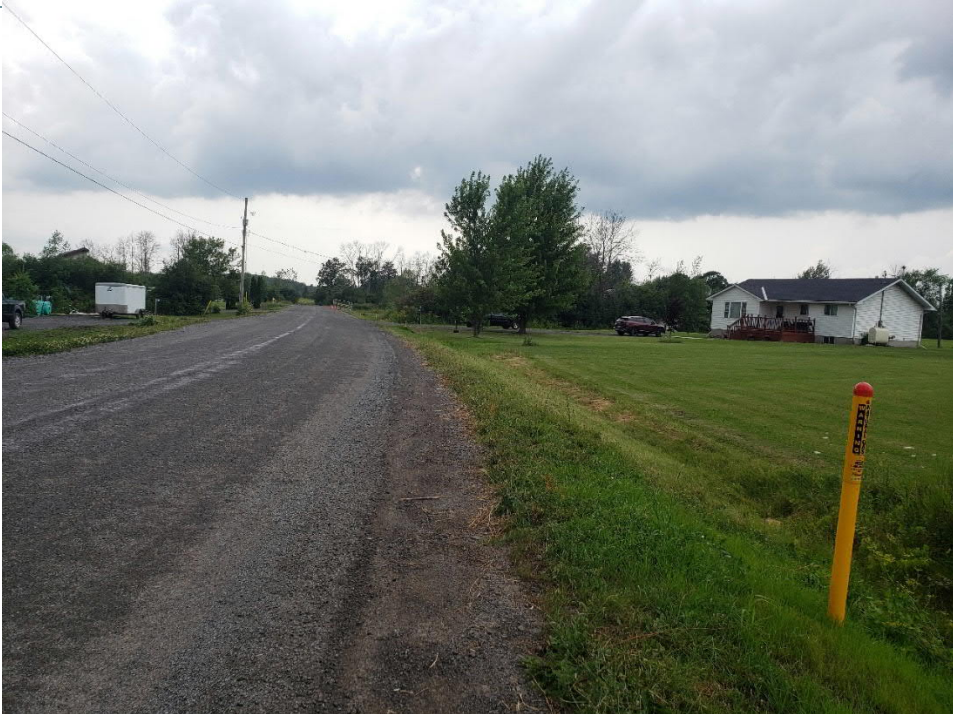
ID #	Location	Site Condition	Additional Work Recommended (Y/N)	Comments/Recommendations	Representative Photo (July 24, 2024)
81	138 Homeland Drive	ROW is gravelled and roadside is vegetated with grass into ditch and adjacent to manicured lawn.	N	No issues to report at time of inspection.

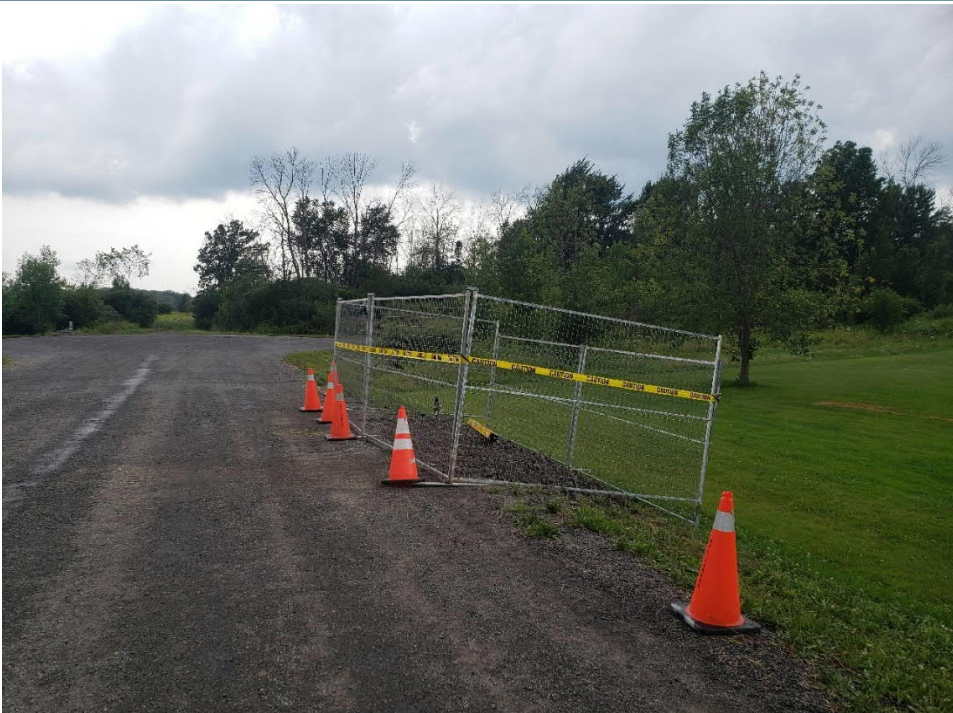
82	152 Homeland Drive	ROW is gravelled and roadside is vegetated adjacent to manicured lawn.	N	No issues to report at time of inspection.

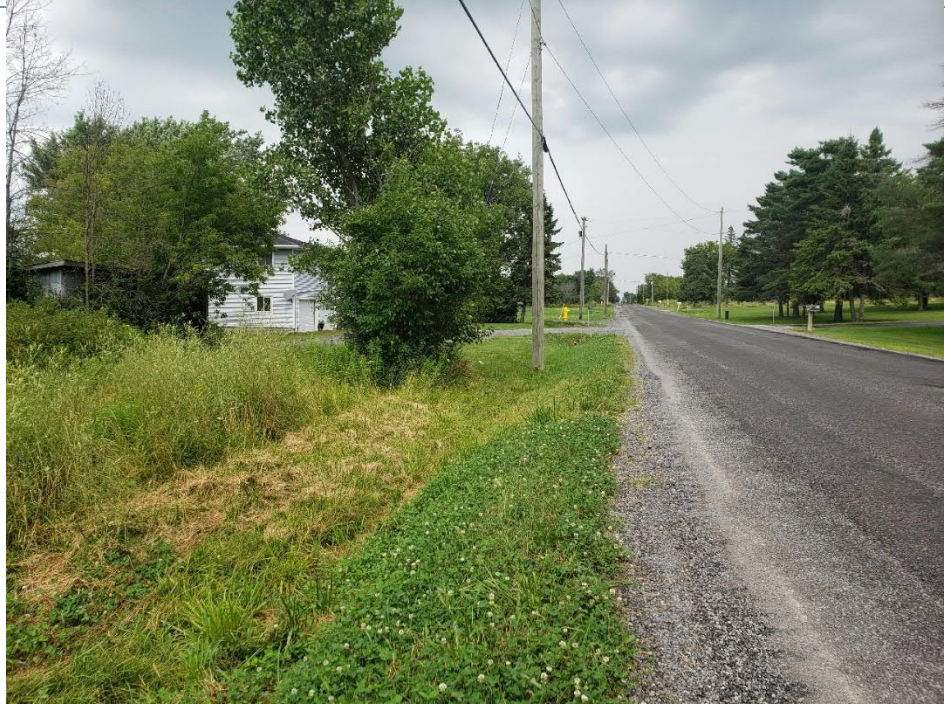
ID #	Location	Site Condition	Additional Work Recommended (Y/N)	Comments/Recommendations	Representative Photo (July 24, 2024)
83	511 Lower Slash Road	ROW is gravelled and roadside is vegetated.	N	No issues to report at time of inspection.

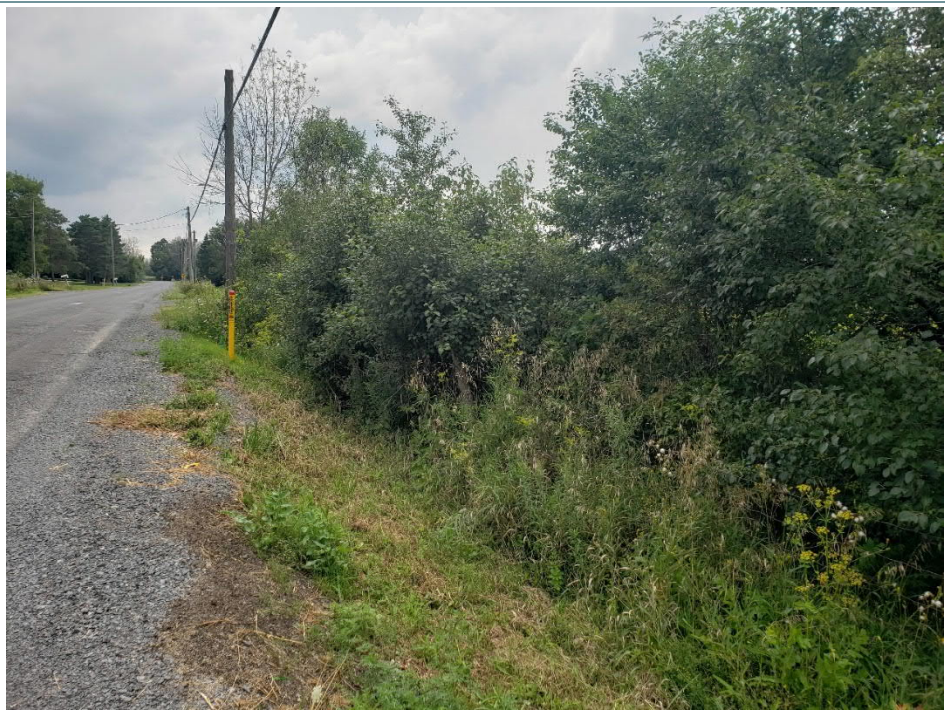
84	Across from 546 Lower Slash Road	ROW is gravelled and roadside is beginning to revegetate.	N	No issues to report at time of inspection.
