ICM Project – Underground Infrastructure and Cable

Handwell Replacement Segment

Toronto Hydro-Electric System Limited (THESL)

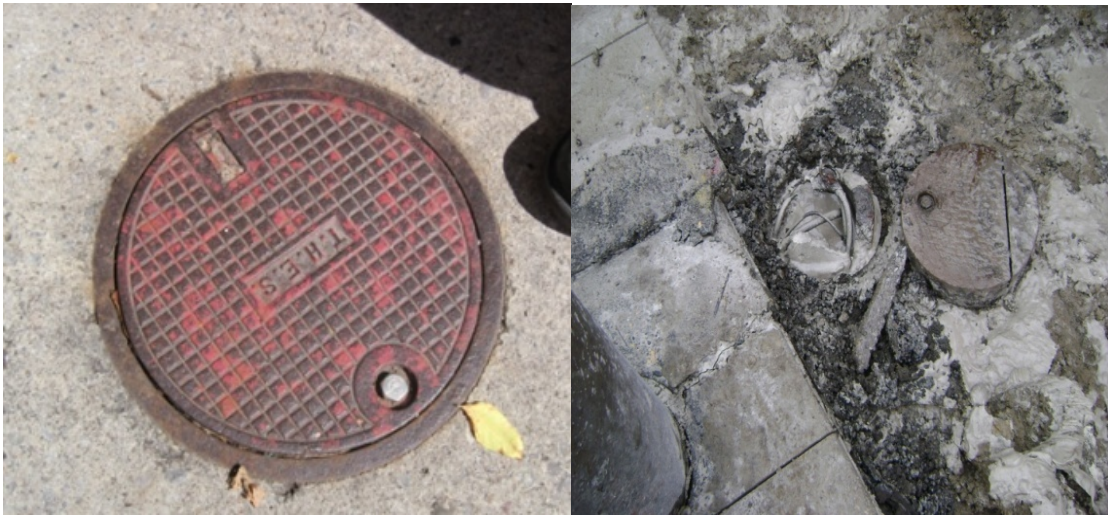
- 1 THESL proposes replacing existing handwells with new non-conductive handwells and lids. The
2 conductive metal covers still found on many handwells are shown in Figure 2a. In THESL's
3 proposal, these conductive lids will be replaced with the non-conductive lids and composite
4 handwells as shown in Figure 2b.

5 **Figure 2a – Metal Handwell Lids**

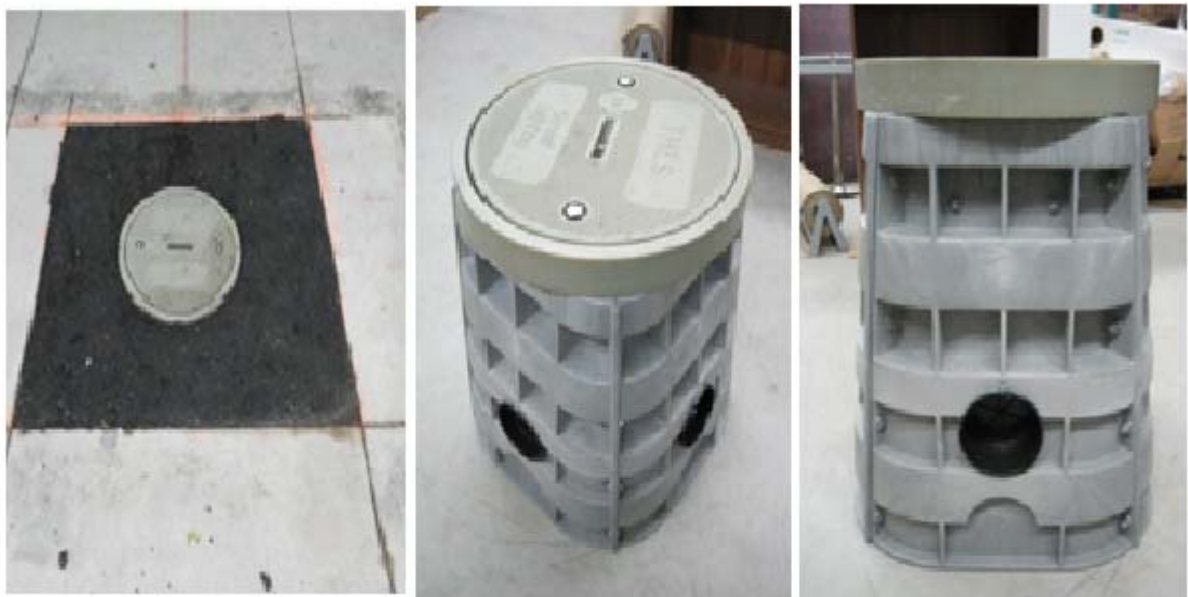
6 **Figure 2b – Non-Conductive Lids and Composite Handwell**

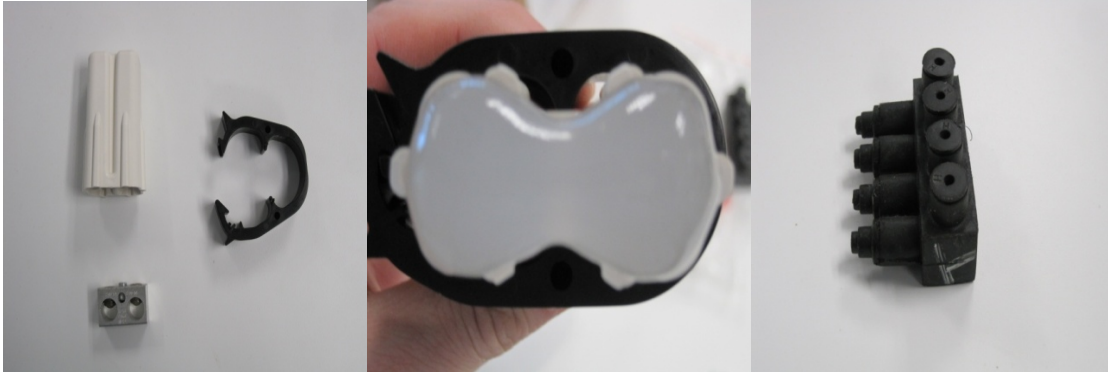
1 **Figure 4 – New Handwell Connectors**

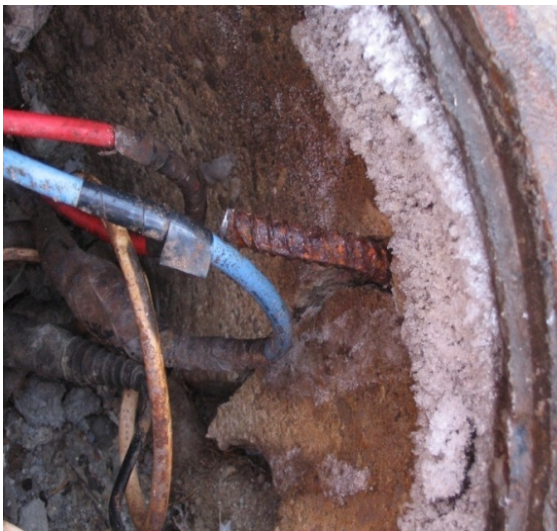
2 **Figure 5 – Repaired Cable**

4 Figure 5 shows a damaged bus cable that has been repaired with PVC and SAP tape. For
5 improved insulation, the bus cable specifications have been revised to require a double
6 insulation cable with a PVC jacket instead of the single insulation cable used previously.

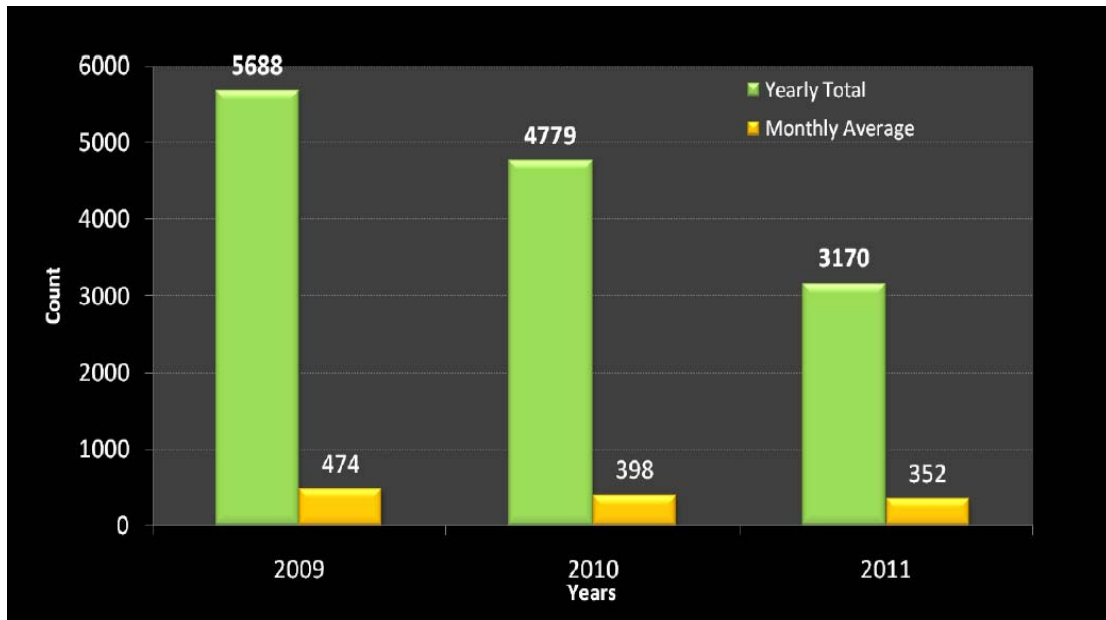
25 Since 2009, THESL has been classifying and addressing contact voltage occurrences proactively
26 identified through mobile surveying, which is performed by an external contractor. Figure 6
27 shows that the number of scanned contact voltage hits has decreased each year since 2009,
28 while Figure 7 shows that since 2009, the average level of contact voltage detected has
29 decreased by 40%.

1 **Figure 6 – Historical Contact Voltage Hits Identified by Mobile Surveying**

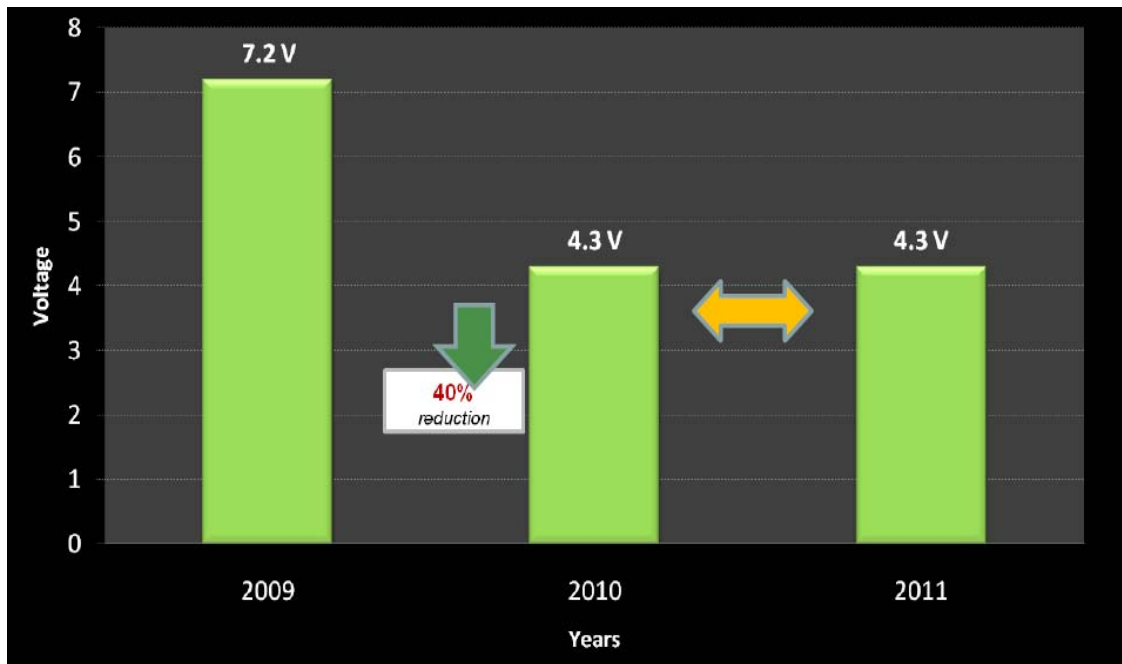
2 **Figure 7 – Average Level of Contact Voltage Detected**

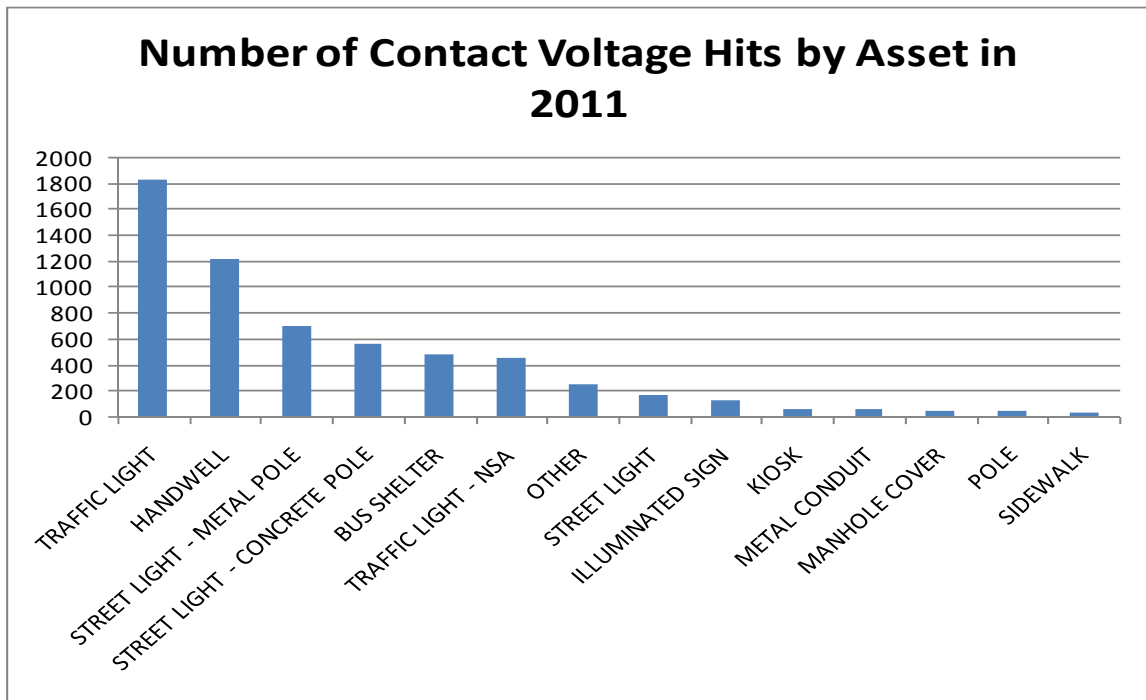
4 Figure 8 shows traffic lights, handwells and street lights among the top three sources of contact
5 voltage hits.

1 **Figure 8 – 2011 Results by Asset Class**

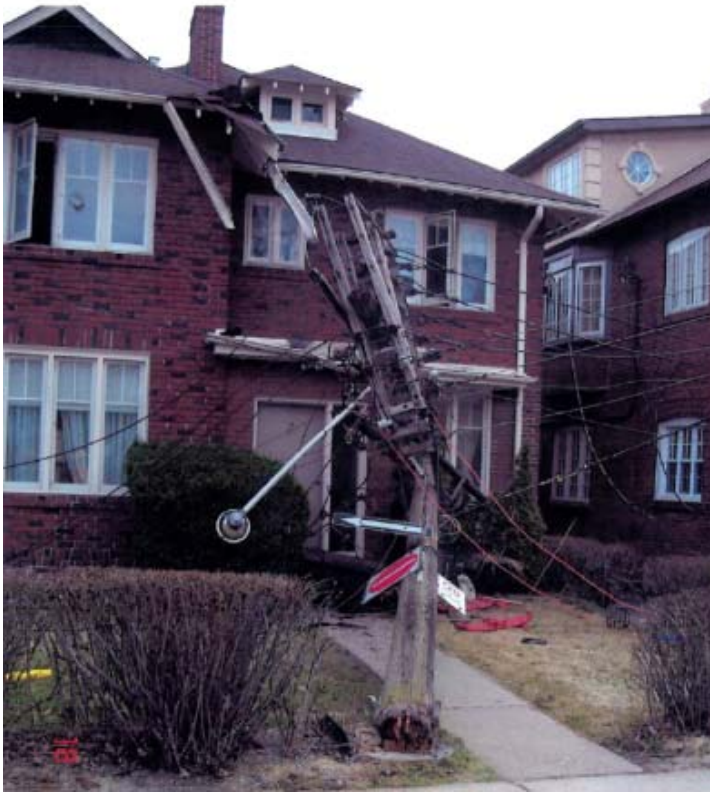
19 Currently, THESL has a total of 106,860 wood poles, of which 11.4 percent are either in poor or
20 very poor condition. This figure breaks down to approximately 2,650 poles in very poor
21 condition, requiring immediate replacement, and about 9,530 poles in poor condition, requiring
22 replacement in the near future (within three years). The Health Index used to assess the
23 condition of wood poles accounts for a variety of degradation factors. These can lead to
24 irreversible damage and include loss of pole strength, cross-arm rot, woodpecker or carpenter
25 ant damage, surface rot at various levels of the pole, pole top feathering, wood loss and
26 mechanical fire damage. Figures 5 through 13 in Section II below illustrate the causes and
27 effects of pole degradation. In an extreme case pole degradation can lead to collapse as shown
28 in Figure A.

1 **Figure A: Fallen Pole on Acacia Road with Rotten Base**

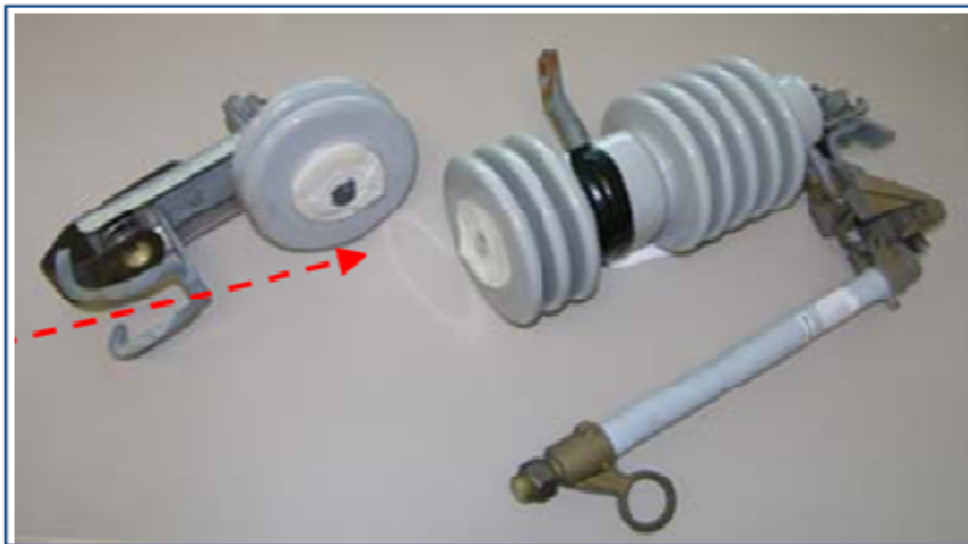
5 Historically porcelain had been the material of choice for electrical insulation of overhead
6 hardware. Though the electrical insulation characteristics of porcelain in and of itself are good,
7 the ability of porcelain to resist contamination build up and electrical tracking is not. Ultimately,
8 this leads to a semi-conductive track that, over time, further weakens the insulator, leading to
9 cracking and breakage that create safety and system reliability concerns. Figure D shows a
10 porcelain switch that broke in the field.

12 **Figure D: Broken Porcelain Switch Returned From Field**

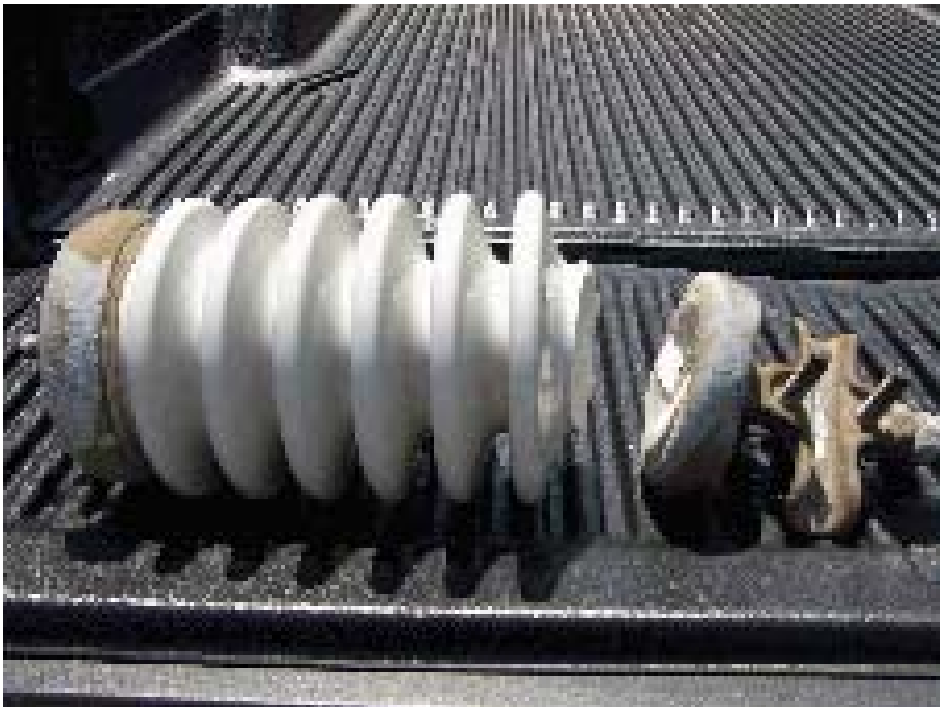
21 Porcelain equipment is also a reliability concern and a significant contributor to customer
22 interruptions within the overhead distribution system. See Figure E for an example of a cracked
23 porcelain insulator installation.

1 **Figure E: Broken Porcelain Insulator**

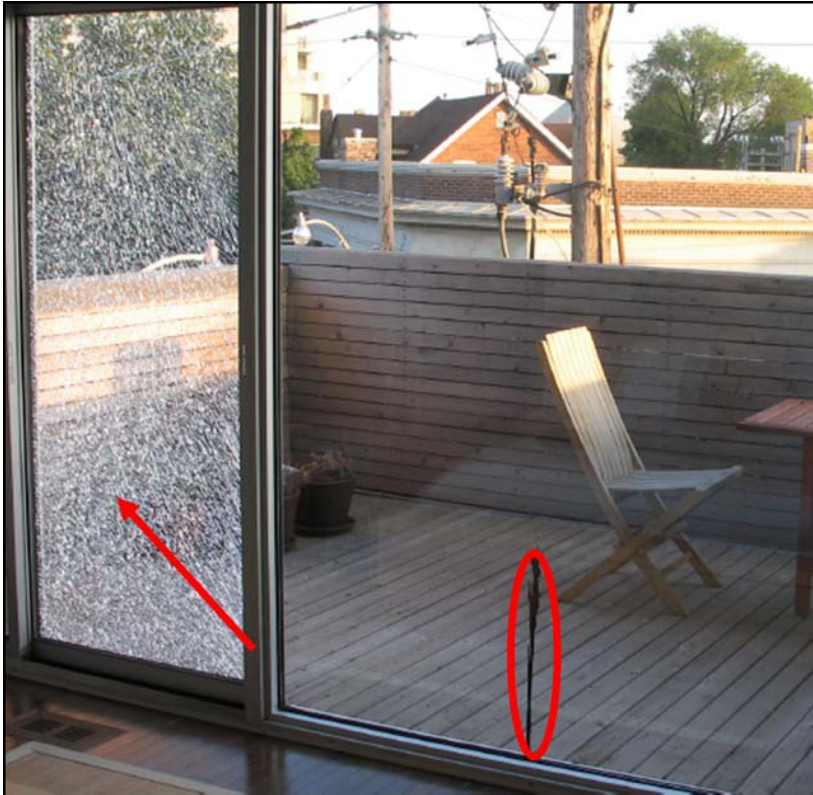
4 **Figure F: Failure Effects of the Porcelain Pothead Terminators**

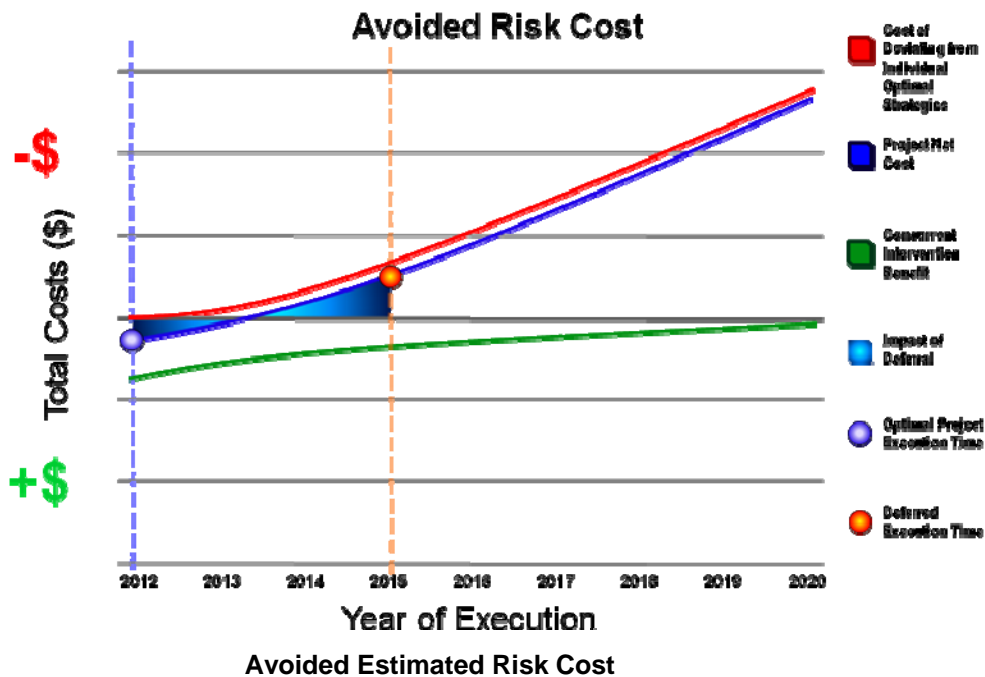
10
 11 When a project analysis is undertaken, assets within the project may be before, at, or beyond
 12 their optimal replacement time, thus some assets will have sacrificed economic life and others
 13 will have incurred excess risk cost by remaining in service past their optimal replacement date.
 14 The cumulative sacrificed life and excess risk costs of the assets involved becomes a cost against
 15 the project, as shown by the red curve in Figure I.

17 **Figure I: Example of Project Net Benefit Analysis for Job-Based Approach**

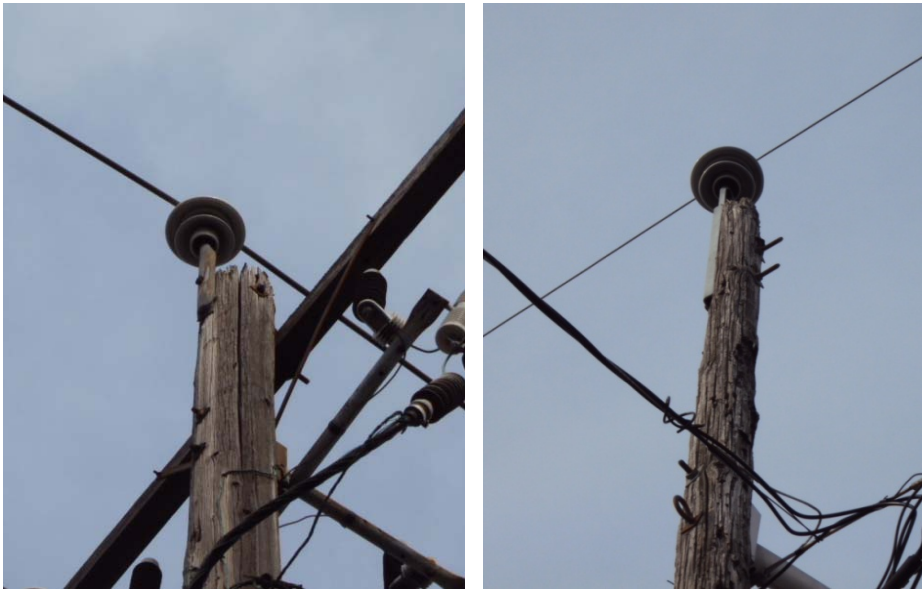
25
26 Figure 3 illustrates a condition found on poles known as pole-top feathering. The top portion of
27 the pole is quite important because it contains the necessary attachments for insulators,
28 brackets and other hardware used to secure the overhead conductors to the line. In an
29 emergency situation, if a pole with a feathered top were to fail as a result of structural damage,
30 the equipment on the pole would pose a potential safety risk.

1 **Figure 3: Pole-Top Feathering**

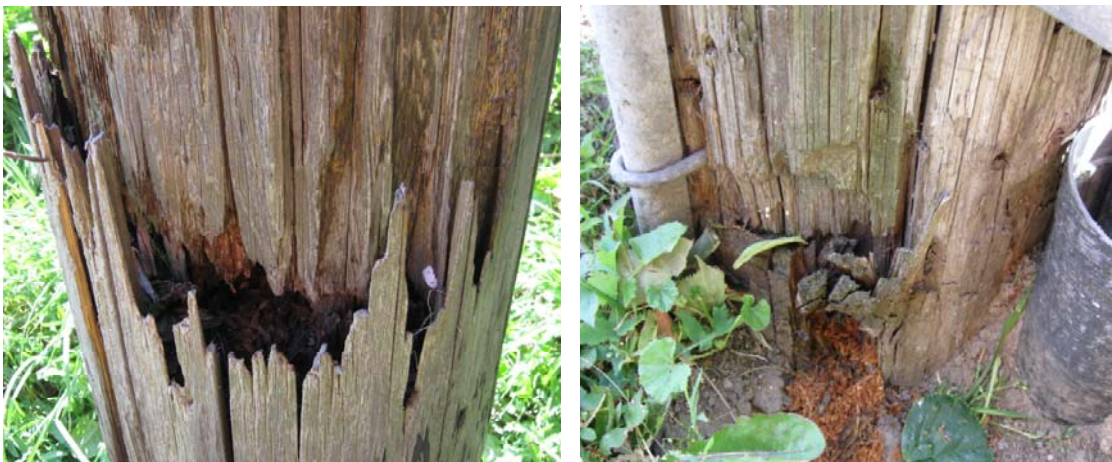
3 Figure 4 shows internal base rot. This type of deterioration weakens the pole base and when
4 combined with external force can cause the pole to fall. A falling pole creates the risk of injury
5 to THESL crews and the public.

7 **Figure 4: Internal base rot**

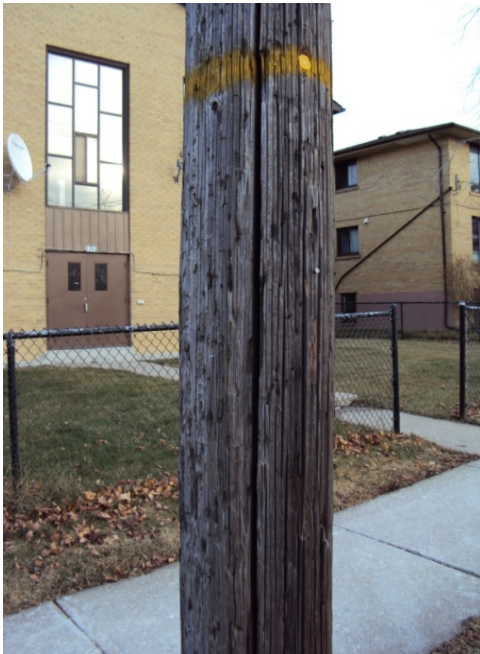
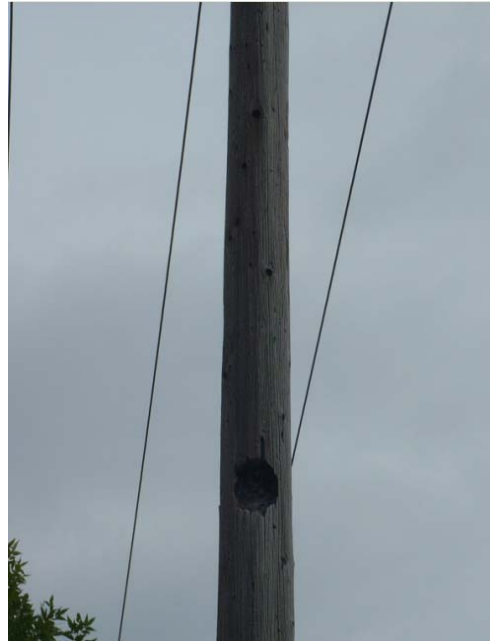
9 Figure 5 shows major cracks and holes that can also cause the pole to deteriorate. Figure 6
10 shows damage from rot and fire.

1 **Figure 5: Pole cracks and holes**

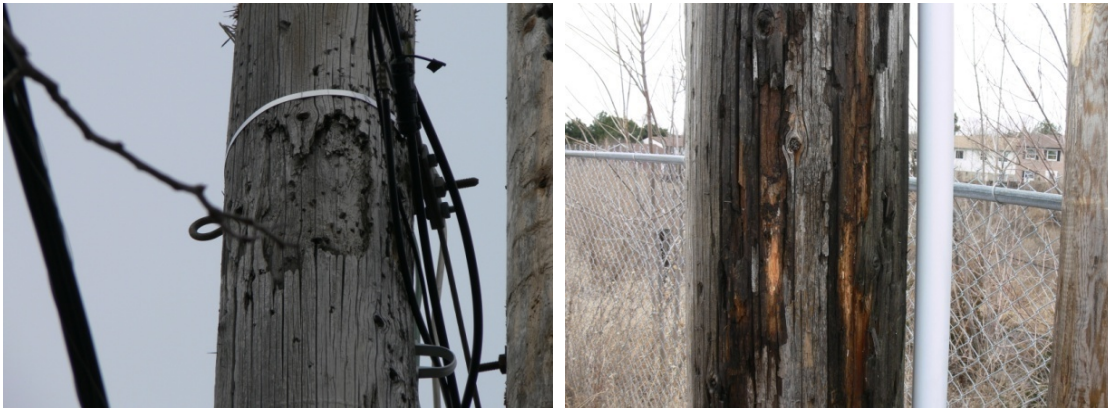
3 **Figure 6: Body of the pole rot and burnt**

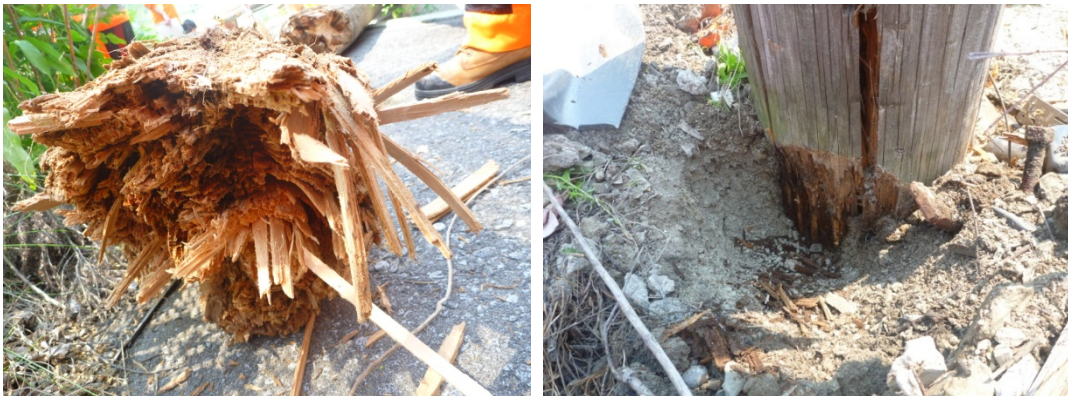
5 A catastrophic failure was reported on Midland Avenue in June 2011, where 13 poles fell within
6 an industrial area during a windstorm. After inspection, these poles had signs of shell rot (Refer
7 to Figure 7) which led to the deterioration of their bases, which caused them to fall during the
8 storm.

1 **Figure 7: Deteriorated pole base**

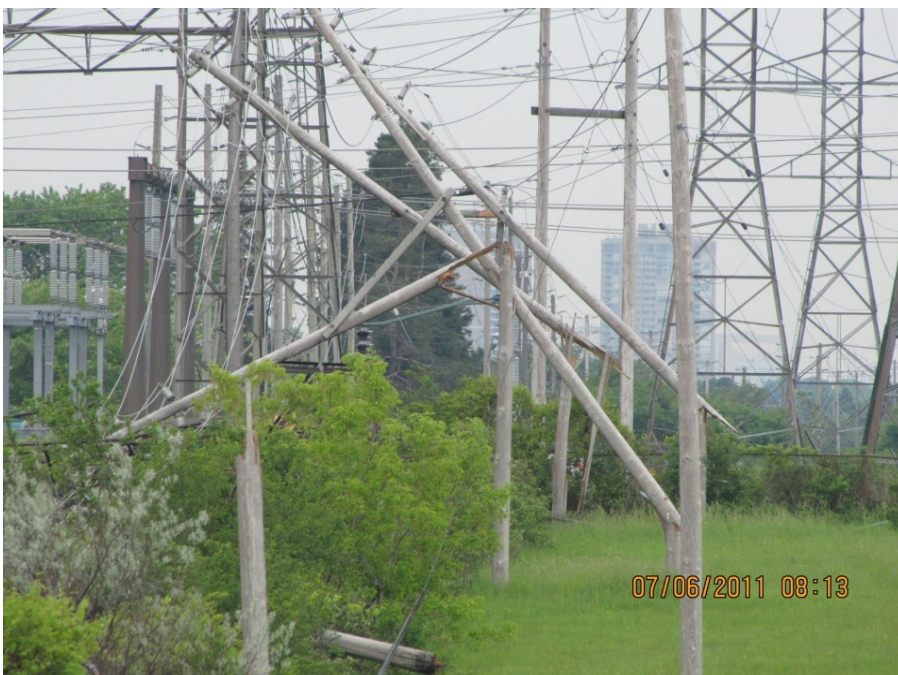
3 As a result of the windstorm, a cascading failure took place shortly after the first pole failed and
4 fell to the ground. This failure caused the rest of the poles in the line to fall as well (Refer to
5 Figures 8 and 9). Investigation of this incident also found evidence of ant infestation, as shown
6 in Figure 10. This type of infestation cannot be completely eliminated and can affect any pole,
7 independent of age. Fortunately, this incident resulted in no injuries and did not require the
8 payment of any property damage claims; however, it had the potential to cause significant
9 injury and property damage.

10 **Figure 8: Multiple Pole Failure**

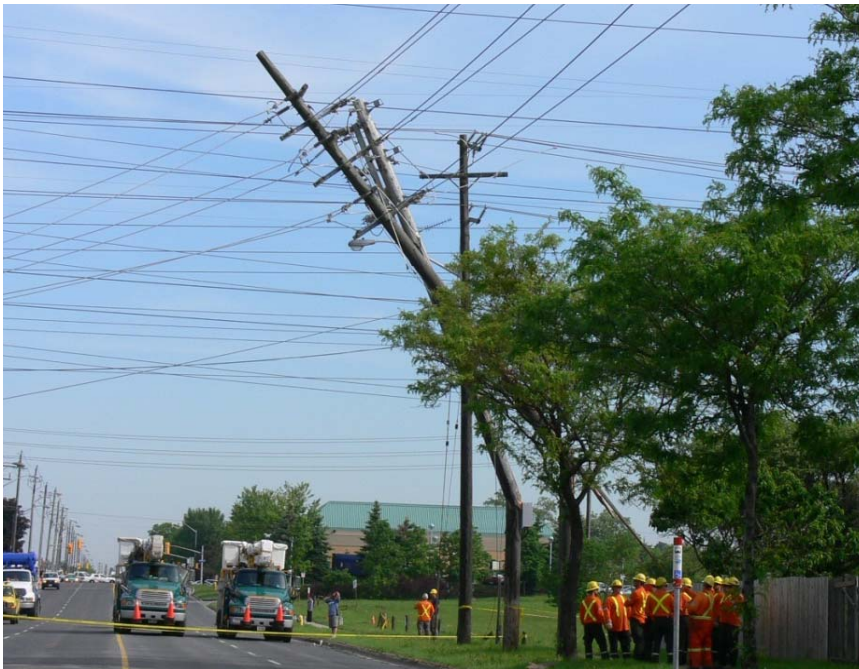
1 **Figure 9: Multiple Pole Failure**

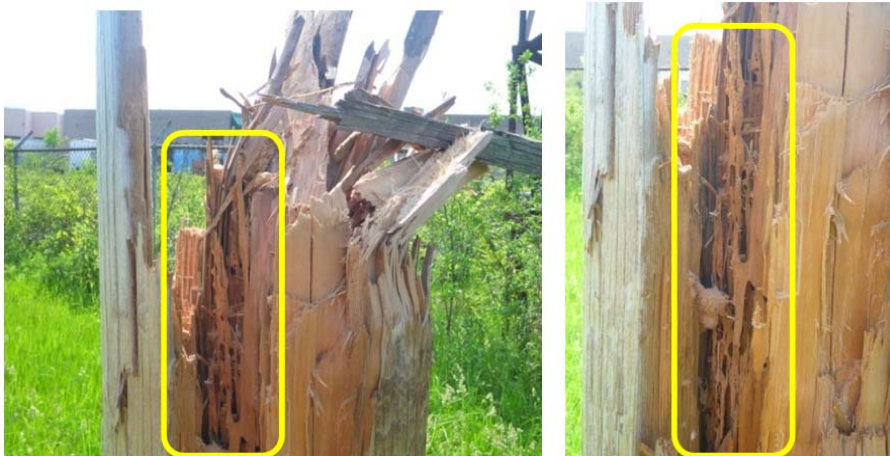
2 **Figure 10: Evidence of Infestation**

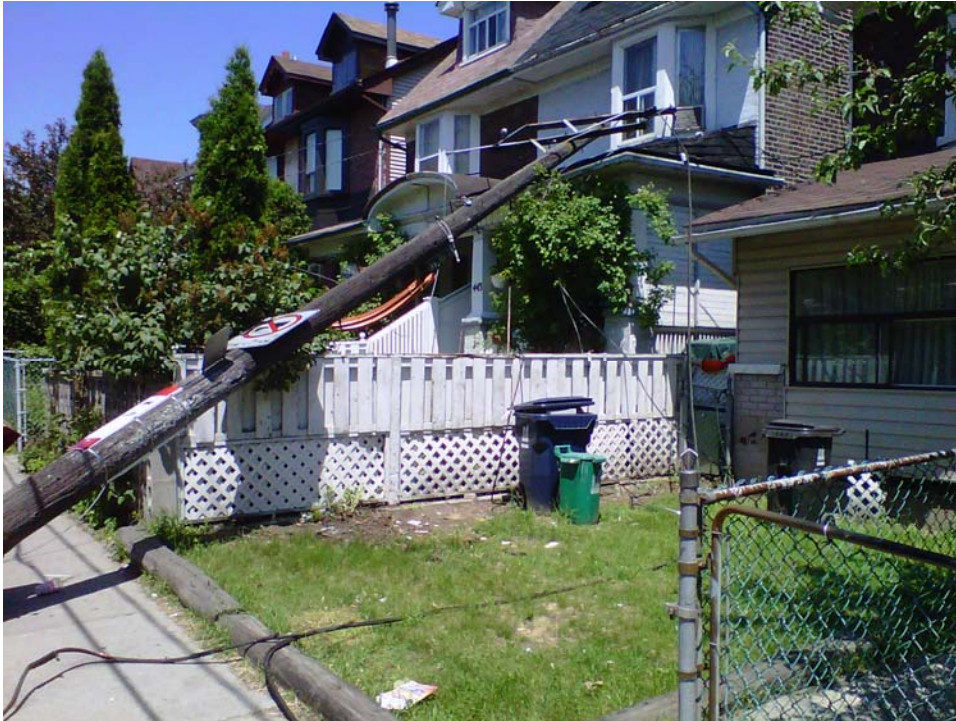
4 Another incident involving wood poles occurred on Pape Avenue during a voltage conversion
5 project. Once the crew had completed the approved procedures for the project, they cut the
6 conductor in order to remove it. After so doing, one of the wood poles began to lean over. As
7 shown in Figure 11, this pole fell on a fence and porch roof with the conductors still attached.

- 4 **Figure 11: Pole Failure on Pape Avenue**

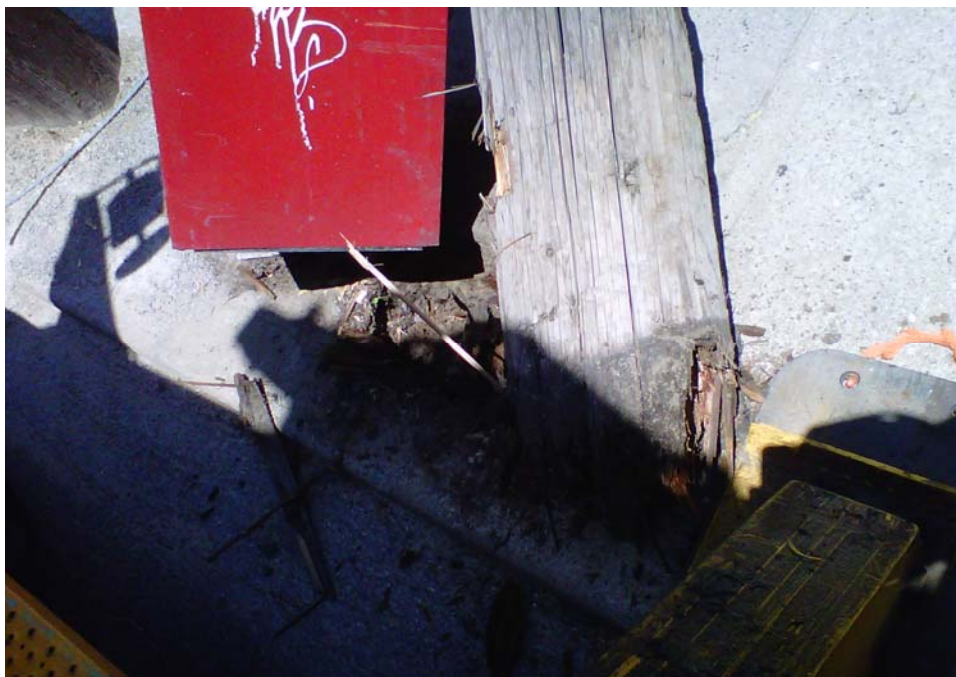
- 1 The incident was caused by an aging pole with a rotten base (illustrated in Figure 12) and
- 2 resulted in a property damage claim against THESL.

1 **Figure 12: Pole base rot at Pape Avenue**

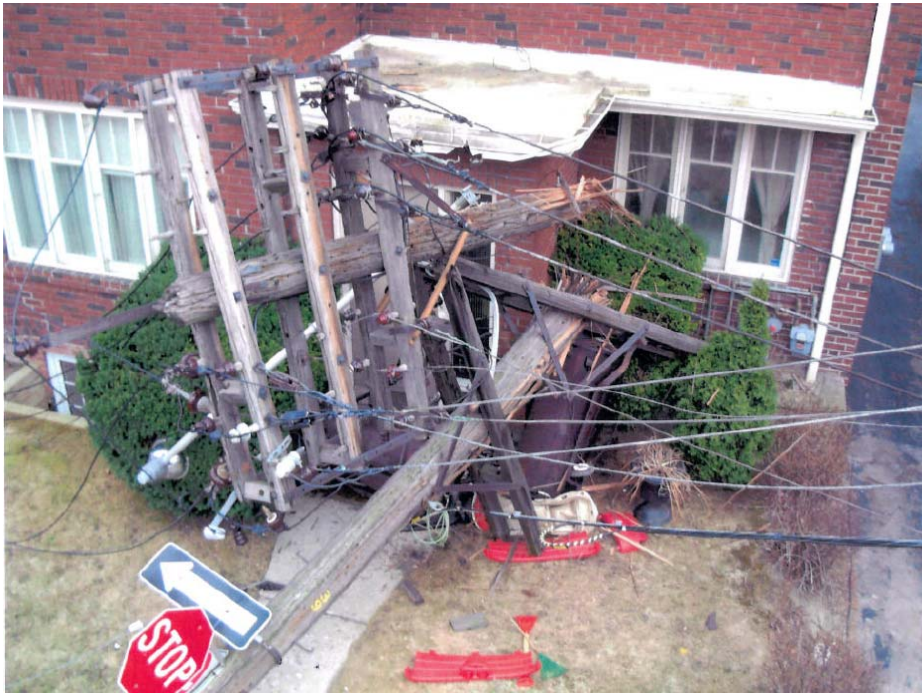
3 A more serious incident occurred on Acacia Road. In this incident, a pole fell onto a residence,
4 causing it substantial damage, as illustrated in Figures 13, 14 and 15. This incident was caused
5 by the poor condition of the pole, which had a rotten base at ground level. The pole, and the
6 transformer attached to it, fell onto the residence, striking the second floor, roof, eaves, rafters,
7 and front door, and damaging personal property belonging to the tenant. The resulting oil leak
8 from the damaged transformer spread across the interior of the home. Fortunately, no one was
9 injured, but the incident had the potential to cause significant injuries to individuals in the
10 residence or standing in the front yard.

1 **Figure 13: Pole Down on Acacia Road**

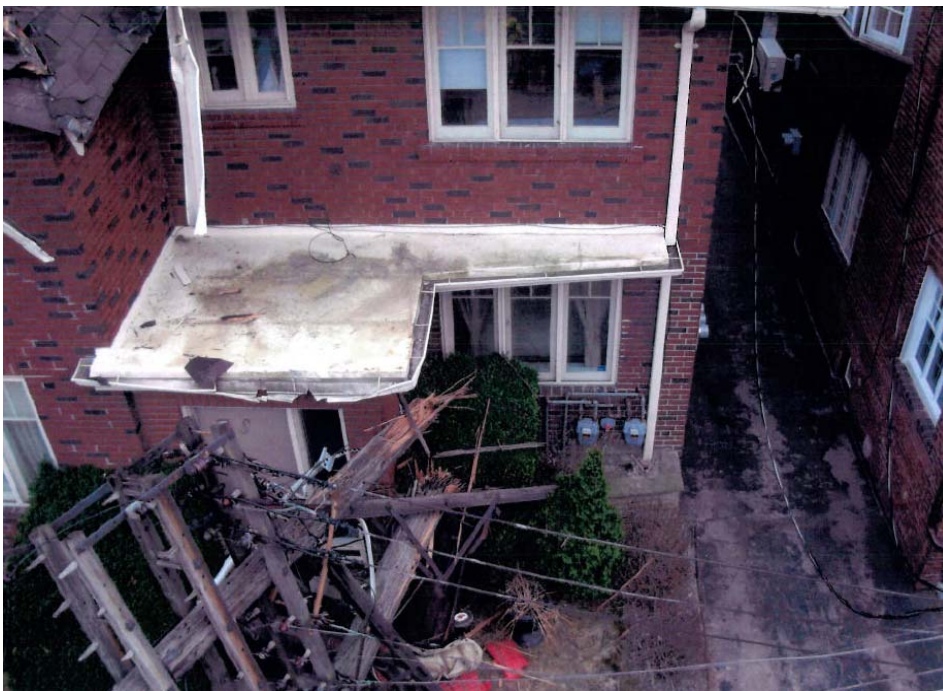
2 **Figure 14: Damage from Pole Down on Acacia Road**

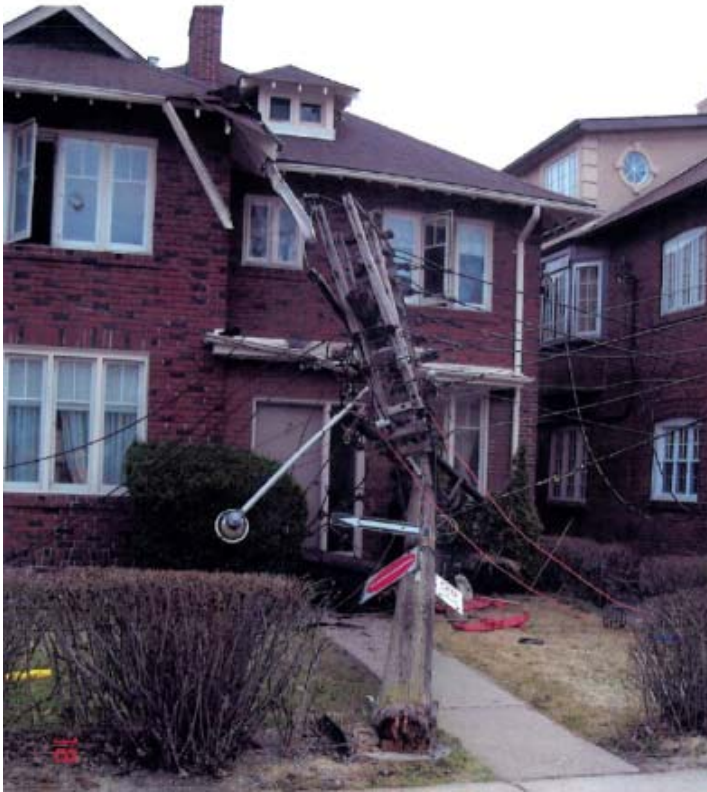
1 **Figure 15: Fallen Pole on Acacia Road with Rotten Base**

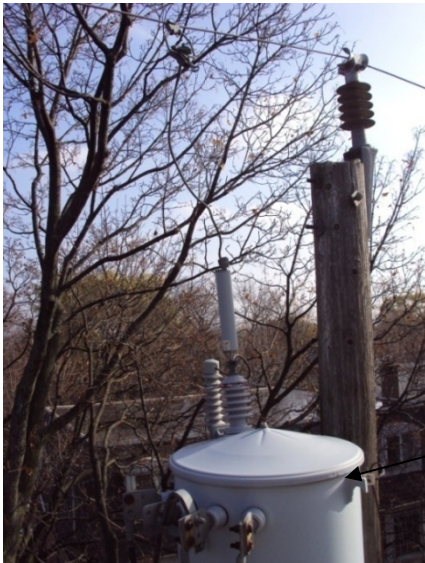
Internal Primary
Fuse

1 **Figure 19: CSP Transformer**

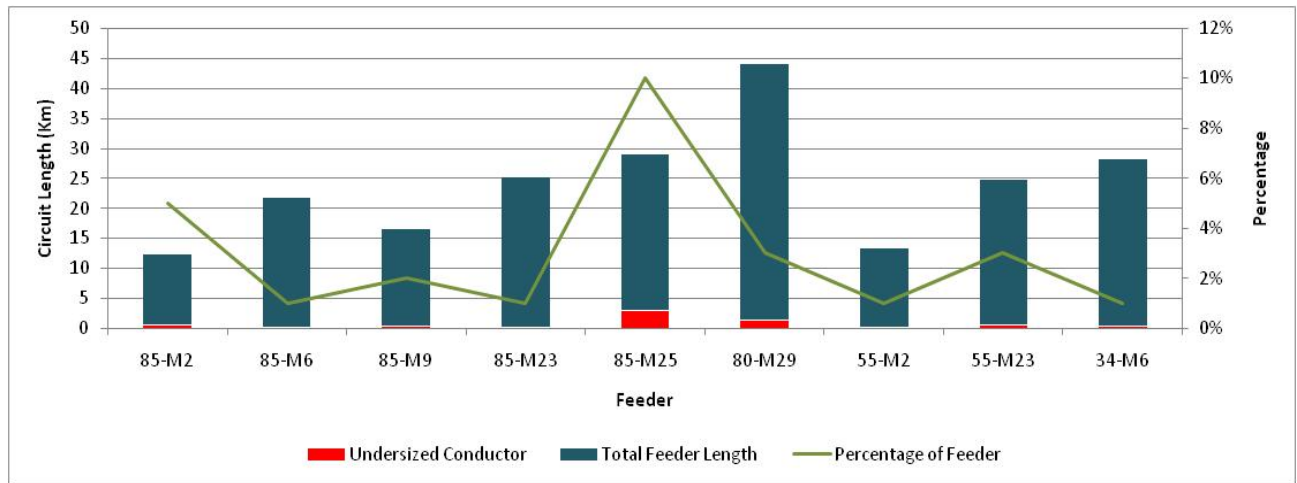
1 **Figure 33: Overloaded feeders with undersized conductor**

17 Table 7 and Figure 33 show that undersized conductor is found on nine of the 24 feeders that

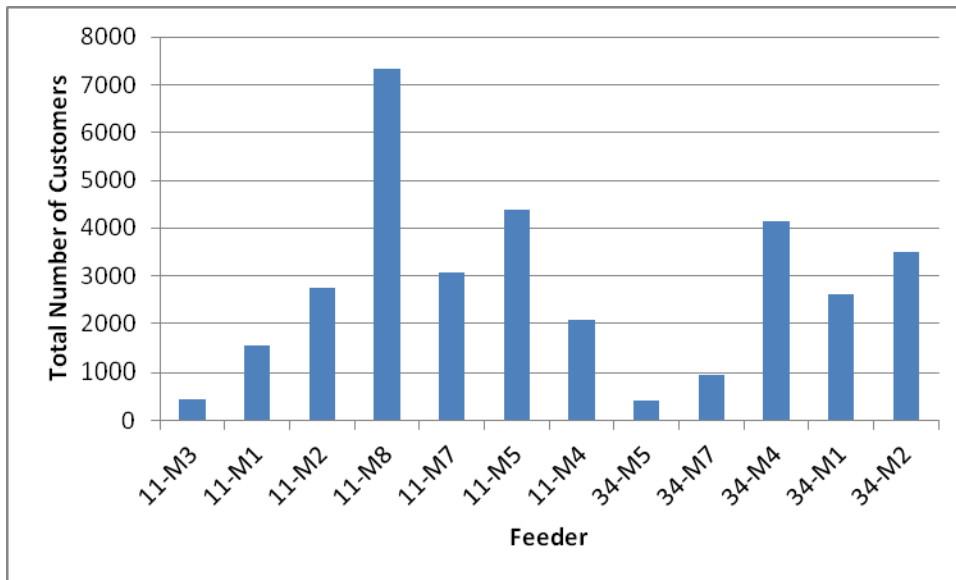
1 **Figure 36: Total Number of Customers**

2
 3 Tree contacts on a feeder trunk circuit will result in an outage that impacts all customers
 4 connected to the feeder, and cause the station circuit breaker to lock out. Figure 36 shows the
 5 total number of customers on each of the 12 identified feeders from Runnymede TS and Leaside
 6 TS. Thus, on each of these feeders, approximately 2,800 customers on average would
 7 experience a forced outage should there be tree contact with the feeder trunk. Tree contacts
 8 on certain feeders such as 11-M8 and 11-M5 would have the greatest impact because of the
 9 number of customers they serve and the amount of bare insulated conductors on their trunks.

21 Runnymede TS and Leaside TS have had the largest number of outages related to tree contacts
22 and these outages have had the highest impacts at the station level. The identified 12 feeders in
23 Figure 36, from Runnymede TS and Leaside TS, require the upgrade of a total of 61 kilometres
24 from bare insulated overhead conductor to 556.5 kcmil tree proof conductors. The capital cost
25 to permanently upgrade the 61 kilometres of bare insulated conductor is estimated to be \$2.5
26 million.

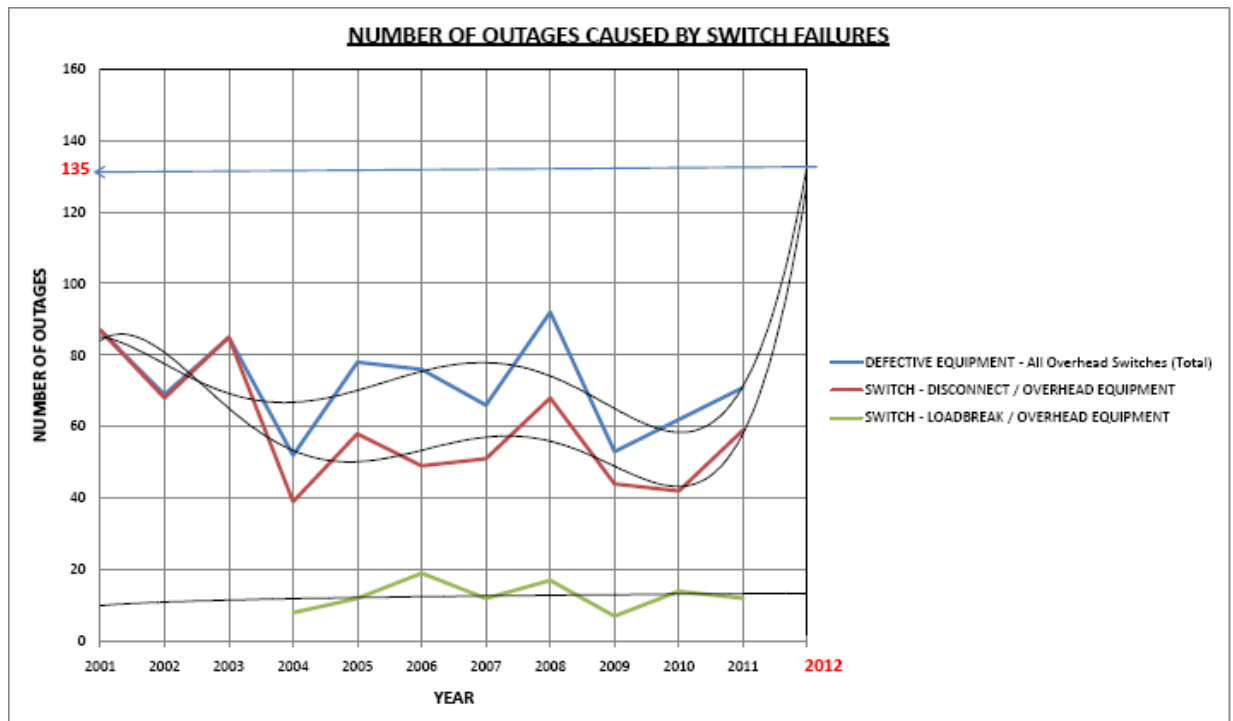
17 **Figure 37: Outage due to switch failures in 2001-2011 and 2012 forecast**

12 Overhead switches gradually wear out in the field. The switches can either fail mechanically or
 13 electrically. Approximately 30 percent of all overhead switches are past their useful life criteria
 14 and 2,600 end-of-life failures are forecast to occur over the next ten-year period. One hundred
 15 thirty-five end-of-life failures are forecast for 2012, as illustrated in Figure 37, which is based on
 16 the data in Table 11.

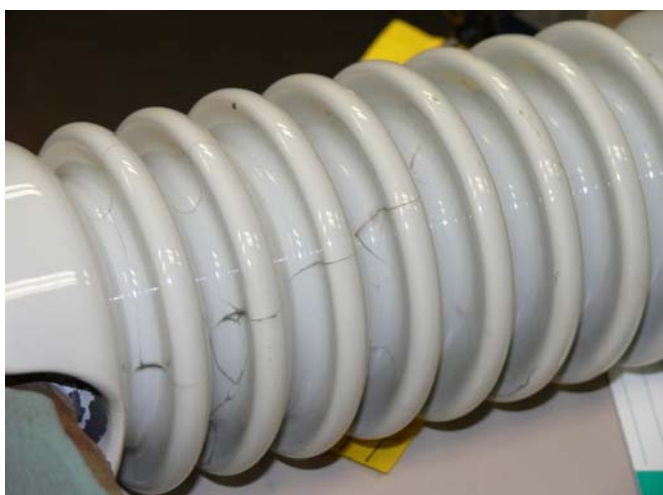
18 **Figure 38: Cracked porcelain insulation**

13 This is a fused disconnect switch typically used in THESL's overhead system to protect lateral
14 circuits on a feeder. It is mounted near the top of the pole and exposed to various conditions
15 including rain, and, in the winter, salt spray from roads and highways, in addition to snow and
16 ice. Figure 38 below shows a picture of a cracked porcelain switch.

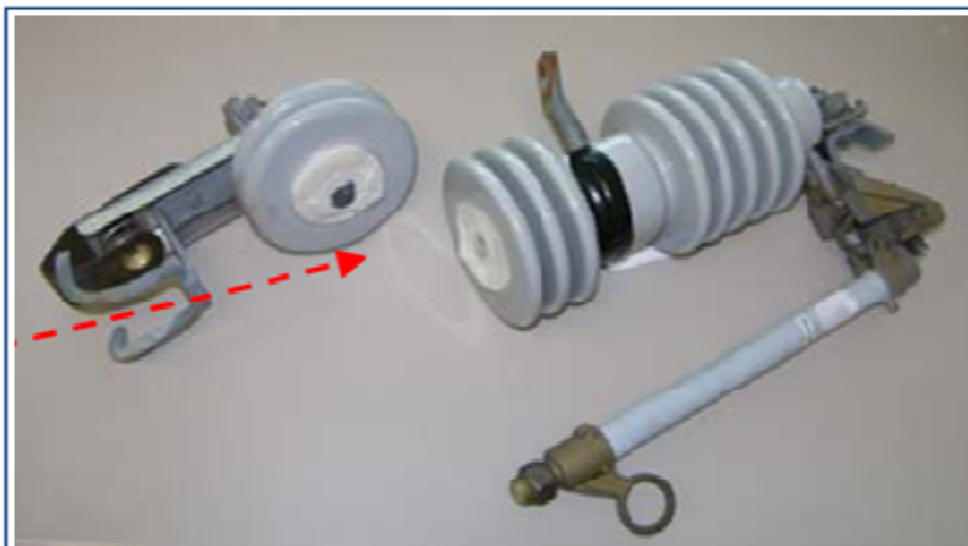
7 **Figure 39: Broken Porcelain Switch Returned From Field**

9 Figure 39 above is a picture of a porcelain SMD-20 which ruptured during operation. This
10 rupture could have posed a potential safety risk to anyone below when the porcelain debris fell.
11 In addition, tracking along the porcelain insulation can lead to a more catastrophic type of
12 failure. Figure 40 below shows a new design polymer SMD-20 switch.

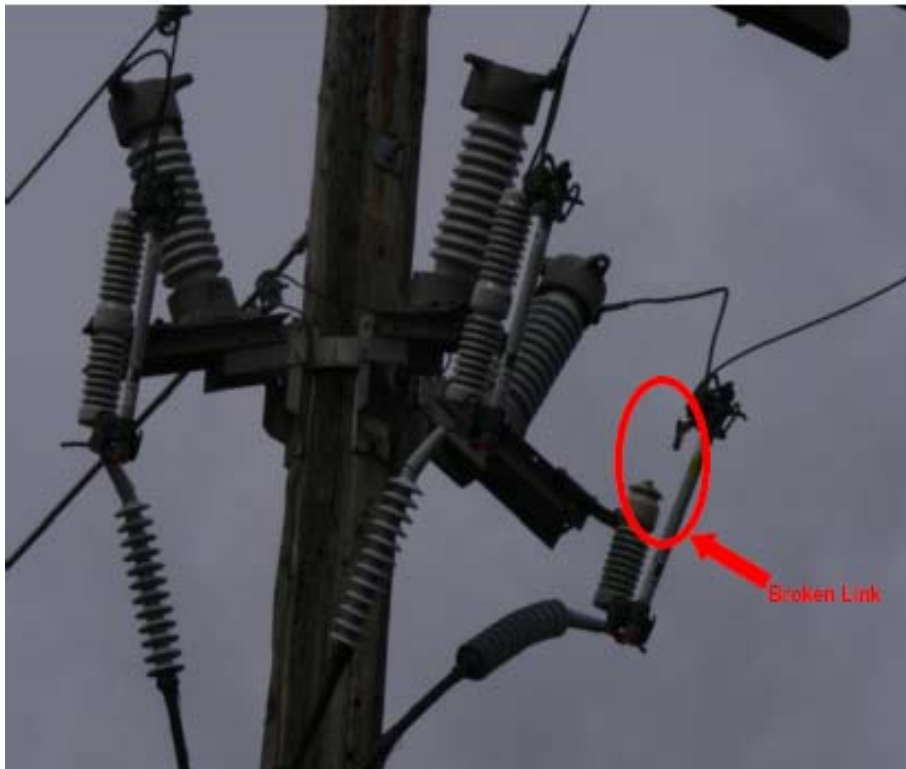
1 **Figure 41: Broken SMD-20 still in service**

3 In addition to failures during manual operation, switches also fail while in service. The safest
4 way to remedy a situation of the type shown below in Figure 41 would be to open the next
5 upstream isolation device so that a THESL crew can replace the broken switch. The resulting
6 outage may impact a large number of customers for an extended time.

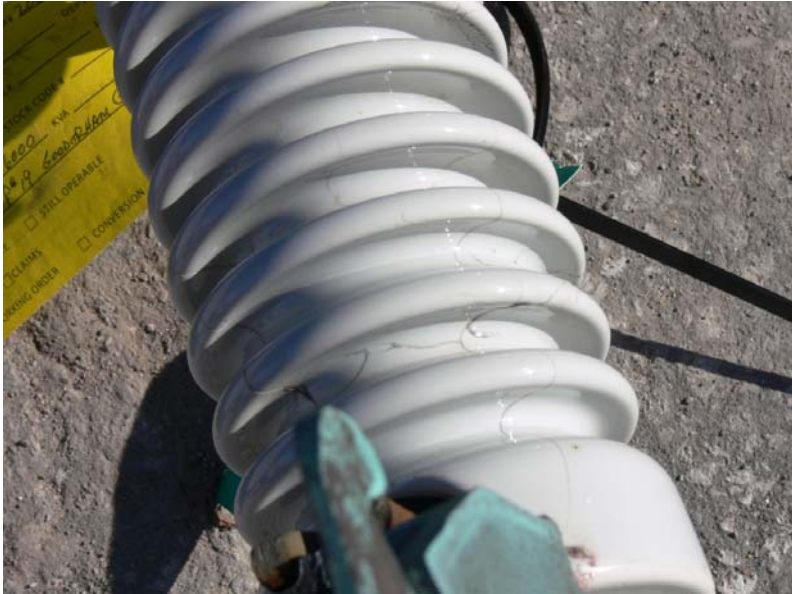
2 **Figure 42: Failed Porcelain SMD-20 Switches from OS 46849 P19 Gooderham at Brian Ave**

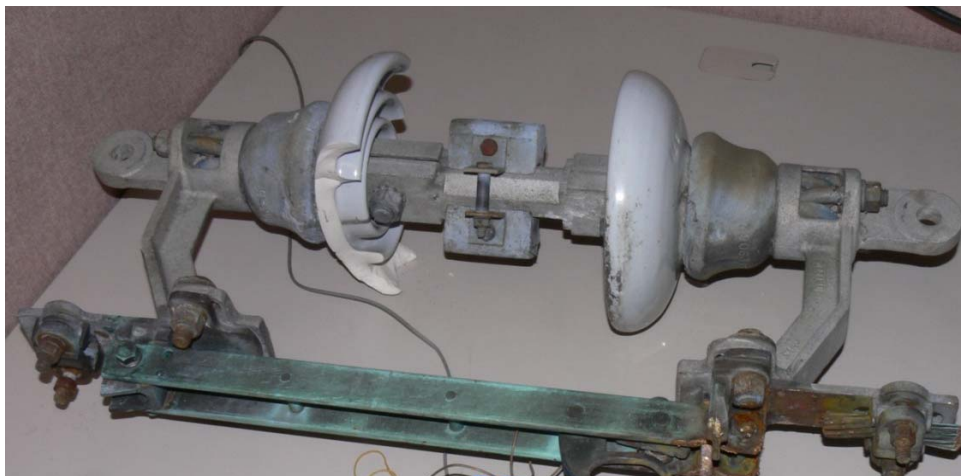
4 **Figure 46: In-line disconnect with part of the porcelain insulation broken off**

17 Figure 46 illustrates an in-line disconnect switch where part of the porcelain insulation has
 18 broken off. This is a potential safety risk as large pieces of porcelain could fall to the ground

1 from switches mounted up to 50 feet (15.24 metres) high, creating the potential for significant
2 injury or damage to property.
