ICM Project – Underground Infrastructure and Cable

Handwell Replacement Segment

Toronto Hydro-Electric System Limited (THESL)

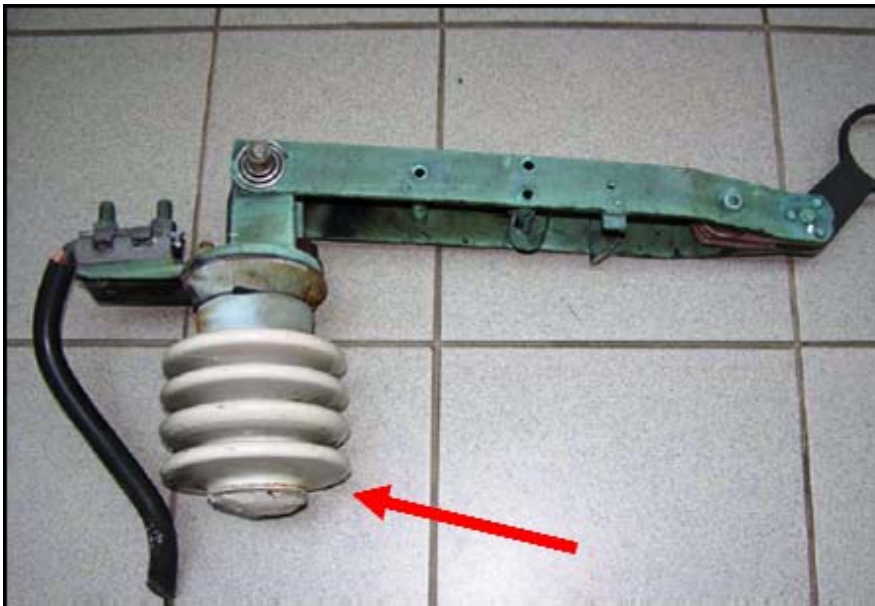
1 **Figure 47: Broken Porcelain In-Line Switch**

6 A THESL construction worker recently detected a failed switch during a routine switching
7 operation. The single-phase switch had failed while the worker was restoring a normally open
8 point between 13.8kV feeders. This particular switch is bracket-mounted and used to supply
9 and isolate equipment. The failure was found to have been caused by a fracture along a weak
10 point where the porcelain mounts to the base. It was later determined that similar switches can
11 break off at various other points, as seen in Figure 47 and 48.

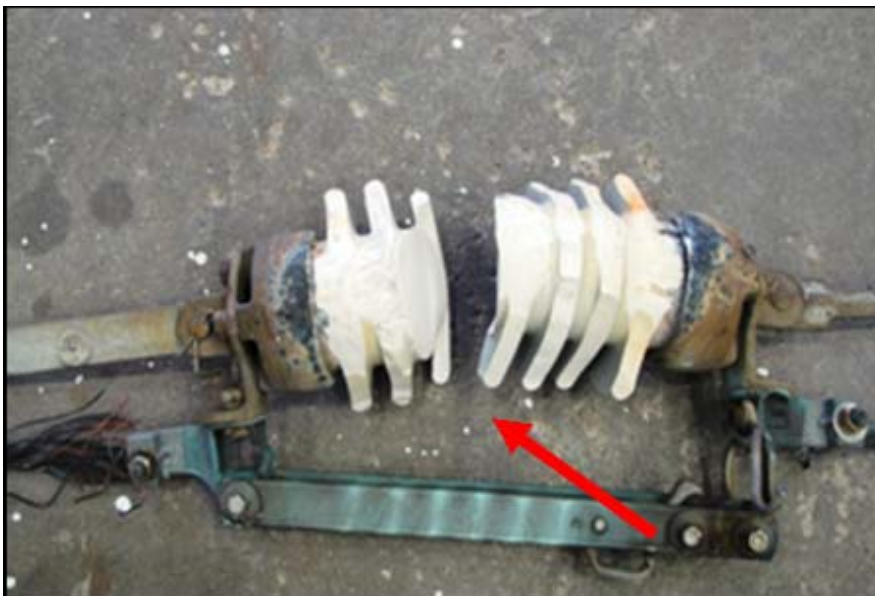
2 **Figure 48: Broken Porcelain In-Line Switch**

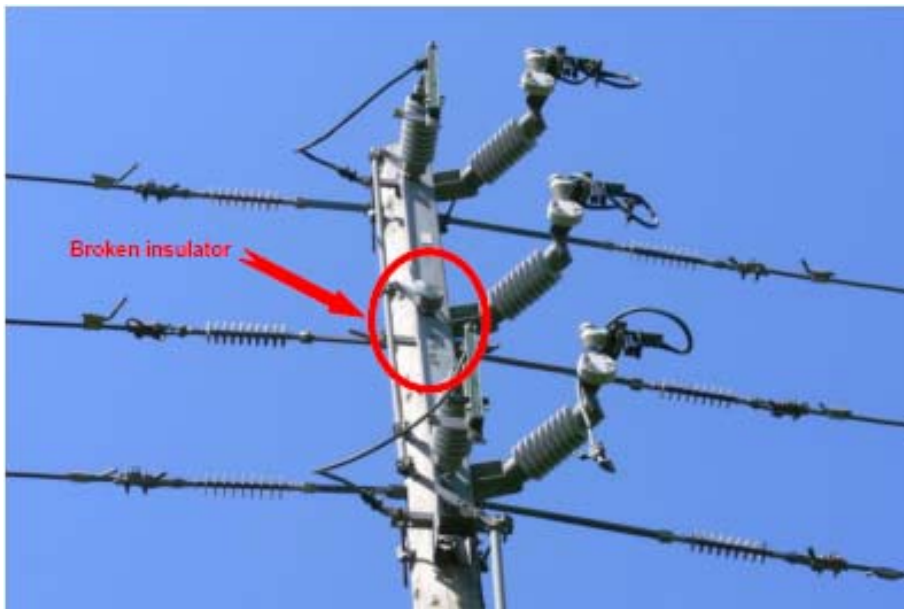
9 **Figure 49: OSL65907 with broken center phase insulator**

4 Similar to the aforementioned switches, the insulation medium for these switches is also
5 porcelain. The porcelain components of these switches are also susceptible to contamination,
6 which leads to tracking across the insulator and eventually failure. Figure 49 below shows a
7 situation where one of the center-phase insulators has broken and fallen off.

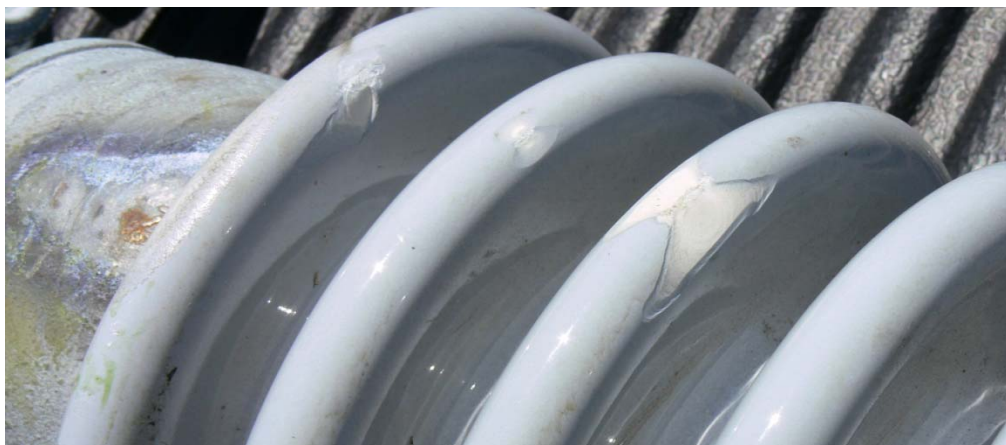
1 **Figure 50: Close-up of Damaged Porcelain Switch Insulator showing tracking**

11 Figures 50 and 51 below show close-up views of the damage to the insulator, caused by
12 electrical tracking over time along the surface.

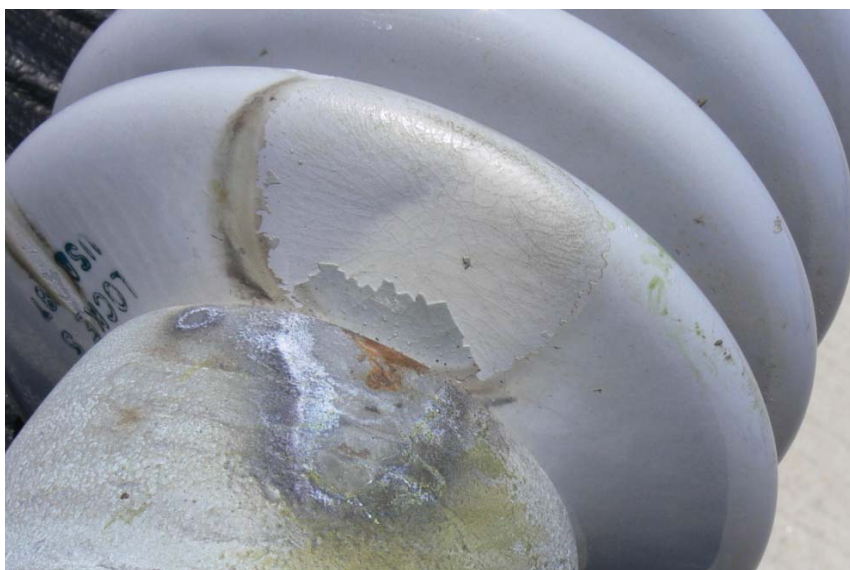
3 **Figure 51: Close-up of Damaged Porcelain Switch Insulator showing tracking**

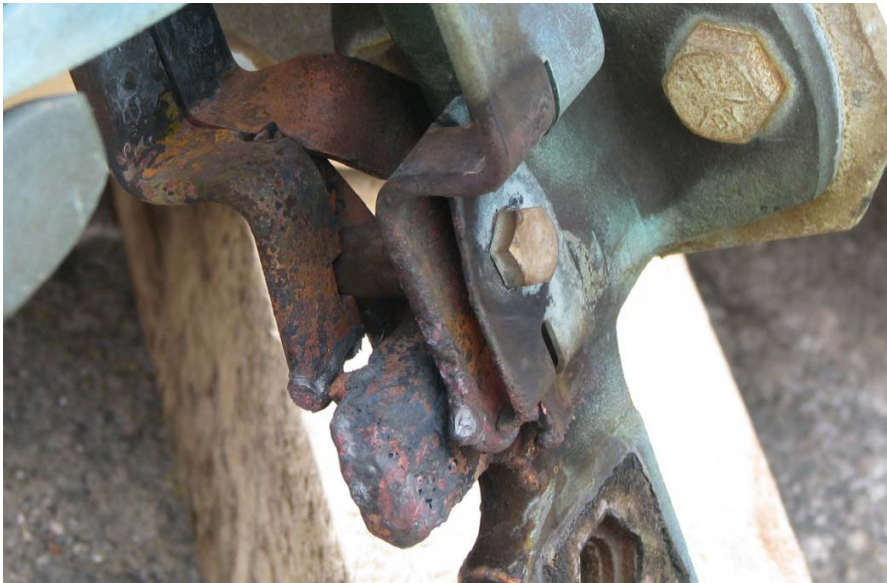
1 **Figure 52: Severely corroded switch blade**

5 In addition to the potential safety risk presented by the failure of porcelain insulators on the
6 switch, environmental conditions also cause corrosion of the load interrupting switch blade,
7 which further accelerates the degradation of the switch as a whole. Figure 52 (below), is a
8 picture of one such blade after the switch had been removed from service.

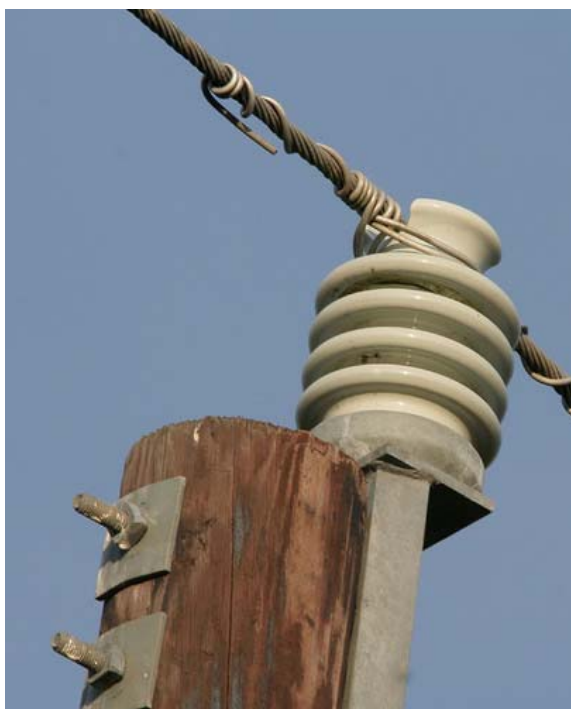
7 **Figure 54: Typical Porcelain Insulator**

1 and a significant contributor to customer interruptions within the overhead distribution system.
2 As porcelain insulators become contaminated due to environmental conditions, a lower
3 resistance path forms across the insulator that eventually allows for a voltage discharge, or arc
4 to ground. Ultimately, this leads to a semi-conductive track that, over time, further weakens the
5 insulator. See Figure 54 for example of typical porcelain insulator installation.

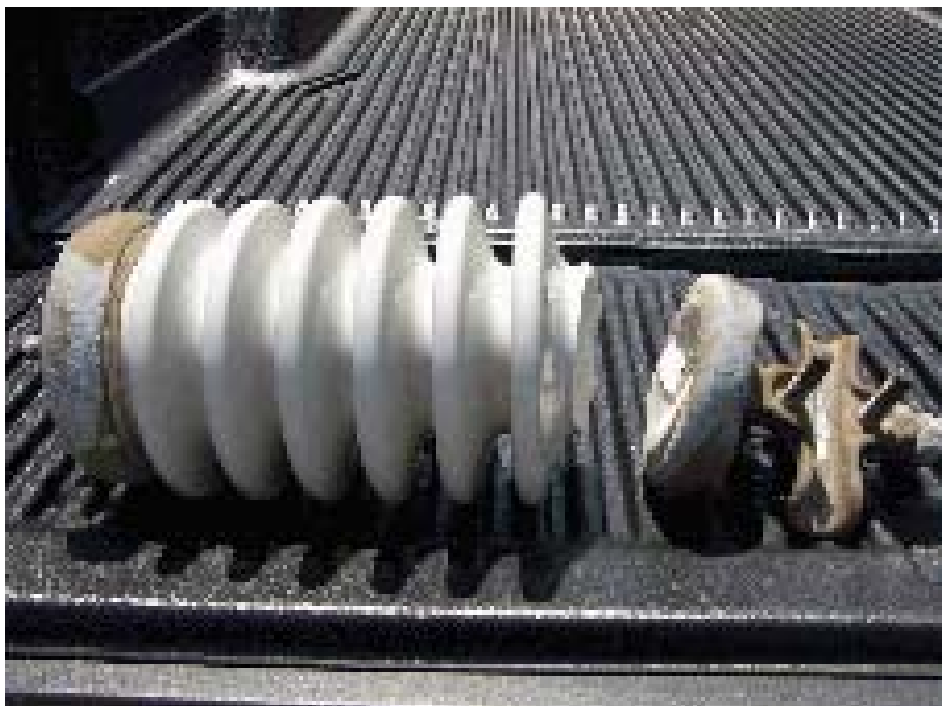
1 Figure 55 shows a broken porcelain insulator. In addition to the safety concerns about falling
2 debris, porcelain fragments can also trigger pole fires.

4 **Figure 55: Broken Porcelain Insulator**

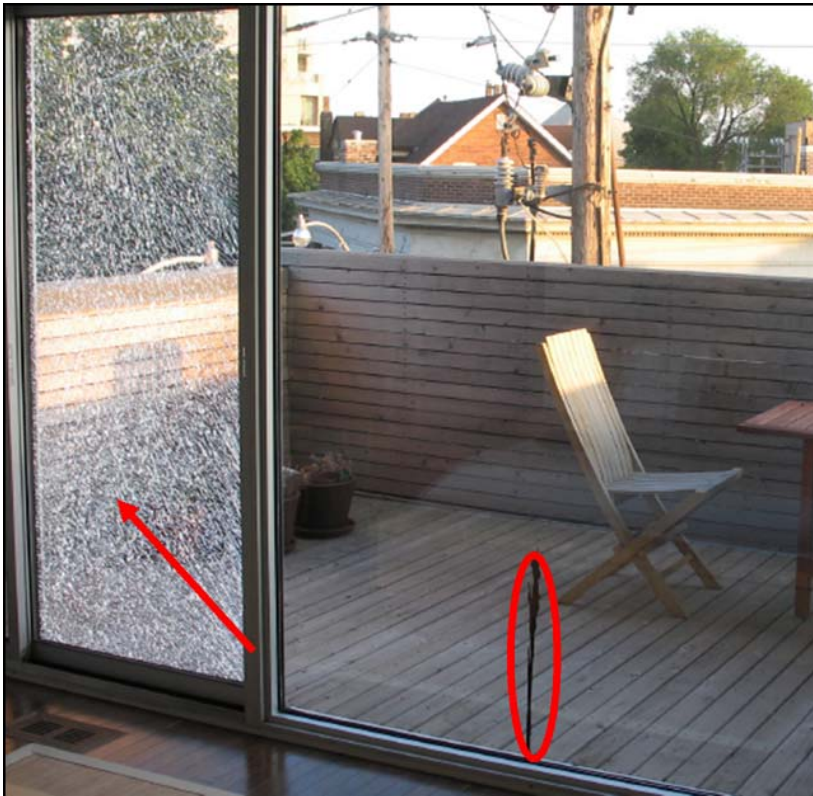
12 In 2009, THESL received a Public Safety Concern from the ESA as a result of a pothead failure
13 sending shards of porcelain onto the balcony of a nearby home, shattering the window of the
14 family room and causing damage to the windshield of a nearby police car. The effects of the
15 failure are seen in Figure 56. THESL replaced the failed porcelain pothead with a new polymer
16 termination shown in Figure 57.

1 **Figure 56: Failure Effects of the Porcelain Pothead Terminators**
2

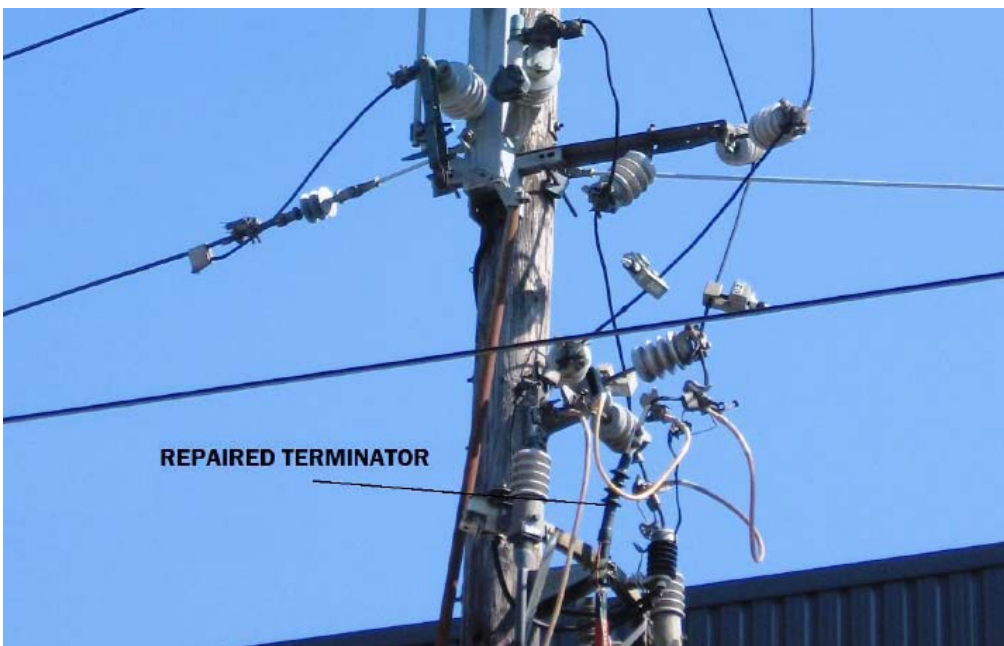
3 **Figure 57: Replaced Porcelain Pothead Terminator**

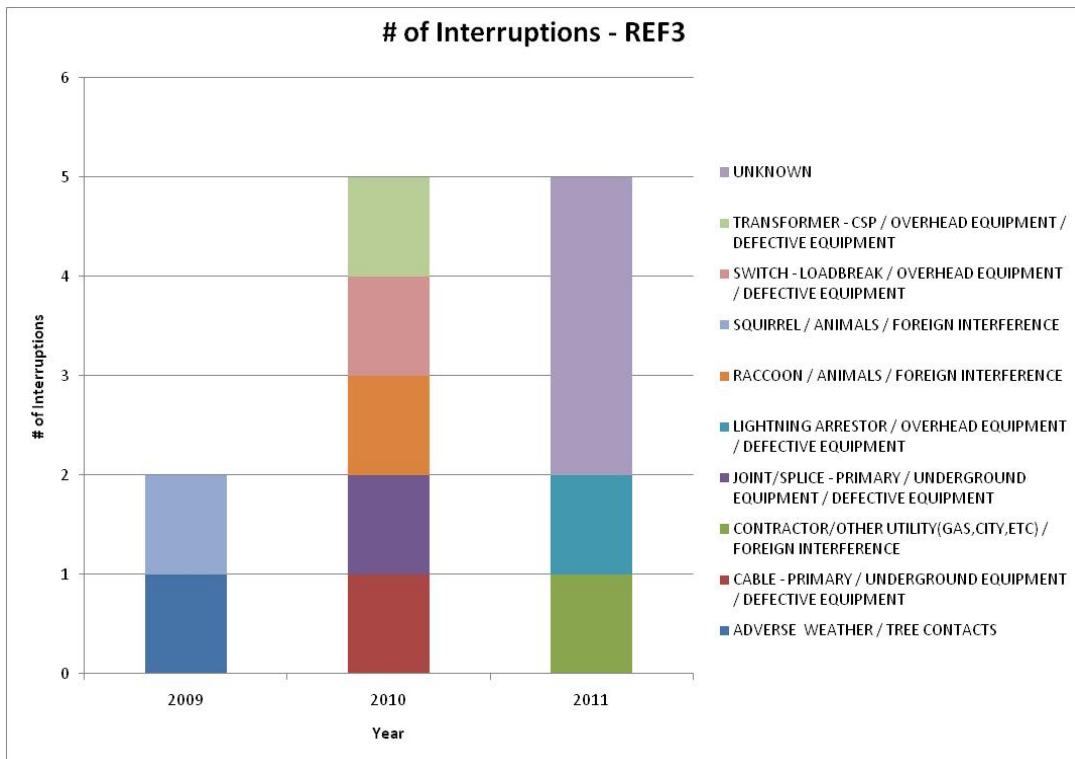
7 **Figure 93: Number of interruptions on REF3**

1 insulators and switches, and CSP transformers. In addition, installing animal guards and
 2 insulating drop wires will reduce the probability of outages caused by animal interference at
 3 strategic areas providing improved service to the customers. Over the last three years the
 4 feeders in question have experienced a number of overhead related faults related to failing
 5 equipment and foreign interference.

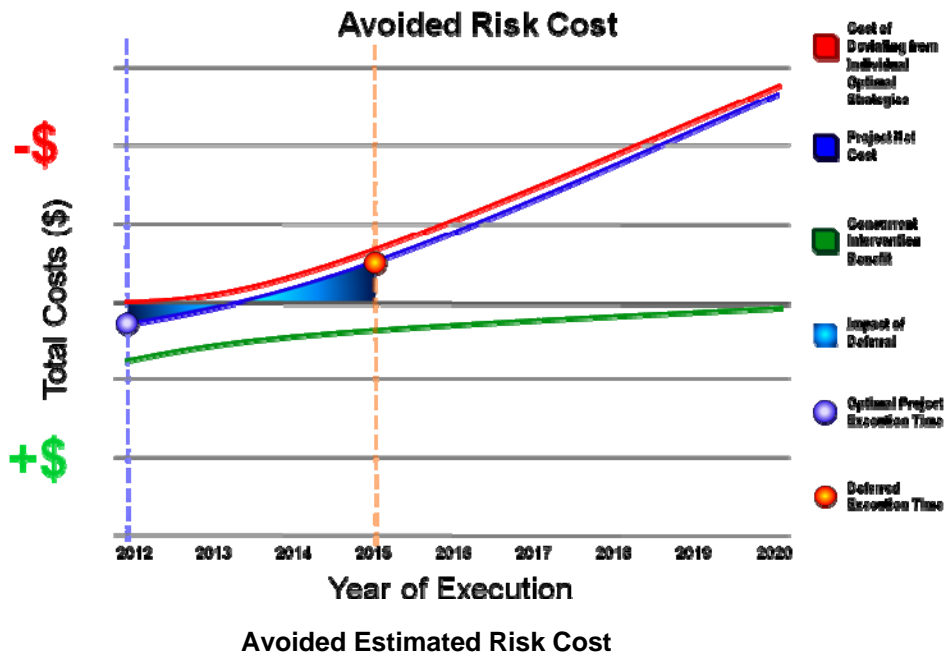
1 **Figure 3: Example of Project Net Benefit Analysis for Job-Based Approach**

- 26 ○ $\text{PROJECT}_{\text{NET_COST}}(2012)$: Represents the total project net costs in 2012.
- 27 ○ $\text{PV}(\text{PROJECT}_{\text{NET_COST}}(2015))$: Represents the present value of total project net costs in
28 2015.

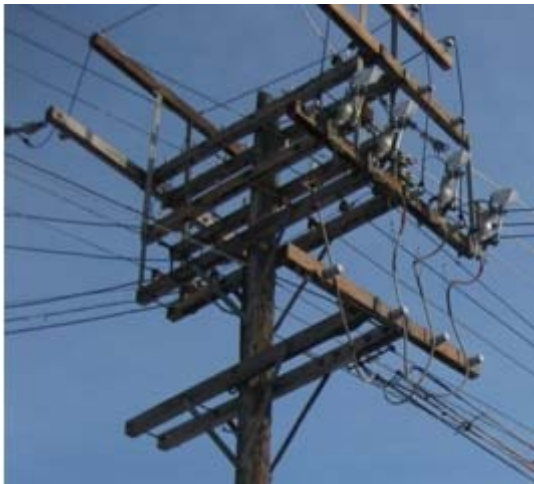
15 **Typical Box Construction Installation (January 16, 2012)**

4 Box construction refers to a type of legacy 4kV overhead construction that was previously used
5 in the former City of Toronto and still exists in some areas of the city. The picture below shows
6 a typical box construction installation in the city. There are a number of reliability, safety and
7 load capacity issues associated with box construction (described below), which THESL plans to
8 address through a proactive program to convert these feeders to standard 13.8kV overhead
9 construction. In addition, there are specific issues that necessitate the conversion of box
10 construction 4kV feeders supplied from stations such as Hazelwood MS (municipal station).
11 These issues are described in detail in Section II, 2. The legacy overhead construction will be
12 replaced with 13.8 kV overhead feeders. The estimated total cost of the proposed segment is
13 \$58.5 million.

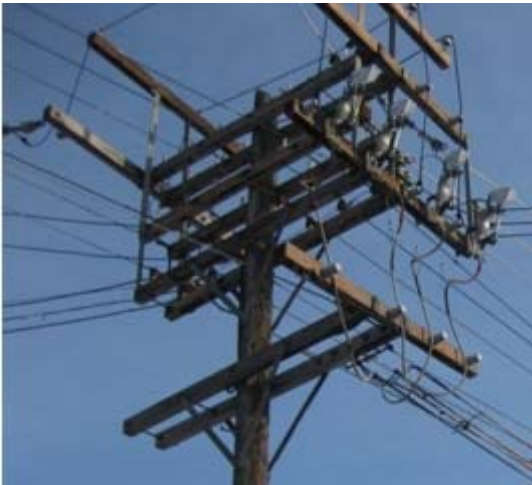
13 **Figure 1: Typical Box Construction Installation (January 16, 2012)**

4 Box construction refers to a type of legacy 4kV overhead construction that was previously used
5 in the former City of Toronto and still exists in some areas of the city. Figure 1 shows a typical
6 box construction installation in the city. There are a number of reliability, safety and load
7 capacity issues associated with box construction (described below), which THESL plans to
8 address through a proactive program to convert these feeders to standard 13.8kV overhead
9 construction. In addition, there are specific issues which necessitate the conversion of box
10 construction 4kV feeders supplied from stations such as Hazelwood MS (municipal station).
11 These issues are described in detail in Section III.

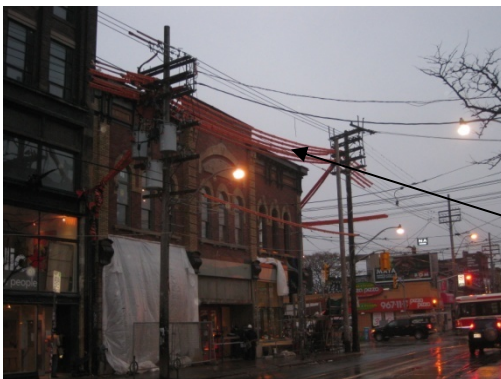
23 **Figure 4: Construction at Queen and Bathurst (January 17, 2012)**

Queen and Bathurst area.
Feeder was isolated in this area
due to work on building at SE
corner of intersection, requiring
extensive temporary circuit
modifications to the area.

12 Clearance issues are also prevalent with 4kV overhead box construction feeders. As per CSA and
13 THESL standards, the clearance between overhead feeders and buildings must be greater than
14 three metres, as shown in Electrical Safety Authority (ESA) standard Appendix B. In many cases,
15 as buildings are replaced or rebuilt, they are being located closer to or even right against the lot
16 lines compromising on line clearances previously achievable. In many instances, the three-
17 metre clearance does not exist between lot line and roadway, due to the large area that the box
18 occupies at the top of box construction poles. Extensive planning must then be done to isolate
19 those conductors within three metres and still feed customers in that area. This work can often
20 be avoided with existing 13.8kV overhead construction standards. See Figure 4, Figure 5, and
21 Figure 6 for examples of these clearance issues in Toronto.

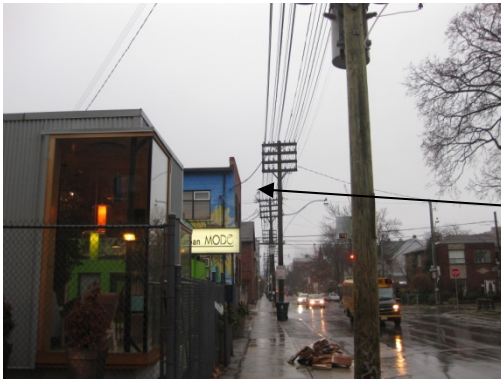
1 **Figure 5: Potential Clearance Issue (January 17, 2012)**

Though not a problem yet, there will be clearance issues in the event that buildings along Tecumseh (south of Queen) need any civil work done.

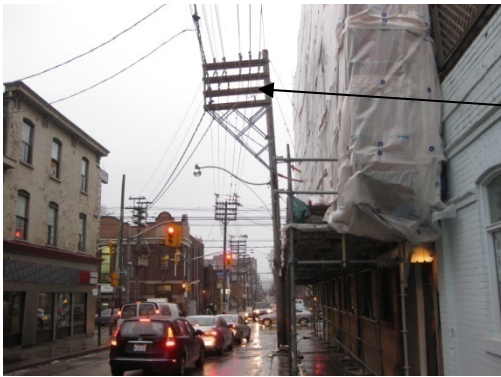
3 **Figure 6: Clearance Issue (January 17, 2012)**

Box pole was modified to accommodate construction project (Palmerston, North of Queen on West side). Specialized work becoming more difficult due to lack of experienced overhead line crews.

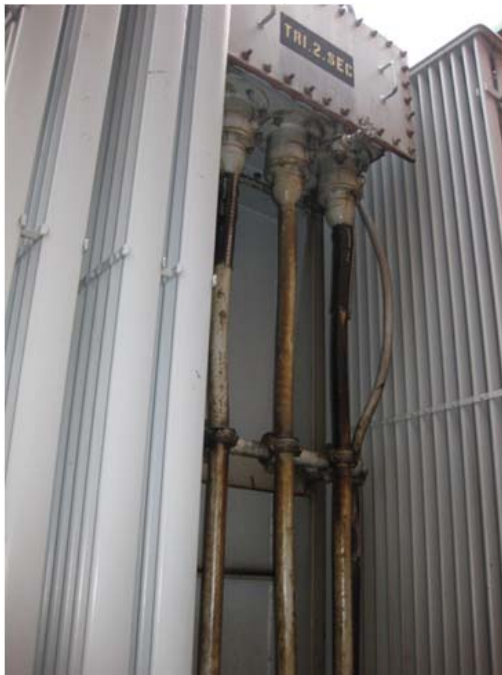
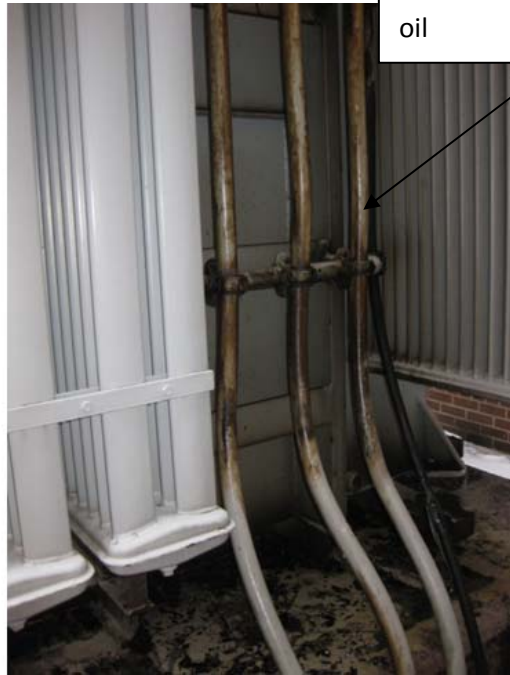
1 **Figure 9: Transformer TR2 with more significant oil leakage (January 16, 2012)**

Outer sheath of cables are covered in oil

13 In addition to the poor dissolved gas analysis results seen in Table-7 and Table-8, a site
 14 inspection of Hazelwood MS revealed problems with the four station transformers, as they were
 15 all leaking oil. Figure 8 through Figure 11 show that the transformers are leaking. If the station
 16 is not decommissioned, it is estimated that THESL will have to replace \$1.73M of station
 17 equipment that are past useful lives and incur \$0.65M in maintenance costs over the next five
 18 years. Note that refurbishing old assets like these station transformers rather than replacing
 19 them does not make economic sense when major components like core, windings/insulation
 20 and oil have to be replaced, as it is estimated that the refurbishment cost will be close to the
 21 replacement cost itself.

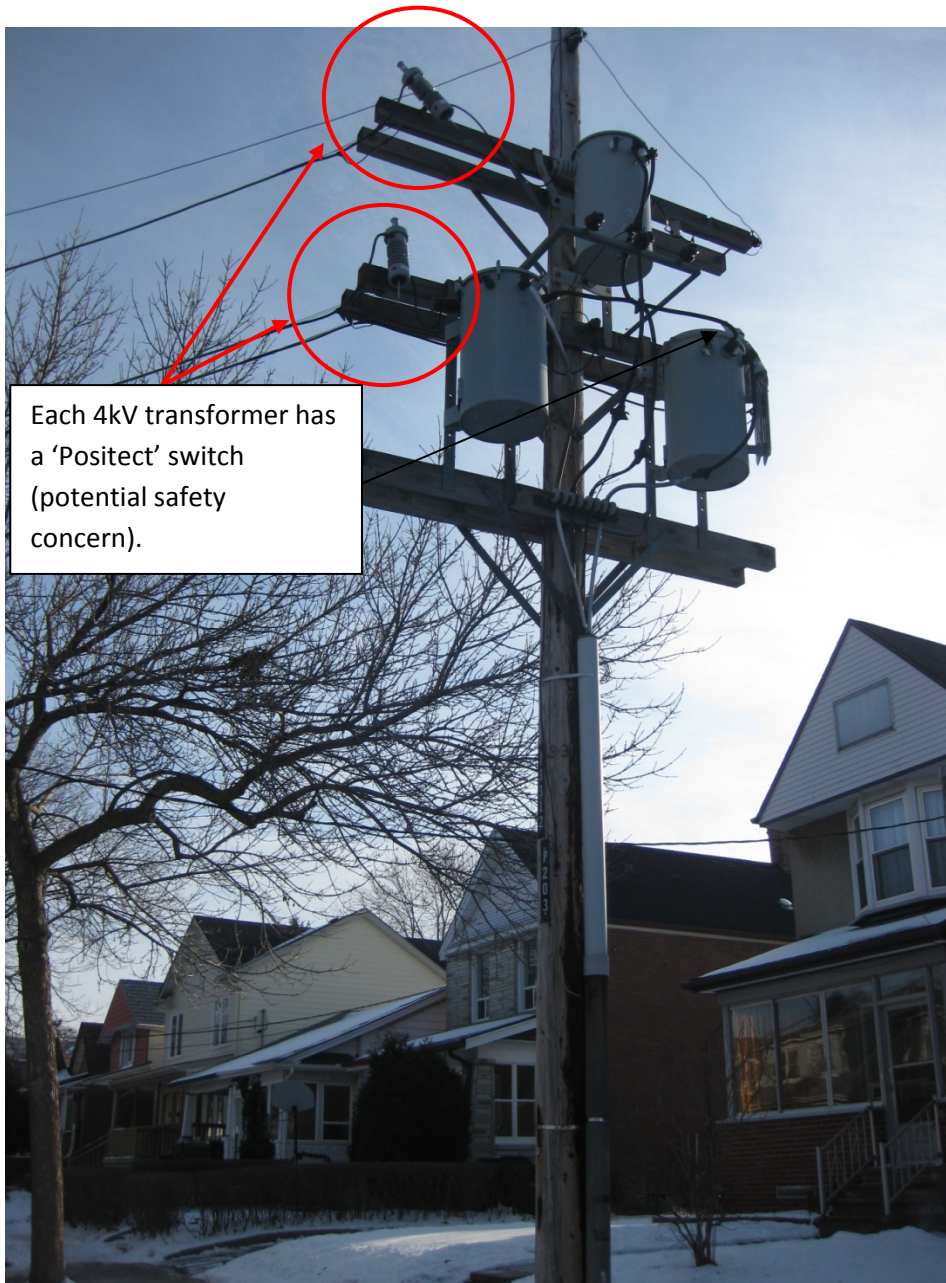
1 Figure 15: 'Positect' Disconnect Switch on B3HW (January 16, 2012)

3 There are also workplace safety concerns associated with 4kV assets not meeting the current
4 THESL standard, as described above in Table 3. Examples of such assets include porcelain
5 insulators (should be polymer type, see C for safety bulletin), and 'Positect' type switches that
6 present a potential safety risk, as field crews operate the switches while directly in front of them
7 (arc flash hazard). See Figure 15 for an example of a 'Positect' switch.

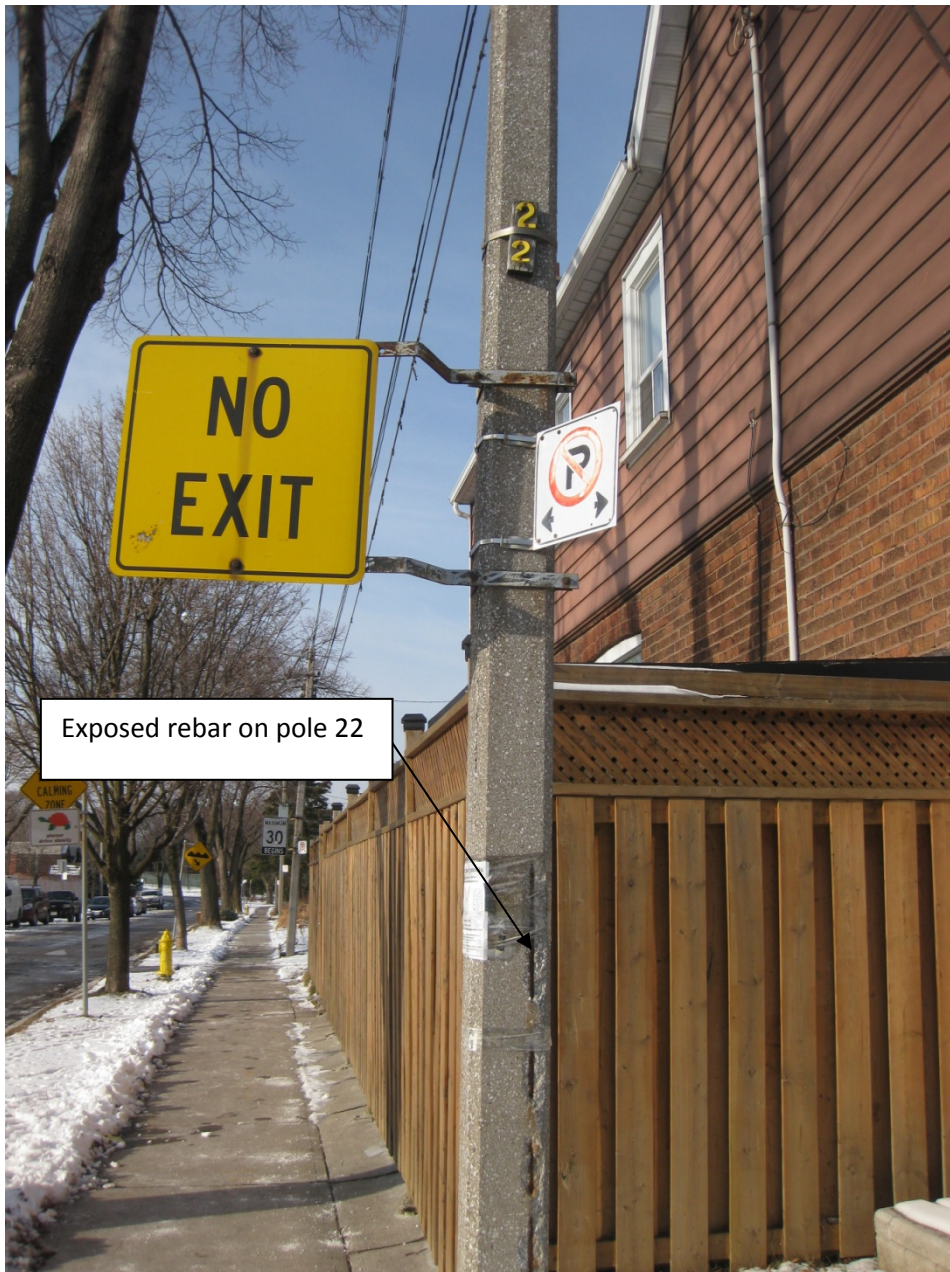
1 Figure 18: Exposed Rebar on B5HW (January 16, 2012)

3 A significant number of assets on all box construction feeders in the city are over 60 years old,
4 and are now past their useful life. Figure 18 and Figure 19 show examples of assets fed from
5 Hazelwood MS which are past useful life.

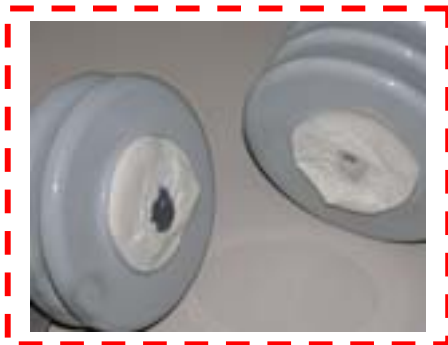
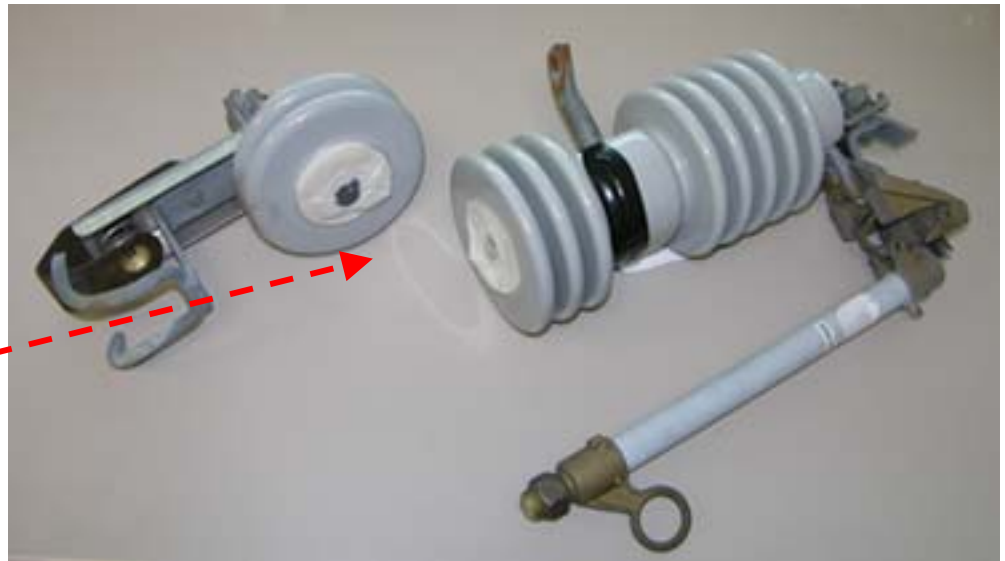
John Boag (ICR High Voltage) has reported that recently there have been a number of failures of the fused porcelain cut out style of switch pictured above. This single-phase switch is bracket-mounted and used to isolate and fuse distribution equipment, in the case of this failure a single-phase standard overhead transformer. The majority of these recent failures have been taken place in the former East York area on 27.6kV circuits. The weak point where the fractures are occurring appears to be where the pin ends inside the glass insulator. Most of these failures haven't occurred during a switching operation.

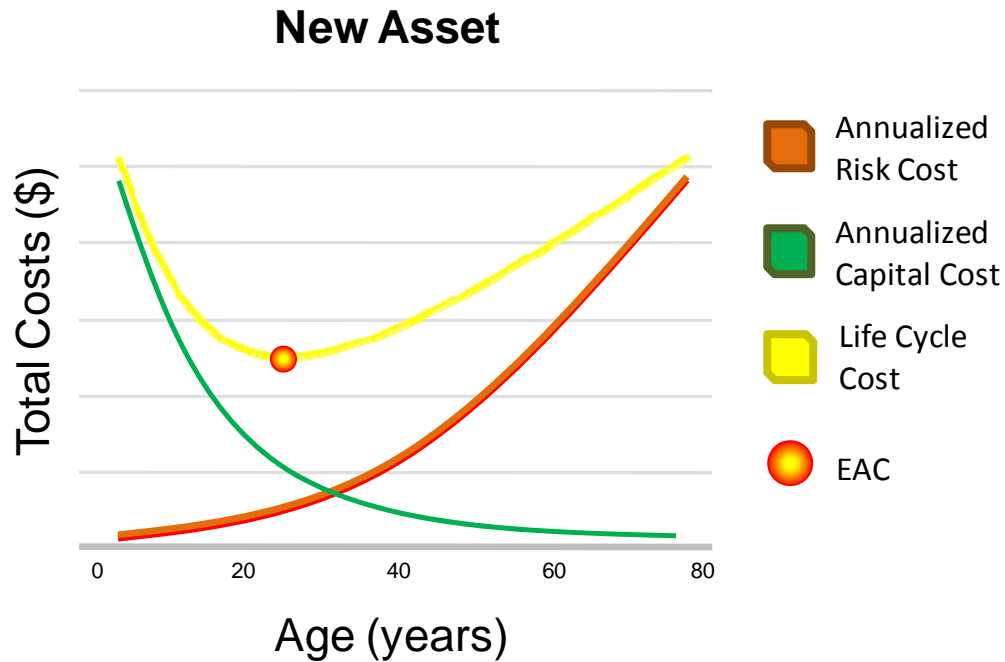
20 account the annualized risk and capital over its entire lifecycle. The optimal intervention time
21 would then be the red marker at which the Equivalent Annualized Cost ("EAC") is at its lowest.

1 **Figure 1: Typical Example of Optimal Intervention Time (New Assets)**

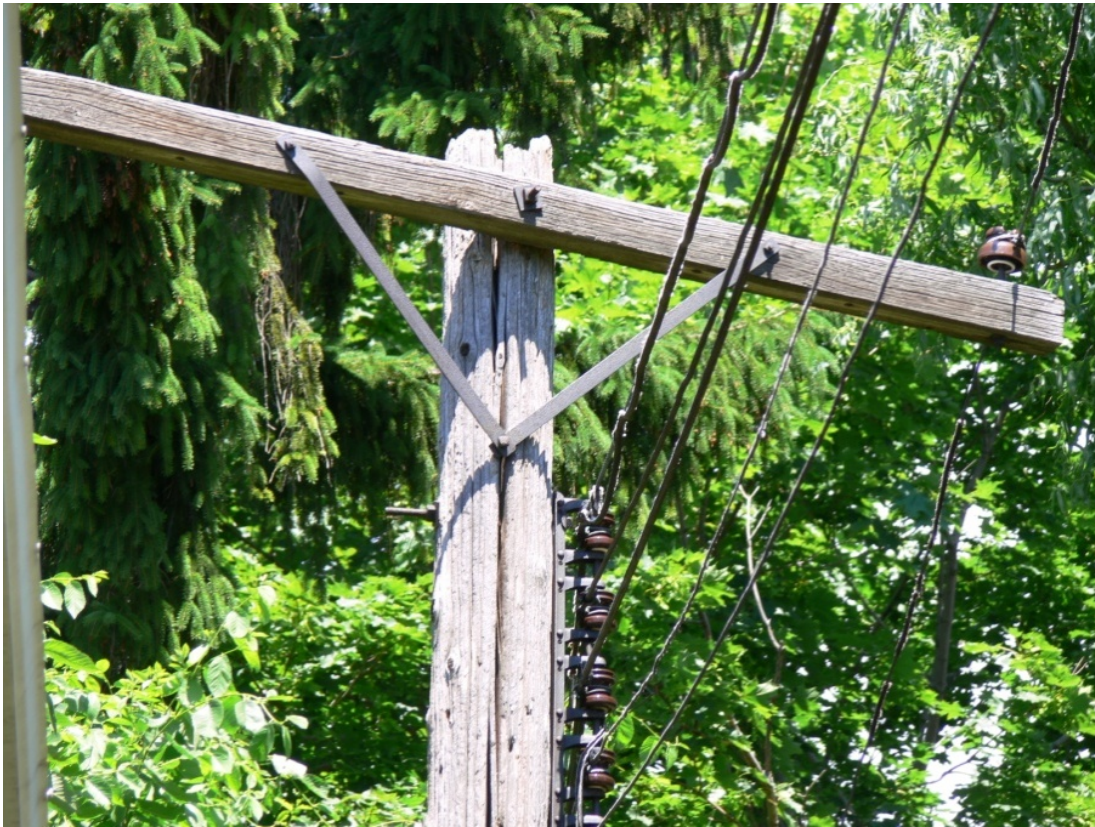
1 **Figure 4: Rear lot pole in poor condition**

- 11 • The majority of poles have rot at the top and show signs of feathering (a dominant factor in
12 determining the condition of a pole) as shown in Figures 4 and 5 below.³ It is evident from
13 these Figures that critical assets on the pole, such as switches and transformers, are not
14 adequately supported due to the extensive cracking. A sample of Health Index data
15 reviewed for rear lot areas, which recently experienced outages in excess of 15 hours,
16 indicates that approximately 10% of the poles are in poor condition and approximately 60%
17 are in very poor condition.

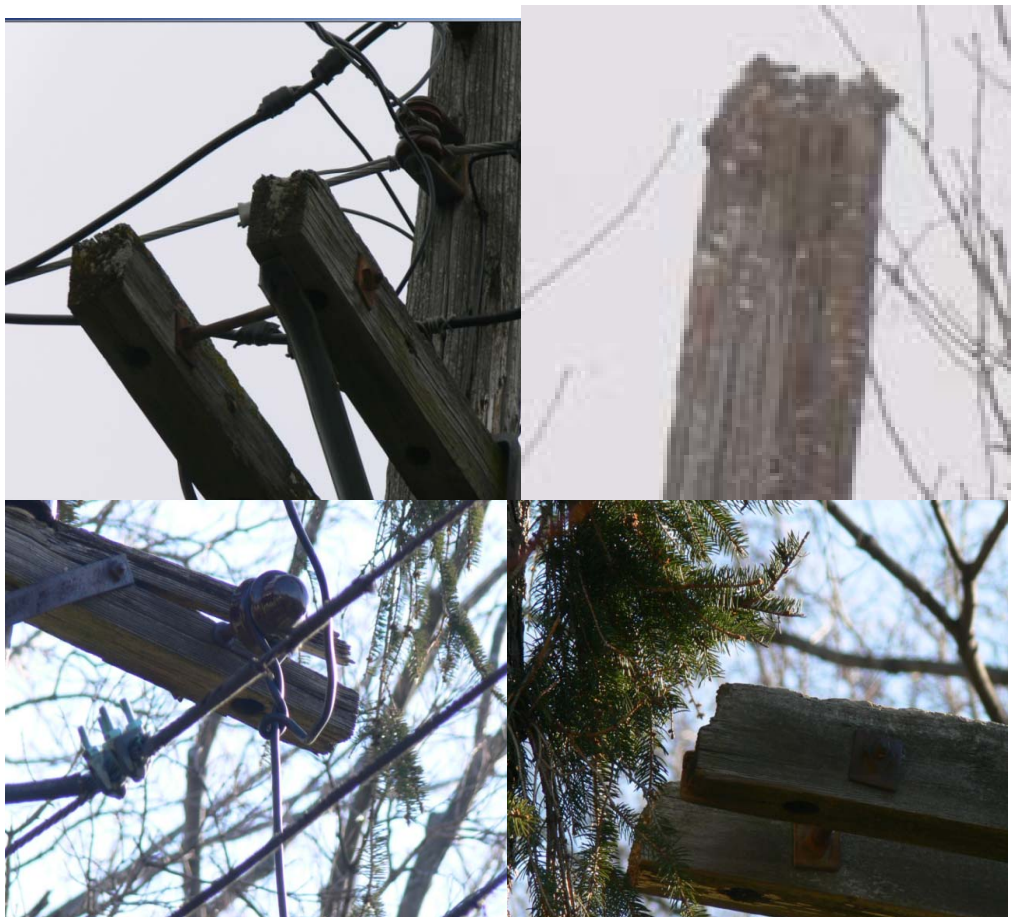
1 **Figure 5: Aging and poor condition plant in the Rexdale Colony, Forest Hill, and Thorncrest**
2 **rear lot area (photo taken in 2012)**

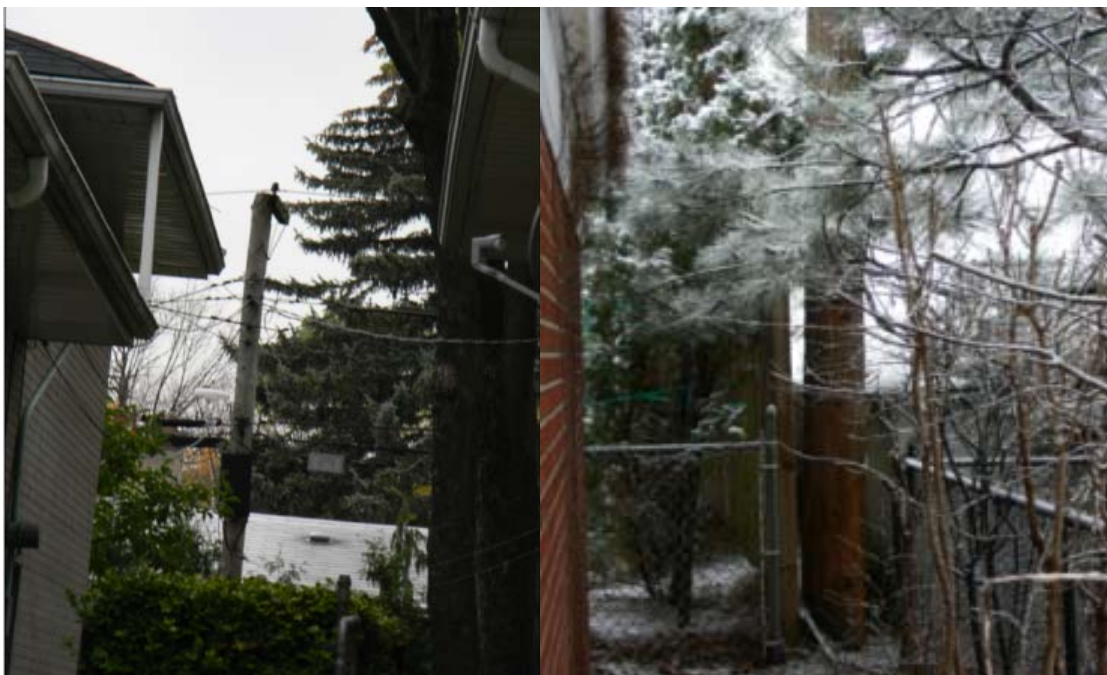
1 **Figure 6: Space limitations cause access restrictions to rear lot plant (photo taken in 2012)**

5 By far, the most challenging issue for the operation and maintenance of the rear lot distribution
6 system is that THESL vehicles and mechanized equipment (e.g., bucket trucks, cranes, and
7 drilling machines) cannot access rear lots to perform their typical functions. As shown in Figures
8 6 and 7, below, the lack of road access, and the fact that pathways are often narrow and
9 obstructed by gates, vehicles, and other customer property (e.g., pools, patios, and sheds)
10 require that many tasks be carried out manually.

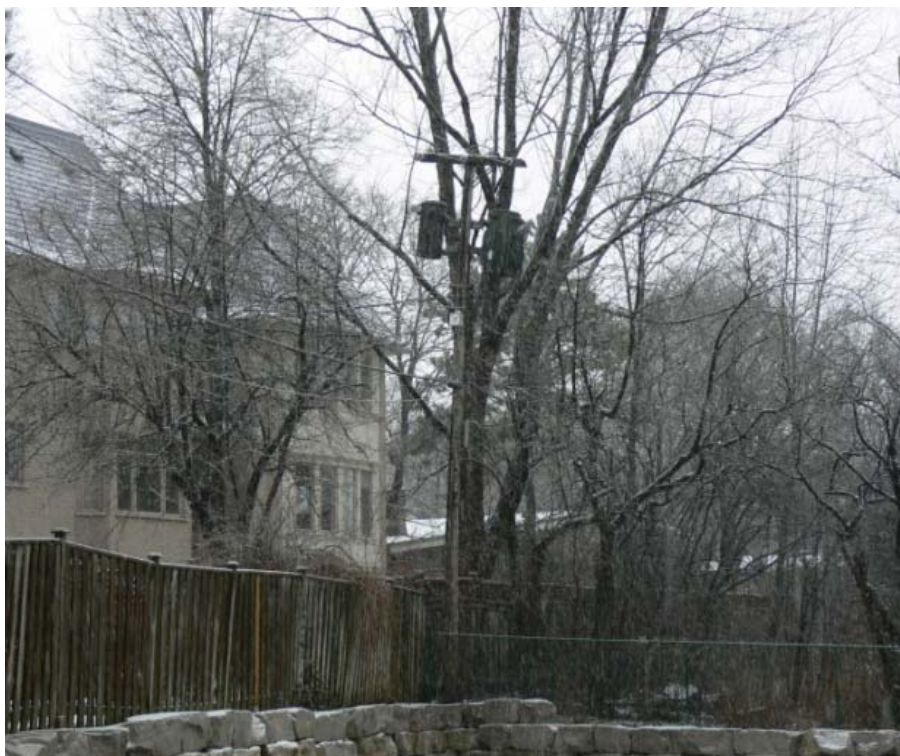
1 **Figure 7: Limited access to critical THESL asset –transformer (photo taken in 2012)**

9 Figure 7, below, illustrates a very difficult access location for an overhead transformer, a critical
10 part of the distribution infrastructure. Examples of lengthy outages associated with the repair
11 of rear lot facilities are described in further detail in the customer service and reliability section
12 of this evidence.

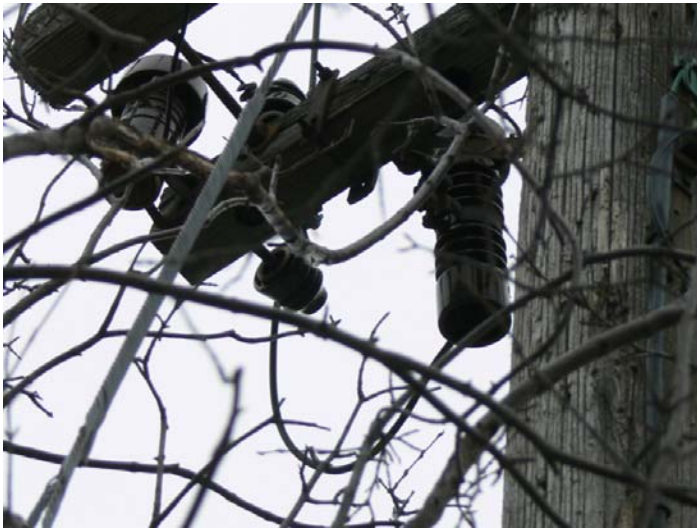
1 **Figure 8: Non-standard Positect switches in the Rexdale Colony rear lot area (photo taken in**
2 **2012)**

9 Non-standard, hand-operated Positect switches are commonly found in rear lot construction.
10 These switches are known to cause arc flash hazards. As a result, THESL crews often are
11 required to operate the next upstream load-break switch and then open the Positect switches
12 after they are confirmed to be de-energized. This leads to additional customers experiencing an
13 unplanned outage and increases outage duration. A non-standard Positect switching equipment
14 is shown in Figure 8.

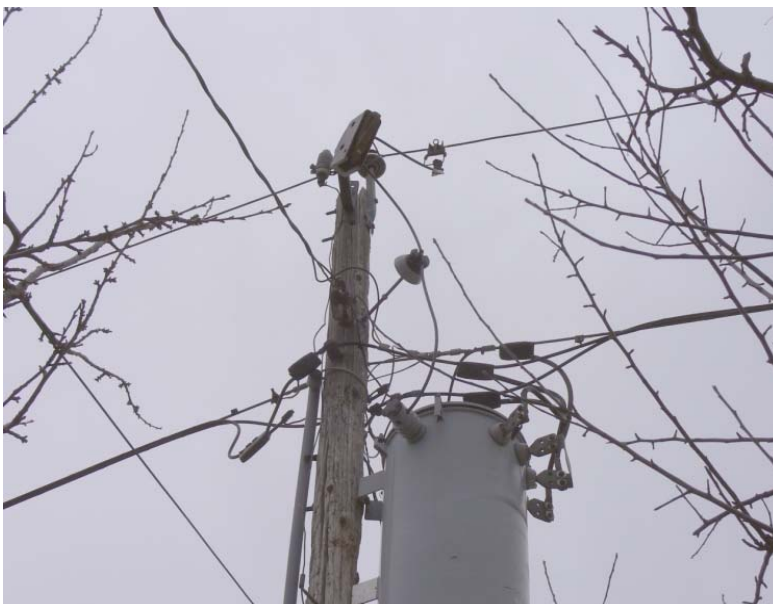
3
4 Figure 9, below, illustrates a non-standard pole top extension with porcelain insulators. Evident
5 from the Figure is the encroachment of vegetation on overhead critical assets, such as
6 transformers.

8 **Figure 9: Example of Non-standard Assets in the Rexdale Colony Rear Lot Area (photo taken in**
9 **2012)**

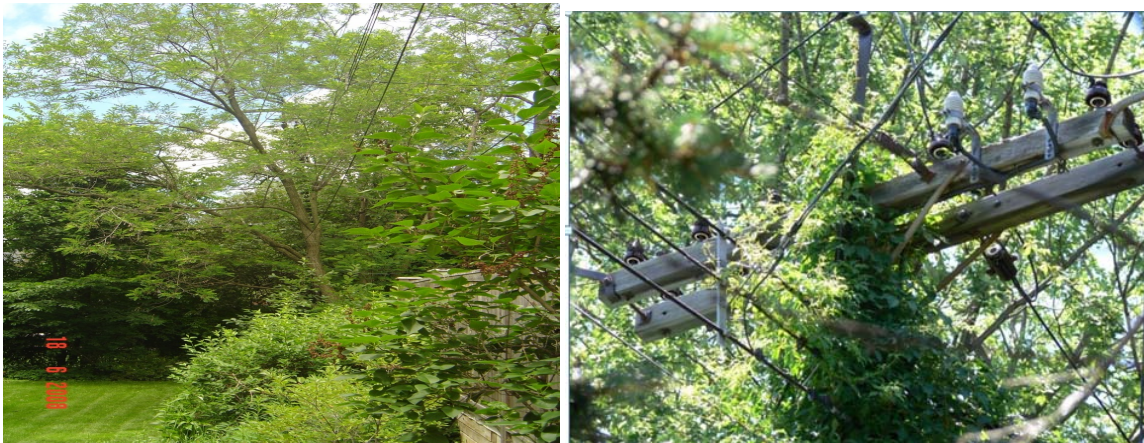
10 **Figure 10: Excessive vegetation in close proximity to rear lot distribution assets**

2 Mature trees and plants in rear lot areas often adversely impact THESL facilities, as shown in
3 Figure 10 below. As backyard trees and plants grow over time, they come into direct contact
4 with the rear lot assets, causing unnecessary outages. Tree trimming is an ongoing issue due to
5 restricted access to rear lots, as well as limited space available for tree trimming efforts.

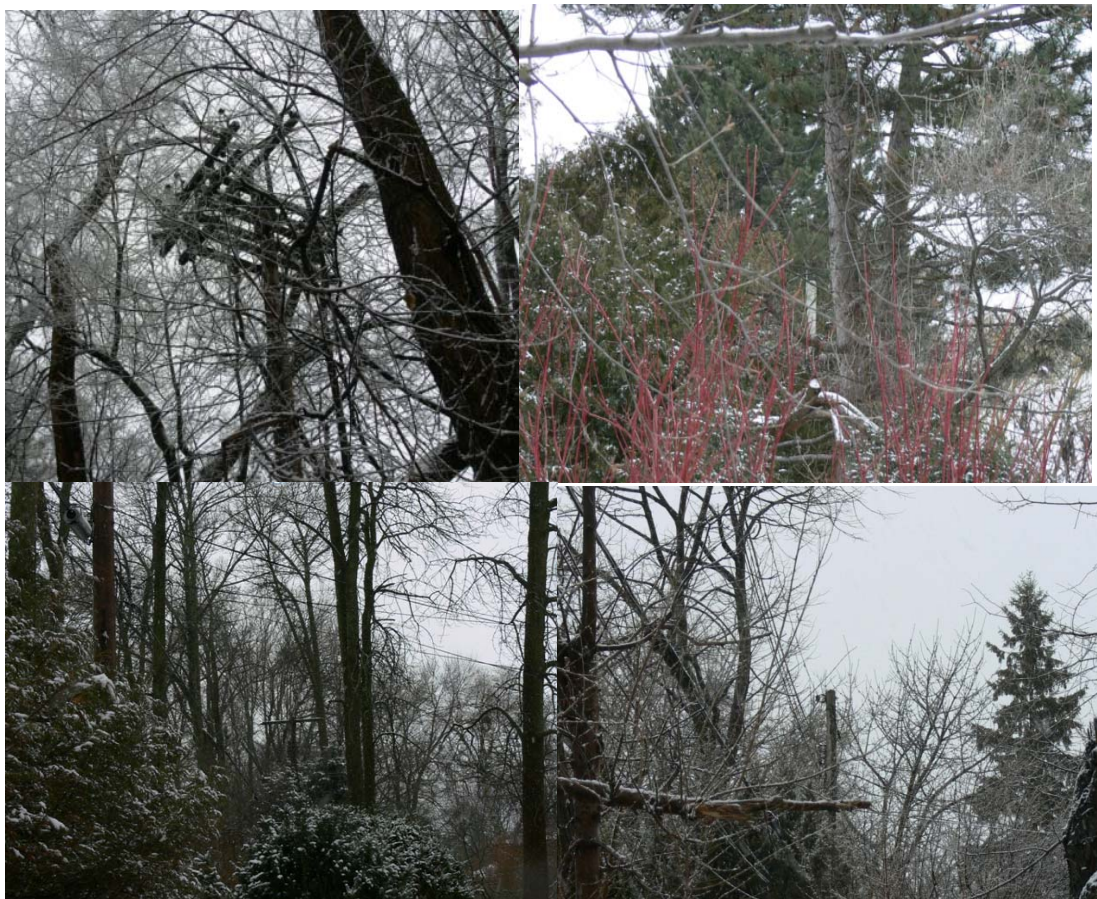
1 **Figure 11: Vegetation encroaching on THESL assets in the Forest Hill, Banbury-Larkfield-**
2 **Charnwood, Livingston Guildwood, and Leslie-Lawrence rear lot area (photos taken in 2012)**

12 Figure 11, below, shows areas in which vegetation has encroached the pole, to such an extent,
13 that THESL crews would be challenged to efficiently and safely climb it. As a result, to respond
14 to an outage, the crew first must trim the trees and then conduct repairs to restore service.

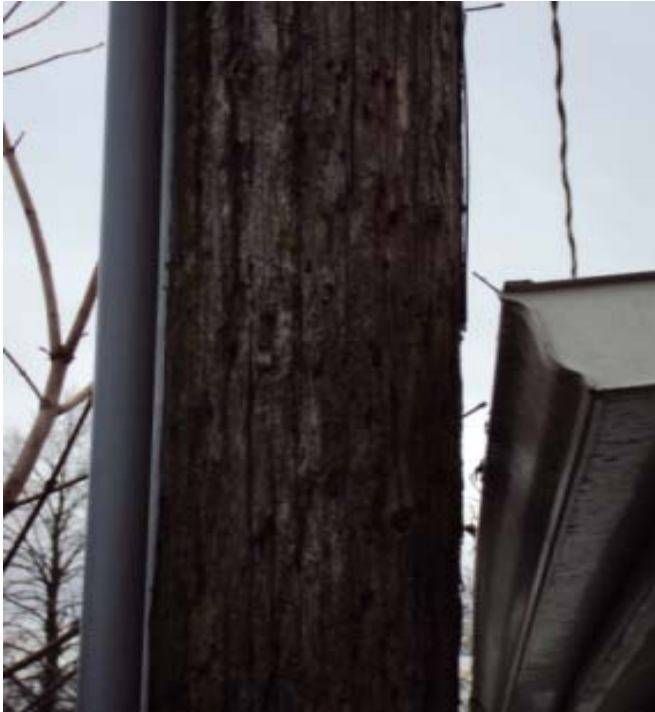
1 **Figure 12a: Example of a rear lot pole close to an eavestrough (photo taken in 2012)**

9 Figures 12a and 12b illustrate situations where the eavestroughs of the houses are very close to
10 the pole and other THESL facilities. A customer using a ladder to clean them would be at risk.
11 Figure 13 illustrates the safety hazard to the public due to the close proximity of the fence to the
12 THESL pole (THESL Standard 03-2400). This represents a particular safety hazard because of the
13 presence of a 4kV energized primary cable rising at this pole location and a high voltage 2,400 V
14 cable (not a 120 V service line). In addition, were one of the poles, shown in the
15 aforementioned Figures, required to be replaced, the close proximity to customer buildings and
16 fences would restrict the amount of space available for THESL crews to work.
