ICM Project – Underground Infrastructure and Cable

Handwell Replacement Segment

Toronto Hydro-Electric System Limited (THESL)

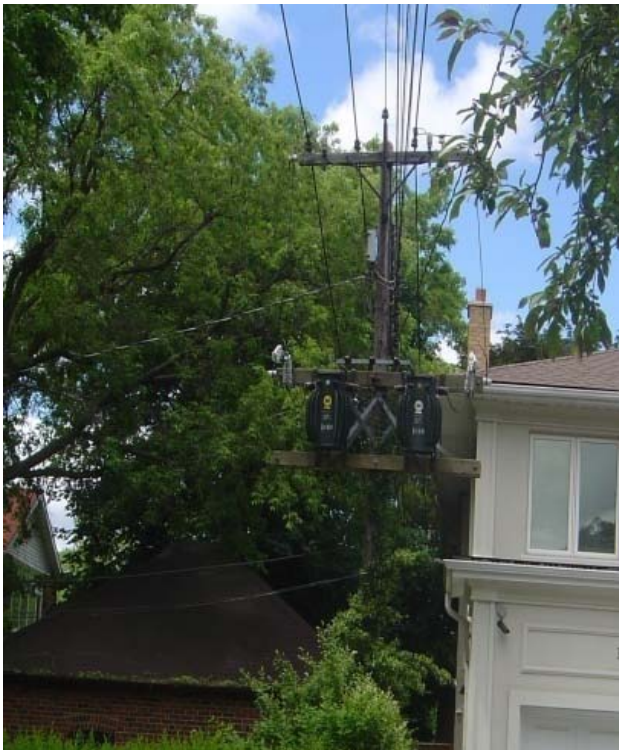
2 **Figure 12b: Example of customer premises in close proximity to rear lot facilities**

9 Figures 12a and 12b illustrate situations where the eavestroughs of the houses are very close to
10 the pole and other THESL facilities. A customer using a ladder to clean them would be at risk.
11 Figure 13 illustrates the safety hazard to the public due to the close proximity of the fence to the
12 THESL pole (THESL Standard 03-2400). This represents a particular safety hazard because of the
13 presence of a 4kV energized primary cable rising at this pole location and a high voltage 2,400 V
14 cable (not a 120 V service line). In addition, were one of the poles, shown in the
15 aforementioned Figures, required to be replaced, the close proximity to customer buildings and
16 fences would restrict the amount of space available for THESL crews to work.

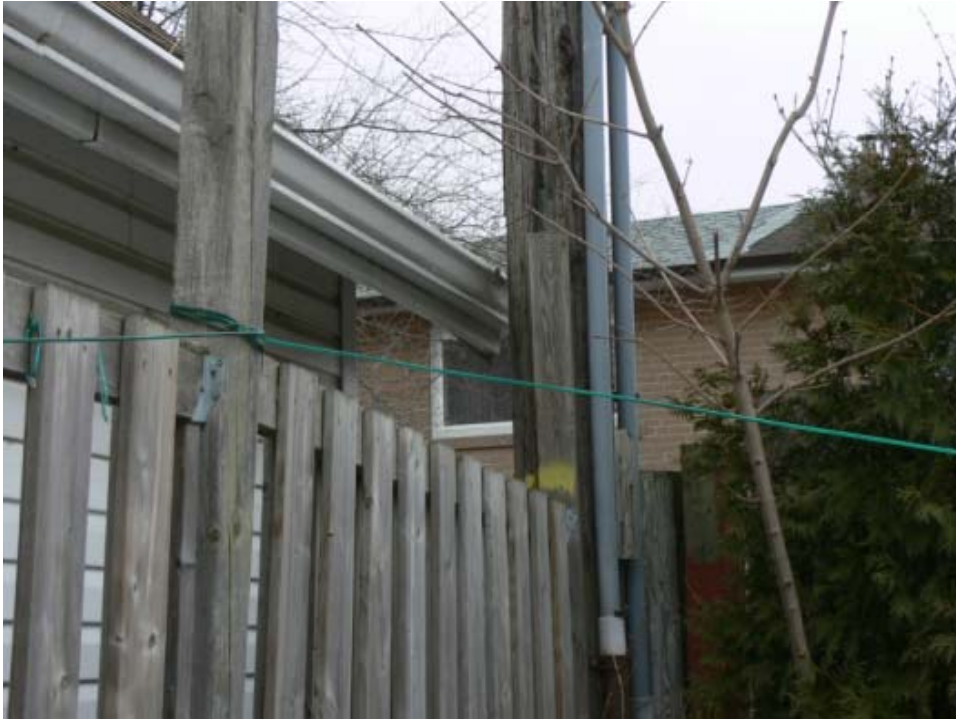
- 1 **Figure 13: Example of customer-owned fence installed too close to a THESL pole (photo taken**
- 2 **in 2012)**
- 3
- 4 Figure 14 shows a clothes line attached to a rear lot pole.

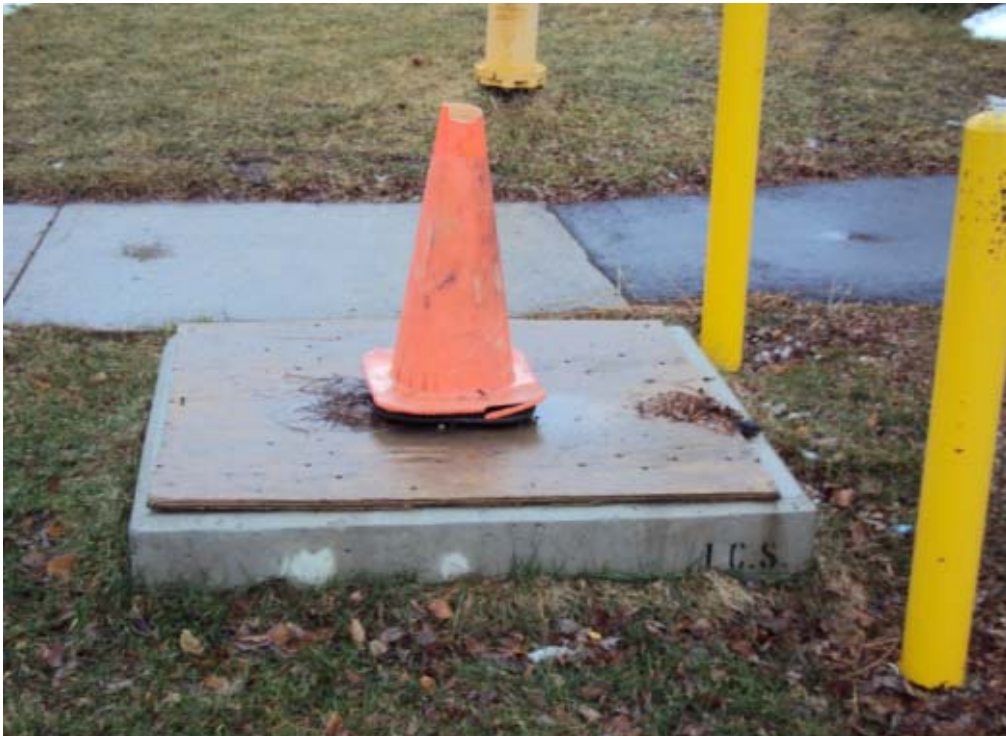
1 **Figure 16: Civil work that has been completed in the Rexdale Colony rear lot area, awaiting**
2 **electrical installation (photo taken in 2012)**

23
24 Figure 16 illustrates an already completed civil phase of a job awaiting electrical installation. In
25 anticipation of funding for rear lot conversion, the civil construction for some of the rear lot jobs
26 was initiated in 2011. Should Option 1 (Refer to Section IV: Alternatives for Addressing Rear Lot
27 Construction) be selected and the proposed conversion activities postponed, THESL will have to
28 return to these areas in 2015 (the anticipated next re-basing year) to complete the conversion
29 work. This will result in further customer disruptions three years from now.

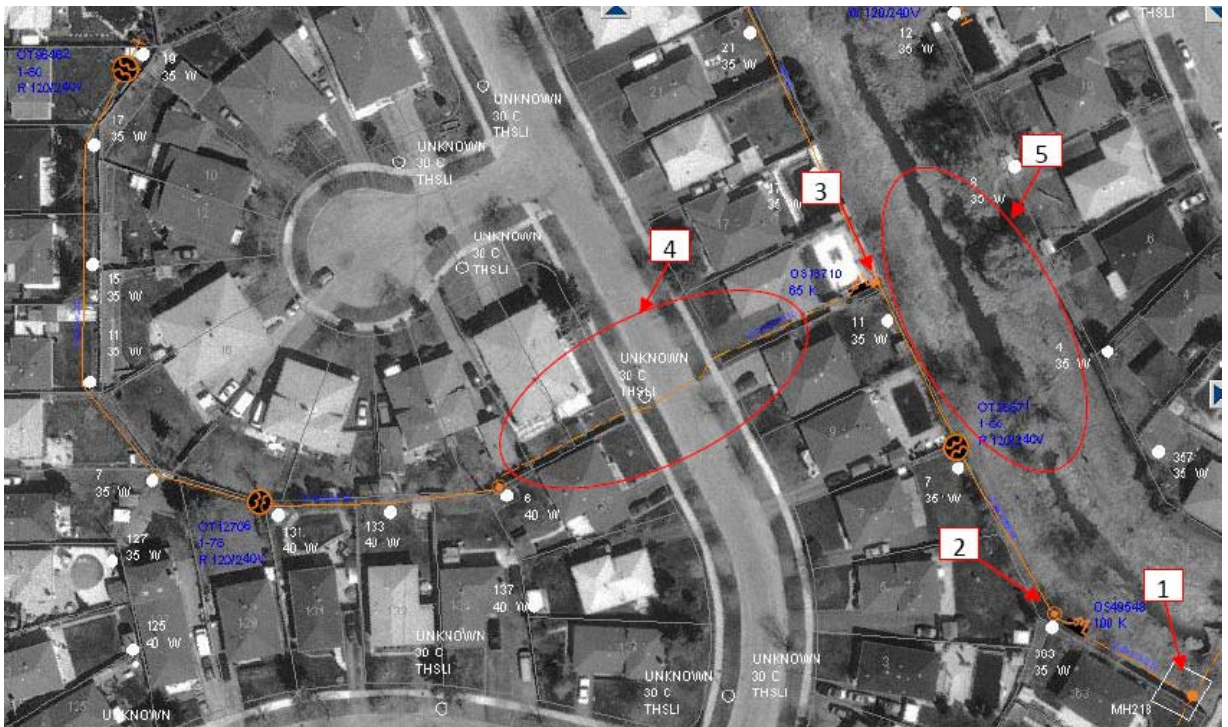
Figure 17: Current configuration of the Rexdale Colony overlaid upon a satellite view

Figure 17 illustrates several operational and safety issues present in the rear lot. Item #1 illustrates the direct buried cables supplying the rear lot plant. This cable is over 40 years old. Should an outage occur on a direct buried cable situated like this one, the restoration time would be quite long.

The Rexdale Colony, located in the western part of Toronto, exemplifies many of the issues facing rear lot areas across the city. Figure 16 illustrates the current configuration overlaid upon a satellite view of the same area:

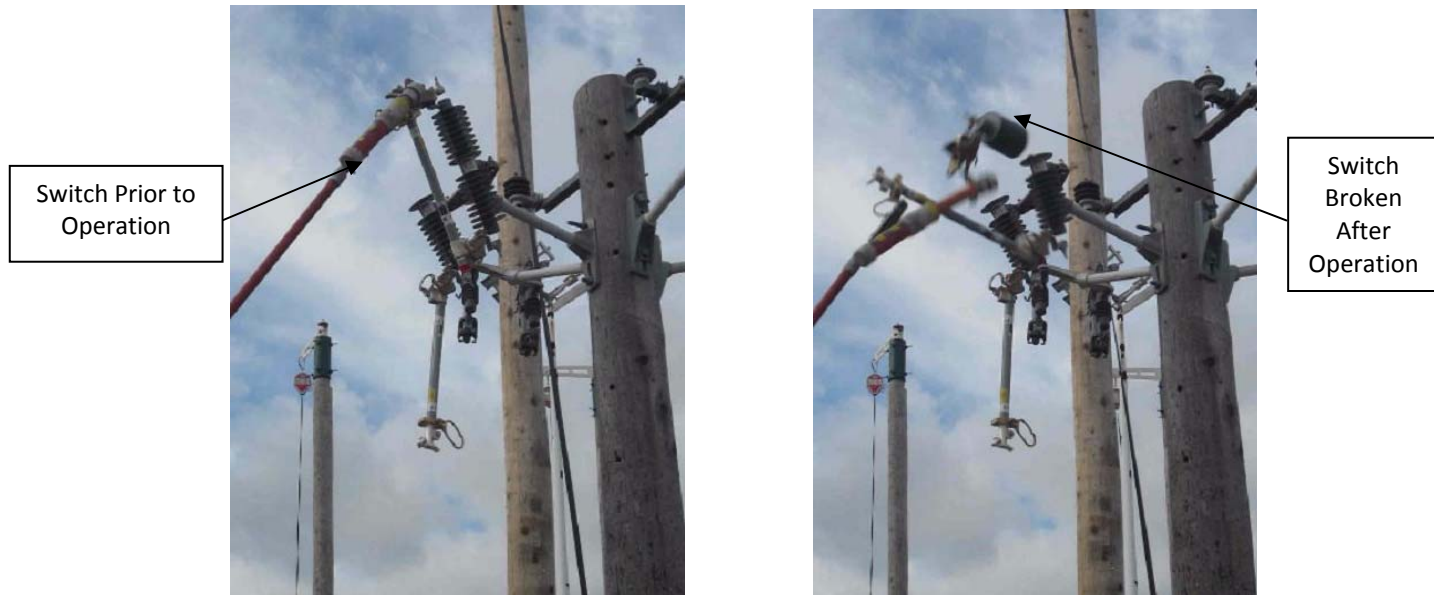
Figure 4: Before and After Switch Operation

7 Table 2 shows the number of operations that took place before the switch broke in half using
 8 the force typically required for its operation under real field conditions. The green colour
 9 illustrates a successful operation and the red colour illustrates a failed operation. Out of the 14
 10 samples, 13 failed in less than ten operations. Among the samples where failure occurred, the
 11 mean number of operations to failure was approximately 3.5 and the median was 3. Figure 4
 12 shows the switch before and after the second test operation of sample “6”.

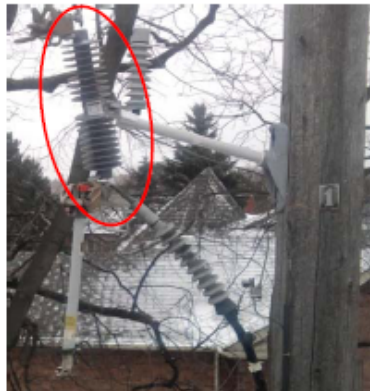
Figure 1 – Switch Installed

Two recent failures have occurred in the field on S&C manufactured SMD-20 pole-mounted switches, where the insulator has broken in half during switching operation (one during open, one during close). These switches are the polymer-type insulators and are used for both 15kV (stock code 7050009) and 25kV (stock code 7050006) applications. Figure 1 is of a switch installed in the field, and Figure 2 is a failed switch returned from the field.

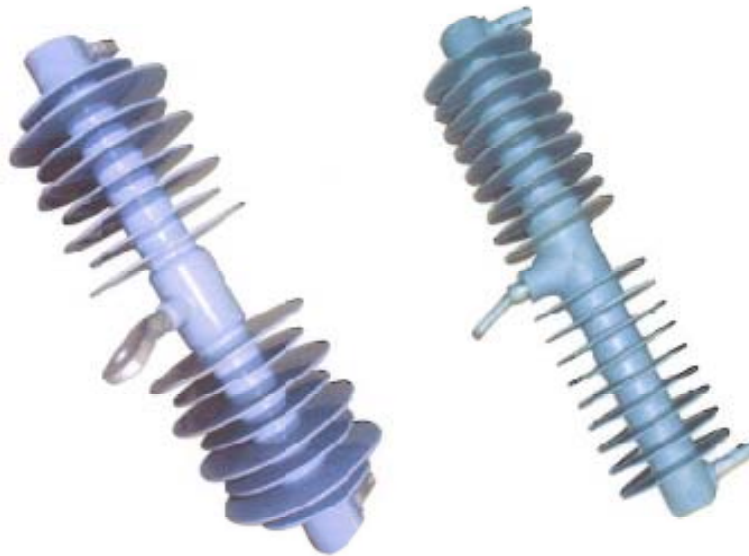
New Design

Old Design

As a point of information, S&C has now incorporated a polymer insulator design which, among other advantages, incorporates a fiberglass core that provides greater flexibility and strength. Its ultimate bend strength is five times greater than the old design. Operating personnel can readily distinguish between the two designs as the redesigned insulator utilizes alternating-diameter sheds, as shown below. The alternating-diameter sheds help prevent "bridging" in wet or polluted environments.

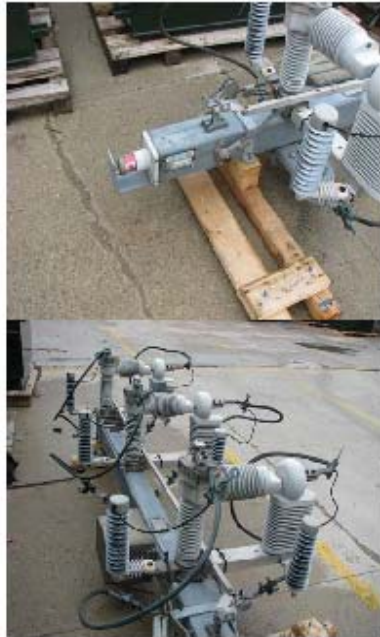
Scada-mate Switches

We recently experienced two similar incidents involving Scada-mate switches that were targeted for repair/maintenance. In both incidents P&C had been requested to investigate the Scada-mate switches because SCADA and the local mechanical switch indicators showed opposite readings (i.e. SCADA indicated switch was open while the local switch indicator showed the switch as being closed).

First incident: The switch was remotely opened and the local switch indicator showed “O” (open). DGO verified that the parallel was broken and the switch was confirmed electrically open. The crew then proceeded to physically declutch and open switch to show the visual open point. During the declutching of the switch using the disconnection lever the switch inadvertently electrically closed causing an unplanned parallel (switch indicator changed from open to closed as witnessed from the ground). Unaware that the switch had closed electrically, the CPLP continued to physically open the manual disconnect portion of the switch. This caused a physical open point between two electrical contacts thus drawing an arc and resulted in both breakers opening, locking out (hold off was in effect) and extensive damage to the switch.

Second incident: The switch was remotely opened and the local mechanical and electrical (control box) switch indicator showed “O” (open). The crew verified with DGO that the parallel was broken and the switch was confirmed electrically open. The switch was placed in the local remote position and the CCL requested the CPLP to perform a current check (amperage) prior to manually opening of the switch (reading was less than 1 amp). During the physical declutching of the switch using the disconnect operating lever the switch inadvertently electrically closed causing an unplanned parallel. The CPLP was aware of the previous failure and did not continue to physically open of the switch but then checked for current and clipped approx. 40 amps at the switch. A local electrical and remote attempt to open the switch was unsuccessful. The feeder breakers did not lockout. The CCL with directions from DGO performed switching to allow safe electrical isolation of the defective switch. An attempt was made to physically open the electrically de-energized switch but the CPLP could only open the visual disconnect switch approx. 3 inches. The line flexes were removed and the defective switch was replaced.

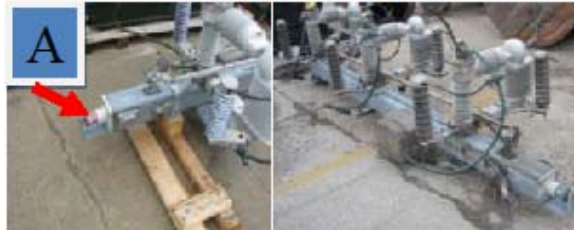
SCADA Mate Switch

This bulletin highlights a concern that was previously reported under EHS Bulletin–2008–009 in which a number of SCADA Mate switches unexpectedly operated (switch closed) during routine maintenance activities in the field. Following this event the local mechanical switch indicators in the field (See A) showed conflicting readings with SCADA in the control room.

The switches exhibiting these concerns are 1st generation SCADA Mate switches (R1) manufactured by S&C in the mid 1990's and appear to be concentrated in Etobicoke and North York. A recent technical investigation of the equipment involved in these incidents has determined that excessive moisture has entered the motor operator compartment of the switch and caused corrosion damage to the components inside. Switches installed post 2004 do not appear to have experienced this problem.
