Hydro One Networks Inc.

EB-2018-0218 - Hydro One Sault Ste. Marie's Application for 2019 Rates and Other Related Matters – Interrogatory Responses

On July 26, 2018, Hydro One Sault Ste. Marie (“HOSSM”) filed an Application pursuant to Section 78 of the Ontario Energy Board Act for an Order or Orders for 2019 transmission rates and related matters.

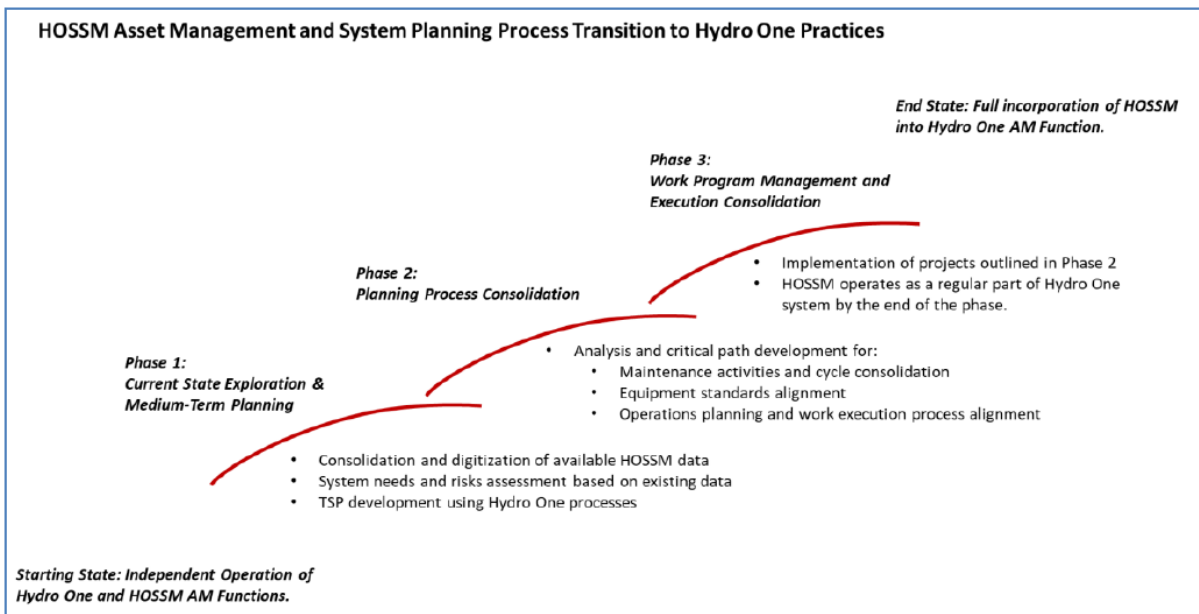
3-1: HOSSM Asset Management Function Integration Process

a) Does Hydro One SSM anticipate that significant capital investments will be triggered in Phase 3 as a result of aligning its equipment standards with Hydro One’s in Phase 2? Please elaborate.

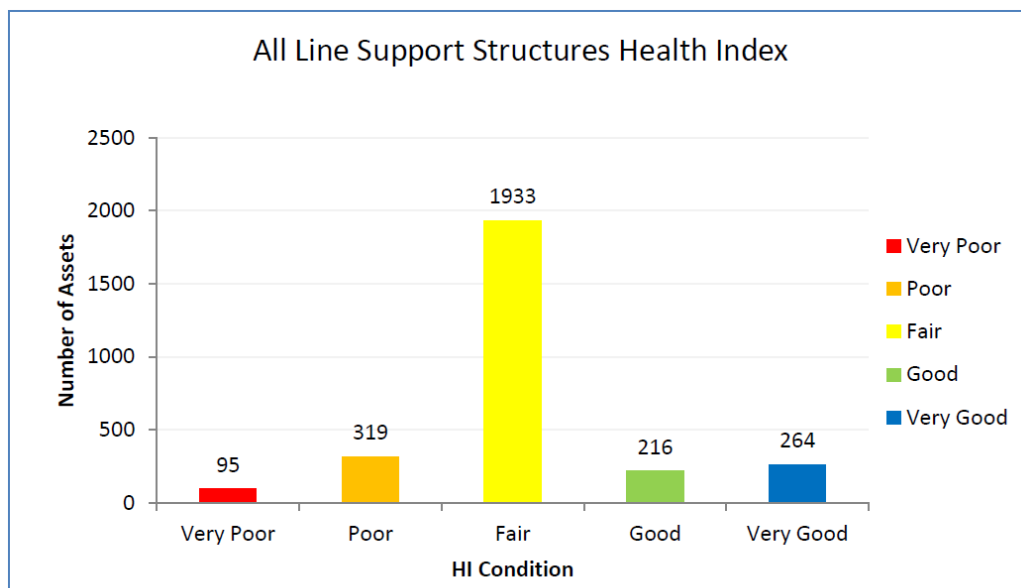
Figure 3-17: HOSSM Structures Health Index

- a) Please explain the reasons for the atypical structure condition distribution shown in the above figure, which indicates that almost 70% of structures are in Fair condition.

All Very Poor, Poor and 98% of Fair structures depicted in the figure are Wood support structures. As Figure 3 showcases, a significant portion of HOSSM wood structures appear to reach Poor and Very Poor condition significantly ahead of the 40-year lifecycle typically used for the planning purposes when installing these assets.

- a) Please confirm that according to Figure 2, HOSSM's total number of structures (wood and composite fibreglass) is 2827.

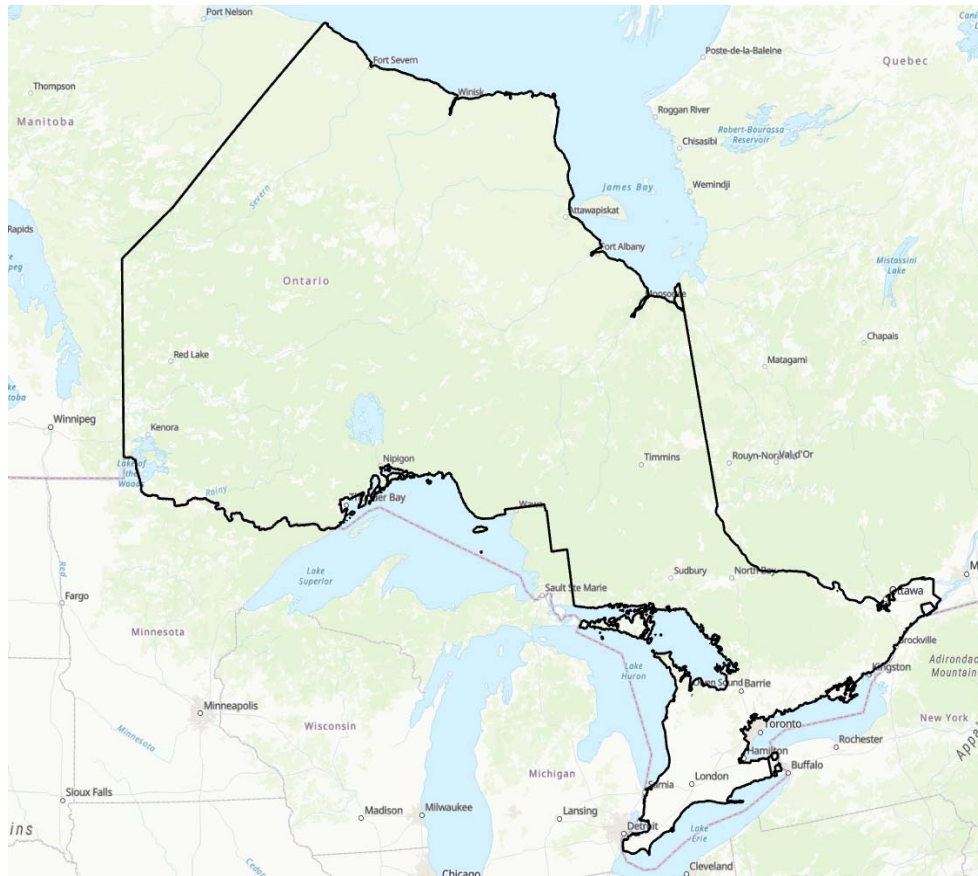
- 10 d) Complete mapping of transmission lines in Canada and the United States is not publicly
11 available. Therefore, for constructing this variable, PSE used the Hydro One Networks’
12 retail service territory as a proxy for its transmission service territory. The following map
13 illustrates the Hydro One service territory.
14

- 4 f) The utility service territories in both Canada and the U.S. are based on the geographic extents
5 of retail service areas. It is assumed that the majority of transmission infrastructure is within
6 service territory boundaries. Results are not an exact representation of transmission line
7 locations but should be a strong approximation.
8

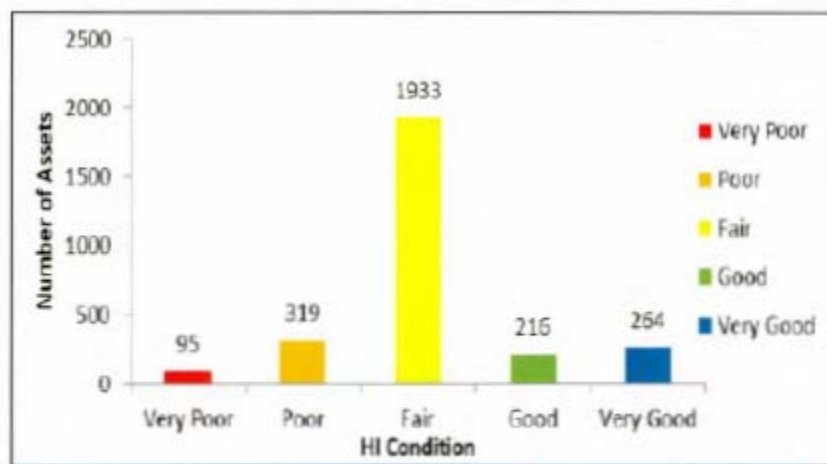
Figure 2 – Structures Health Index Distribution

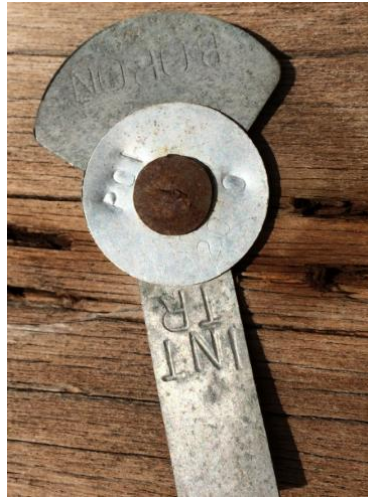
PoleCare produced a detailed inspection report identifying the remaining life of each wood pole. This analysis is the primary basis for GLPT pole replacement plans and in particular over the next 10 years. Figure 4-1 shows an example of a tag indicating pole-butt treatment from 2010.

Figure 4-1 Example Pole-butt Treatment Tag (2010)

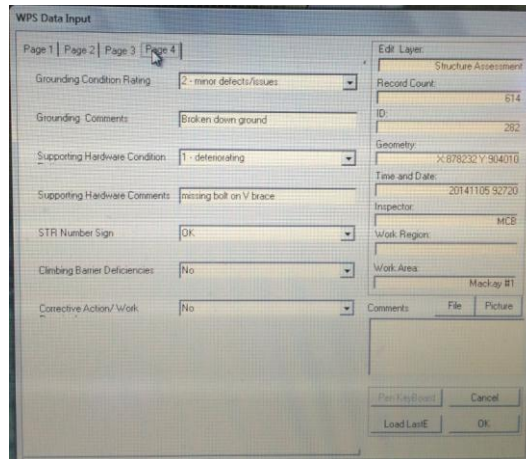
The observations of detailed inspections have historically been in the form of paper records. In the last two years, GLPT has been transitioning to recording observations into a database. The software being utilized is WPS (a Davey Product for tree clearing and access road conditions) modified to record transmission line components. A screenshot of the WPS software is shown in Figure 4-2.

Figure 4-2: WPS Software - Screen-shot

Some recent inspections in the Wawa area were recorded with this software. Hatch did some spot checks of its own field observations against the database record. These were reasonably consistent. GLPT is progressing with the implementation of this system which has GIS functionality and includes access road and other information.

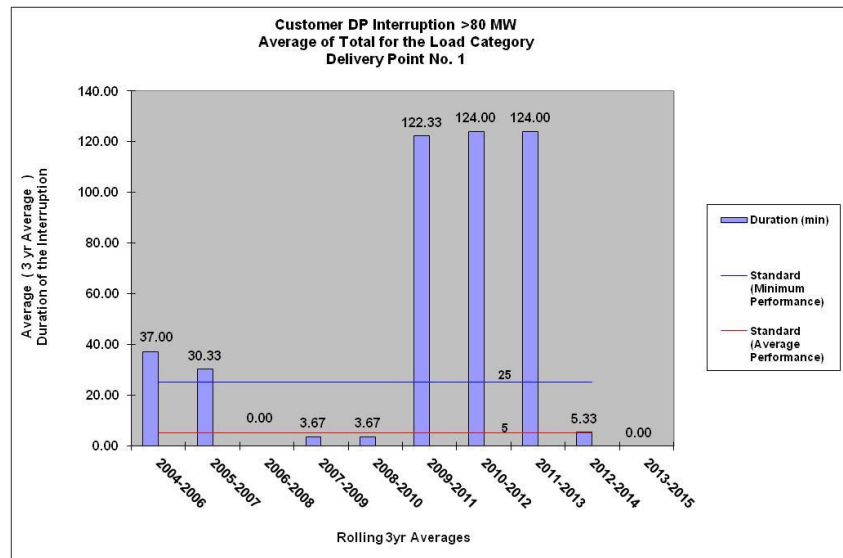
Figure 8-2: Customer DP Interruption >80MW

Figure 8-2 shows a 3 year rolling average. The high duration of interruption value of over 120 minutes is the result of an outage caused by failed equipment at the Third Line TS. As a result of the calculation process, this continued to affect statistics for 3 year post event. This impact also applies to Figure 8-3 and Figure 8-4. This issue was remedied by the Third Line TS redevelopment project which forecasted this type of issue and was underway at the time of the equipment failure.

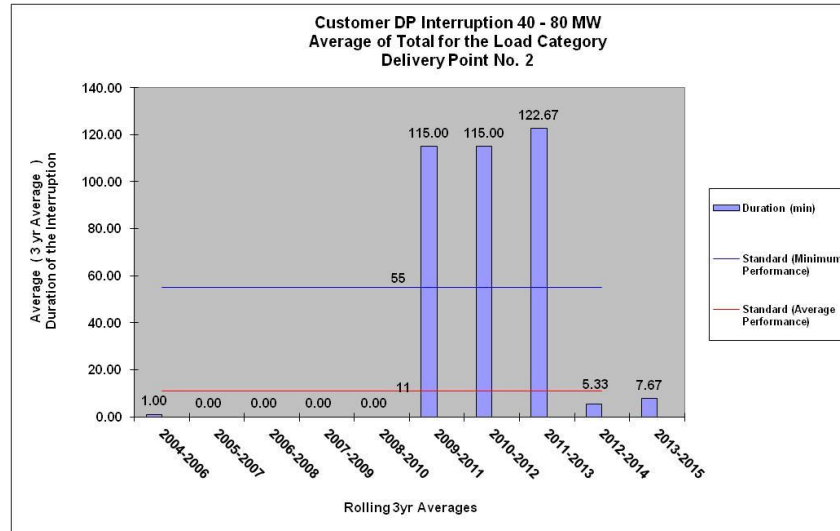
Figure 8-3: Customer DP Interruption 40-80MW

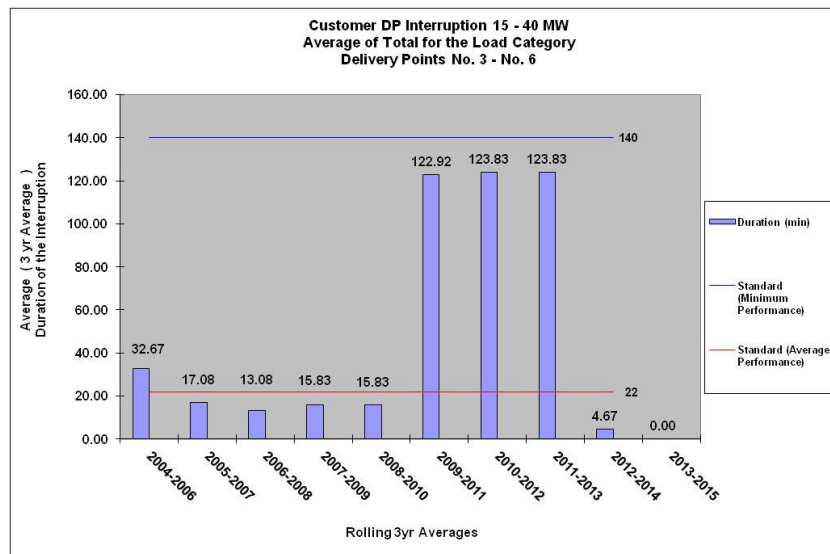
Figure 8-4: Customer DP Interruption 15-40MW

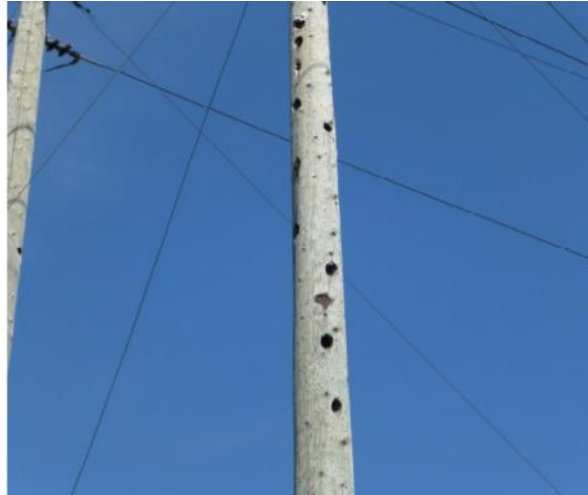
Figure 9-1 provides an example of woodpecker damage to a wooden pole, as shown in the 2012 rate application (EB-2012-0300, Exhibit 4, Tab 2, Schedule 2, Page 14 of 35).

Figure 9-1: Example of a Wooden Pole with Woodpecker Damage

Hatch observed that woodpeckers have made holes in numbers of poles in the GLPT system. This seems to be more applicable for full-length treated poles and less for the butt-only treated poles. Based on Hatch's review of the Wood Structure Replacement Program, the projects are agreed upon in principle. The Wood Structure Replacement Program is an appropriate measure to ensure GLPT continues to operate safely and reliably into the future.

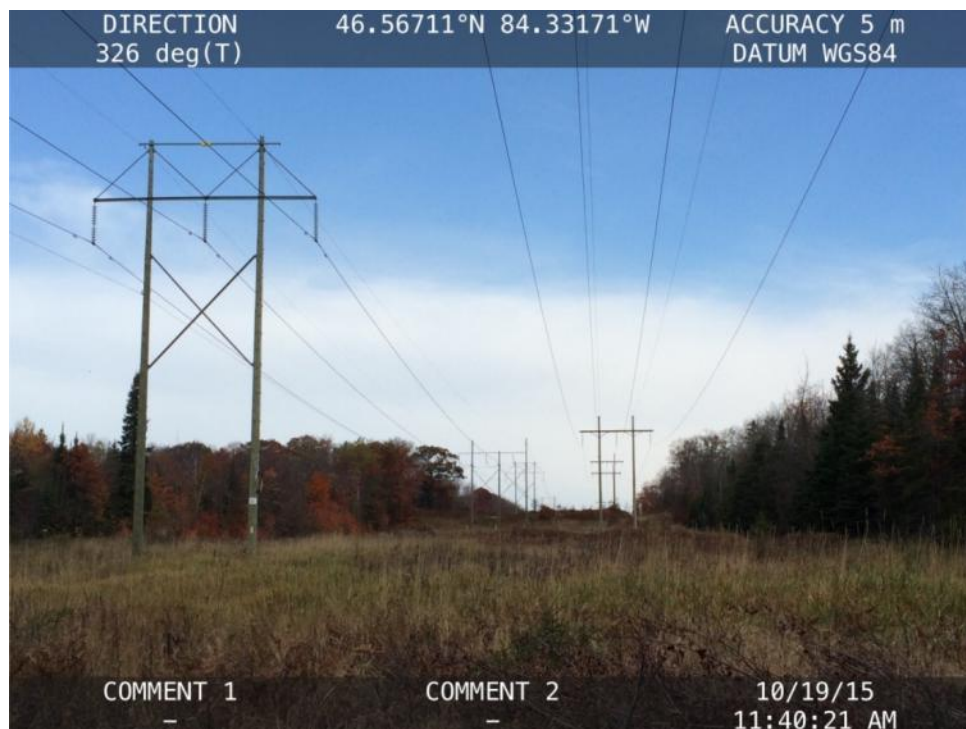
The line originates at Third Line TS and terminates at MacKay TS and is parallel to the 115 kV No.3 Sault line. The line is generally accessible until Goulais TS and then veers away from the main highway coming close near Batchawana TS and then remaining in generally remote areas till its termination at MacKay TS.

Figure 1-1: K24G and No.3 Sault at Fourth Line Crossing

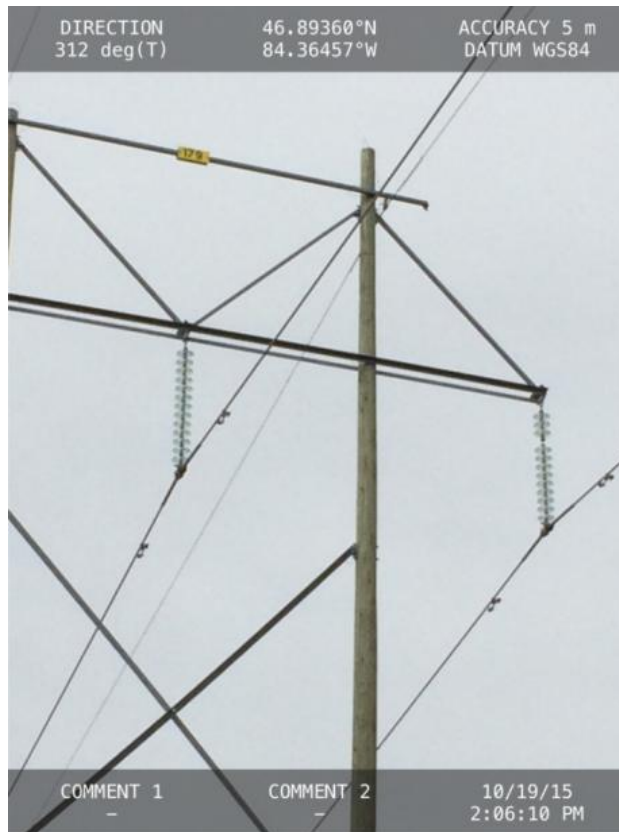
Some insulator discs were observed to be broken at several locations and GLPT is aware of these.

Figure 1-2: Broken Insulator Disc (Right Phase_Str-178)

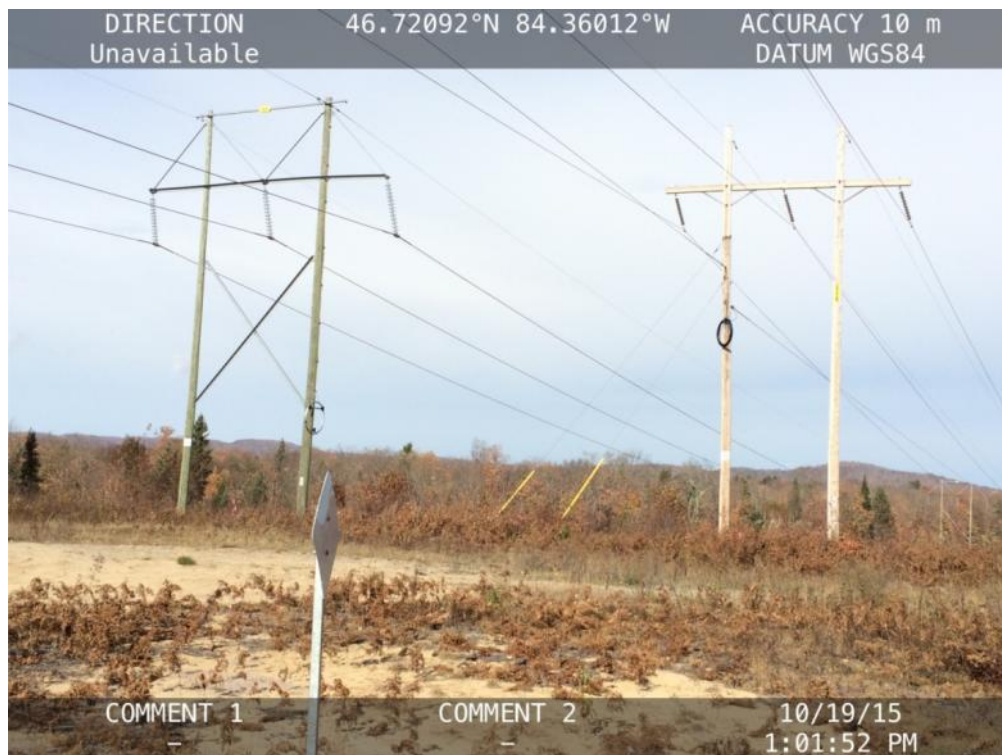
Figure 3-1: No.3 Sault Structure (Towards Right)

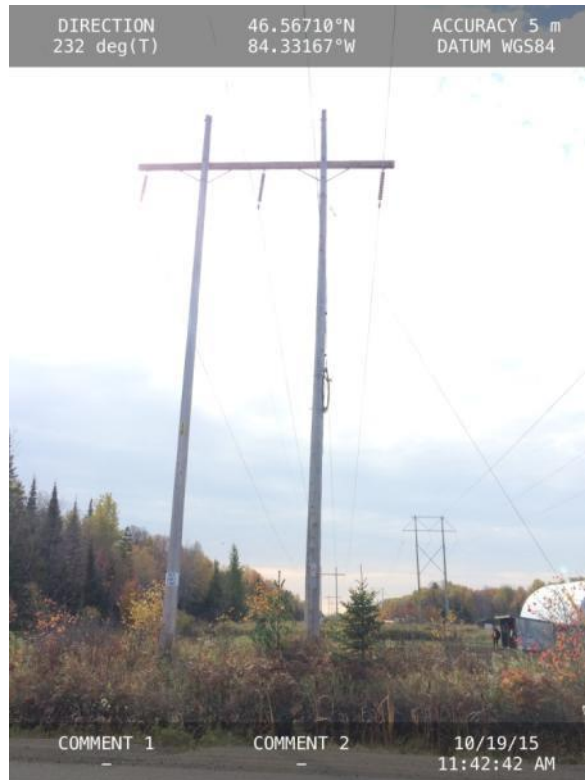
Figure 3-2: No.3 Sault Structure with Composite Insulators

The line was constructed in 1956. A section of the line (from Mackay TS) was re-conducted in 1980s/90s, together with replacement of insulators from porcelain to composite types.

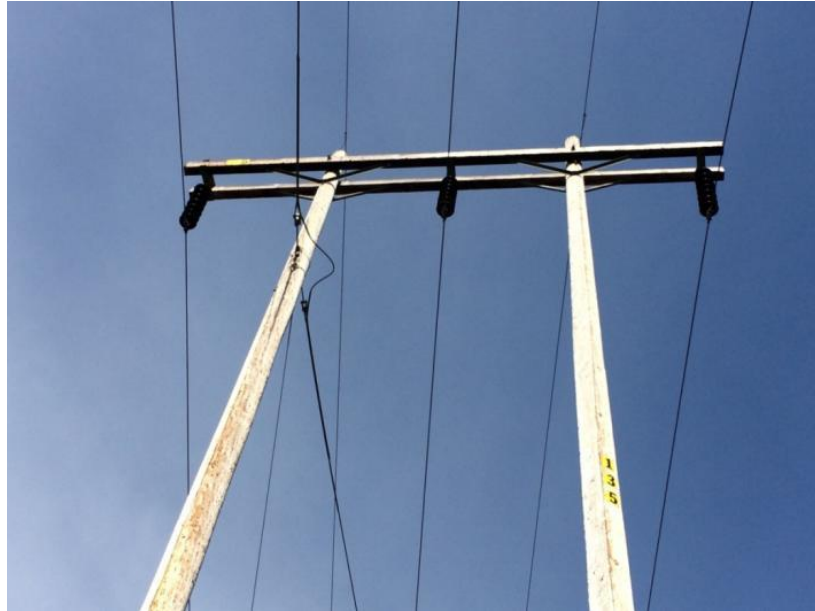
Figure 3-3: No.3 Sault Structure with Porcelain Insulators

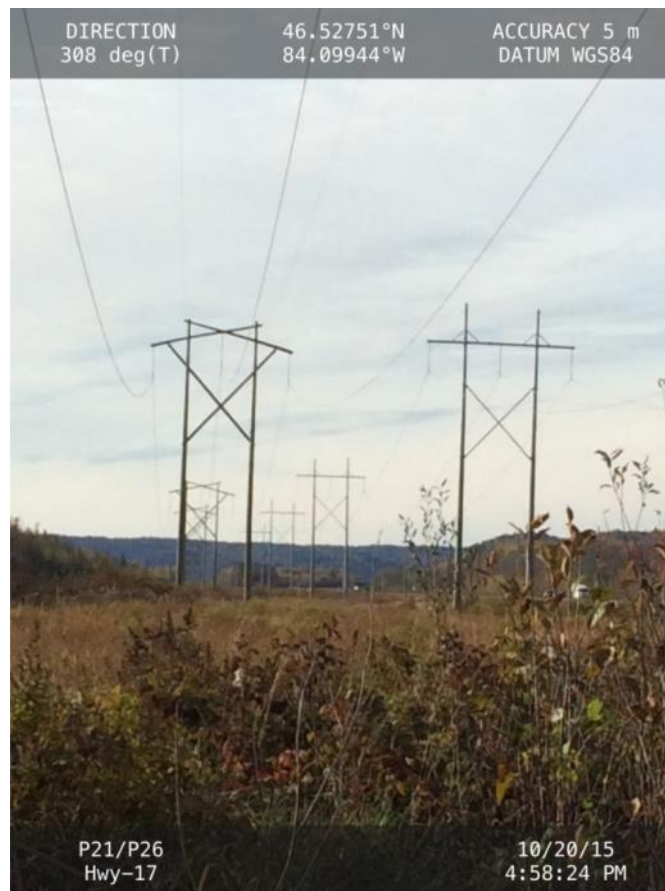
The two lines originate at Third Line TS and terminate at Mississagi TS. These run parallel to each other in the same corridor. There is limited access to the transmission lines.

Figure 4-1: P21G and P22G Transmission Lines

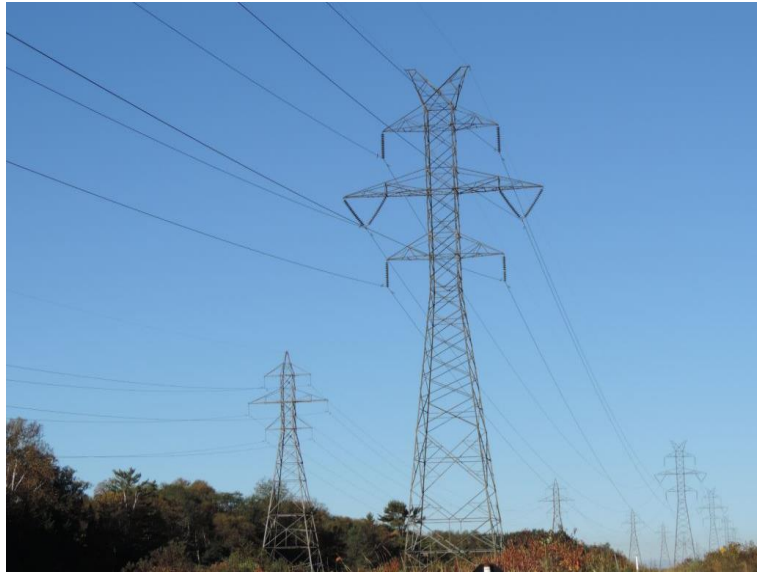
Figure 4-2: Lattice Towers near Third Line TS

The first few structures (approximately 13 in count) near Third Line TS are self-supporting lattice steel towers that support both P21G and P22G. The insulators are porcelain type.

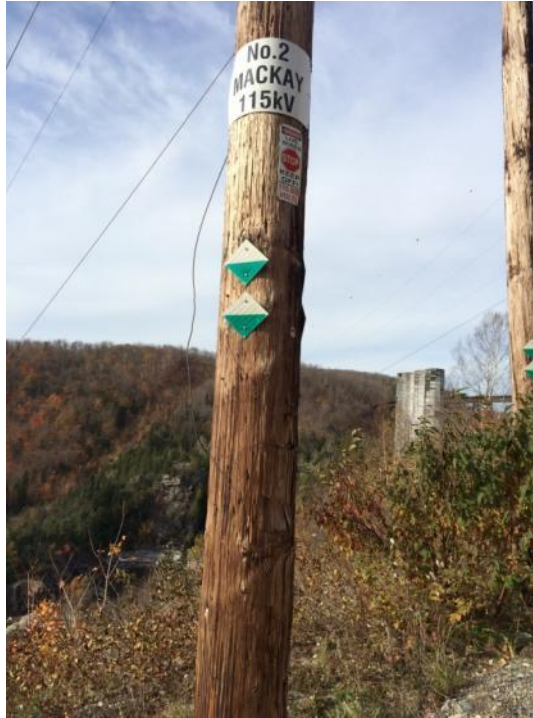
Figure 5-1: No.2 MacKay

These structures were constructed in 1960s.

The condition of the structures (especially those near the MacKay GS) seems poor and should be retrofitted or replaced in short timeline.

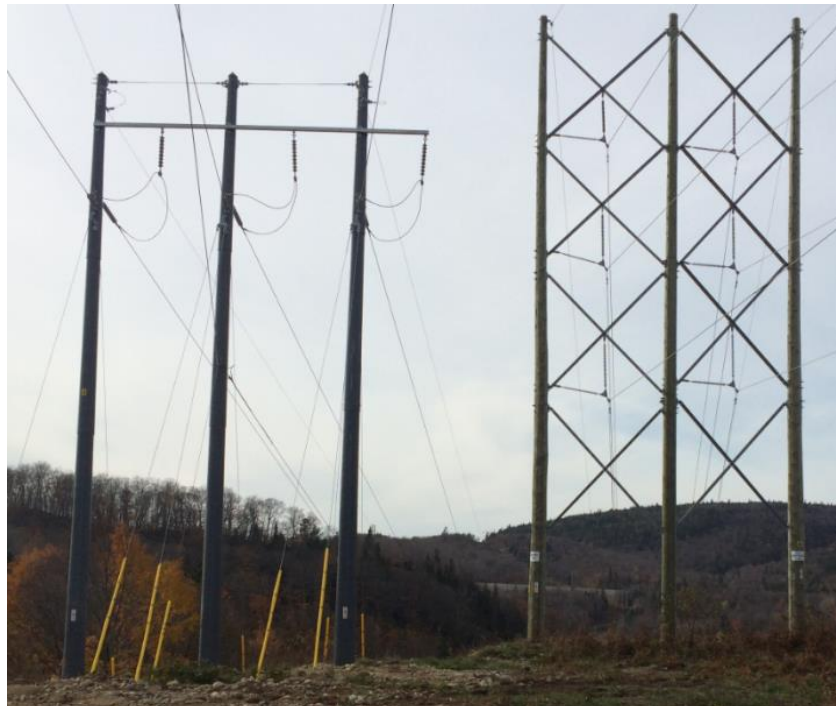
Figure 7-1: No.3 Gartshore (Sharing Structure with Andrews Line)

The No.3 Gartshore Transmission line originates at Gartshore GS and terminates at Gartshore TS, and is less than 1 km long. Only one structure was reviewed by Hatch, and that was shared with the Andrews line.

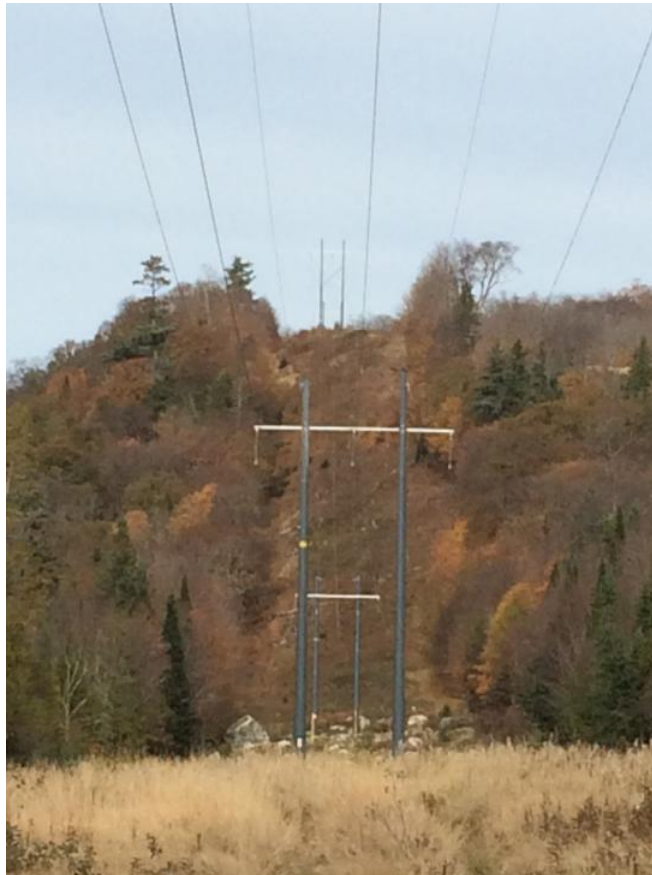
Figure 9-1: Hogg Transmission Line

The line was constructed in 1964, but the wood structures have recently been replaced with composite poles (RS make). The date on one of the poles indicates May 2015. The insulators are composite polymers.

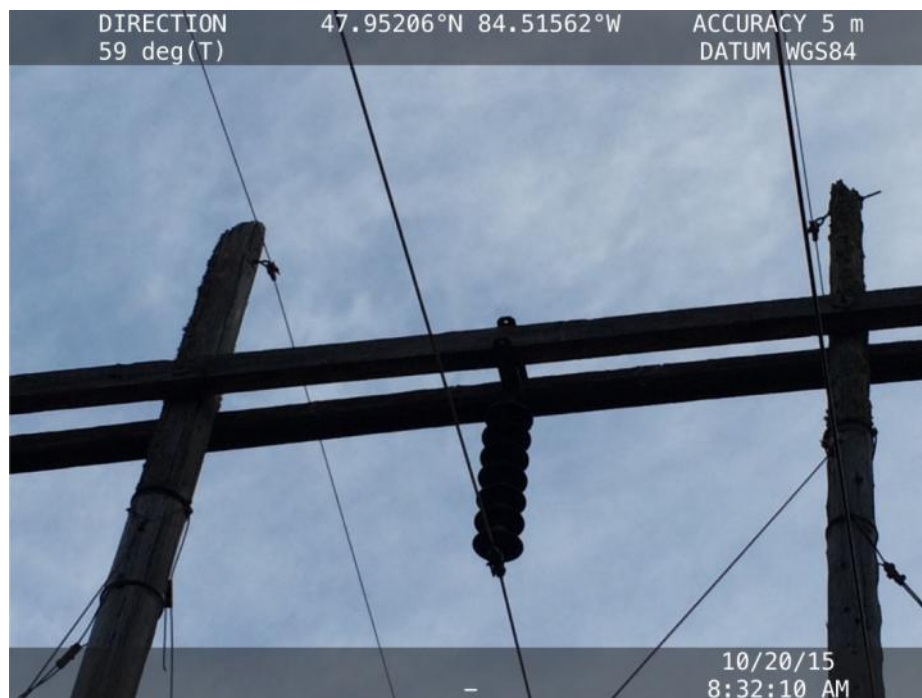
Figure 10-1: Hollingsworth Transmission Line

The structure comprises wooden H-frames, wooden cross-arms and porcelain insulators. Composite insulators have replaced porcelain types on a number of structures.

The general condition of the wood poles is poor with rot visible for many pole tops, and wood-pecker holes on some.

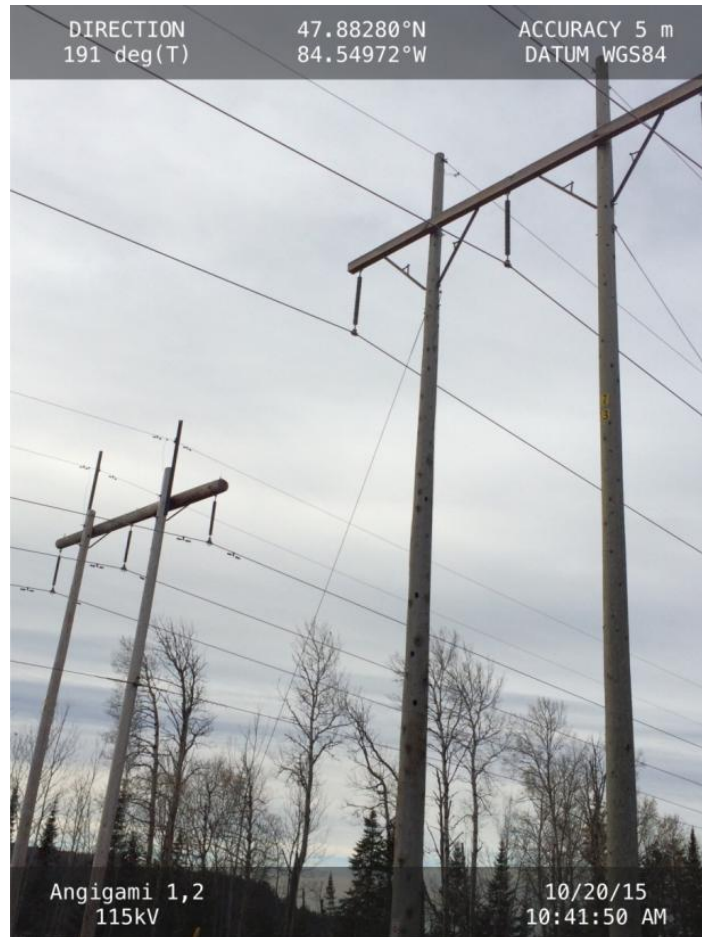
Figure 11-1: High Falls (No.1 & 2) Transmission Line

The No.1 and No.2 lines were constructed in 1989 and 1929 respectively.

Hatch could only observe a couple of structures at Wawa end, which is not sufficient to form an opinion. Woodpecker holes and cracks were observed on few structures. Some of the porcelain insulators have been replaced by composite insulators.

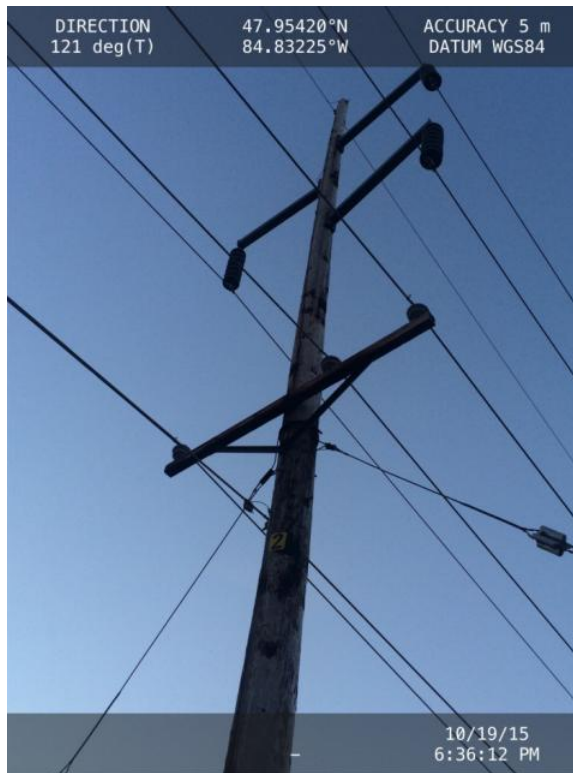
Figure 12-1: Magpie Transmission Line

The transmission lines were constructed in 1989-90.

The condition of structures is generally fair.

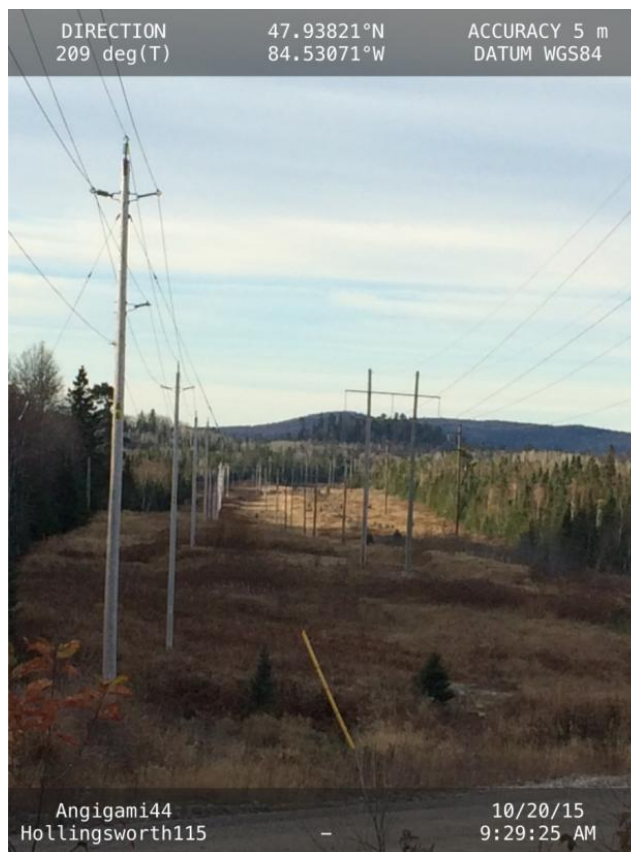
Figure 13-1: Anjigami Line (on Left)

These are generally single pole (wood) structures with composite insulators (stand-off post type).

The condition of the lines is fair (Limer) to poor (Anjigami).

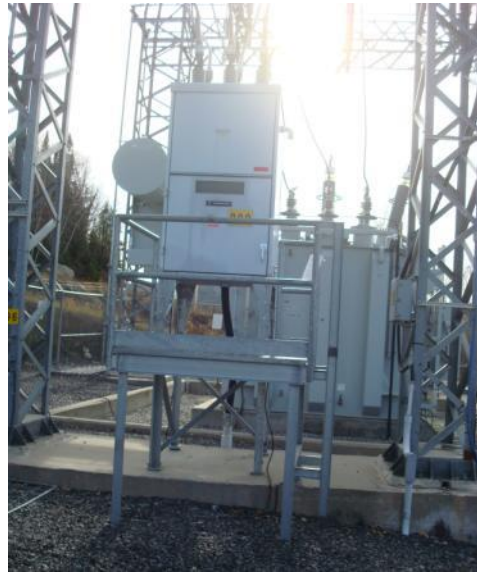
Figure 1-1: Hollingsworth TS

The Hollingsworth station is the transmission station located generally east of Wawa, associated with the Hollingsworth generating station.

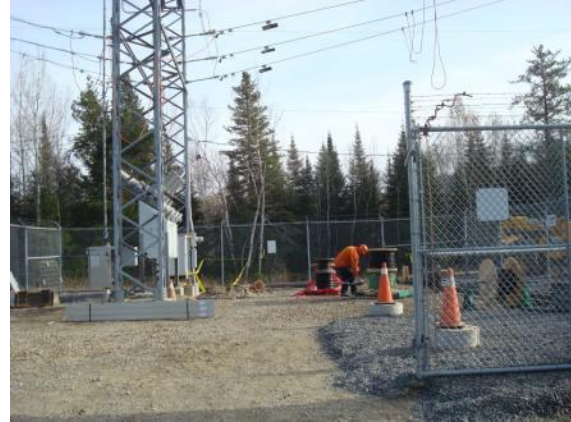
Figure 2-1: Highway 101 TS

The highway 101 station is on the 44 kV Limer line originating at Hollingsworth and terminating at local distribution in Hawk Junction and Anjigami. As of October 2015, it was out of service and bypassed as it was being redeveloped to ensure proper switching and selectivity of tripping on the line when faults occur. Its purpose is apparently to service a wood products customer. As of June 2016, the station is reportedly in service.

The site was expected to be completed in the relative near future in October 2015, as an E-building with the necessary switching and control equipment was understood to have been delivered to site at this time.

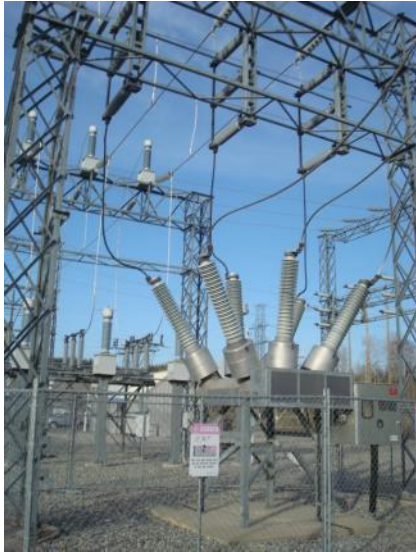
Figure 3-1: Anjigami TS Circuit Breaker

The Anjigami station is the GLPT transmission station associated with the Hydro One 230/115 kV Wawa transmission station.

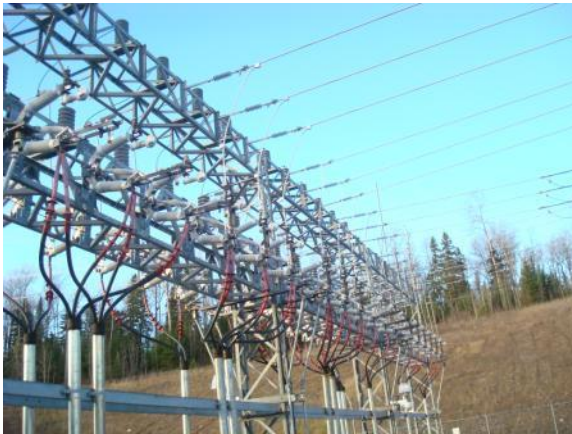
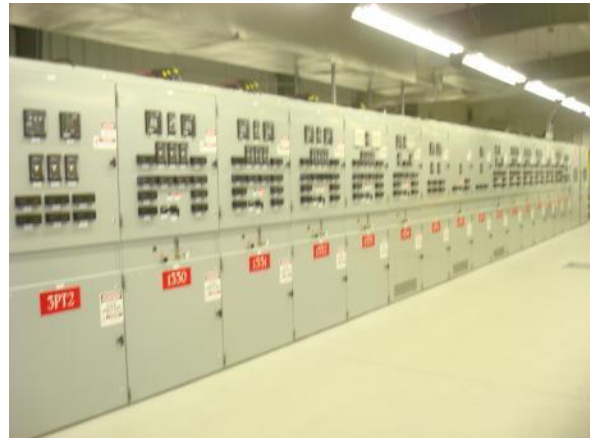
The Watson TS connects generation from the Scott, McPhail and R.A. Dunford generating stations to the GLPT bulk 115 kV transmission system at Anjigami through the High Falls 1 and 2 lines. These generating stations and Watson TS are located on the Michipicoten River system, south of Wawa. The station is rather unique in the GLPT system in that it is a mostly indoor station with 34.5 kV metal-clad switchgear.

While very neat and clean looking, the station was observed to have a number of deficiencies and problems that are outlined below. The Watson TS is connected to the GLPT 115 kV bulk power system at Anjigami.

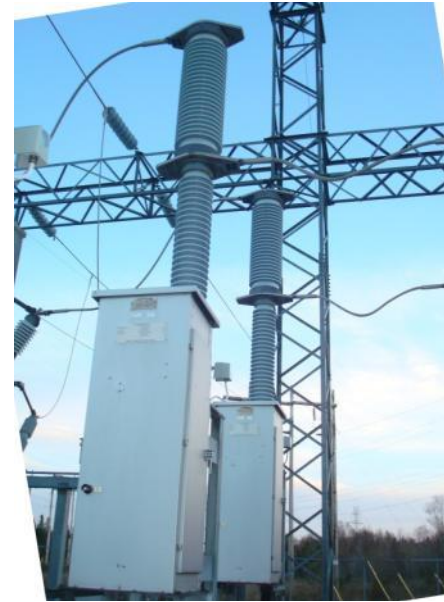
Figure 5-1: Magpie TS

The Magpie station is a 115 kV station that connects generation from the Steephill Falls, Harris and Mission Falls generating stations to the GLPT bulk 115 kV transmission system at Anjigami through the Magpie 1/High Falls 1 line. These generating stations and the Magpie station are located on the Magpie River system, west of Wawa. The station is an outdoor 115 kV station configured in a 115 kV vertical ring.

- a) Transformers - there are no HV transformers at Magpie.
- b) The breakers in the ring consist of 4 ABB single pole SF₆ live tank 115 kV circuit breakers with separate CTs. The breakers appear to be in good condition without leaks or other obvious signs of poor condition. Some of the Trench CTs leak, but no serious problems have occurred as yet.

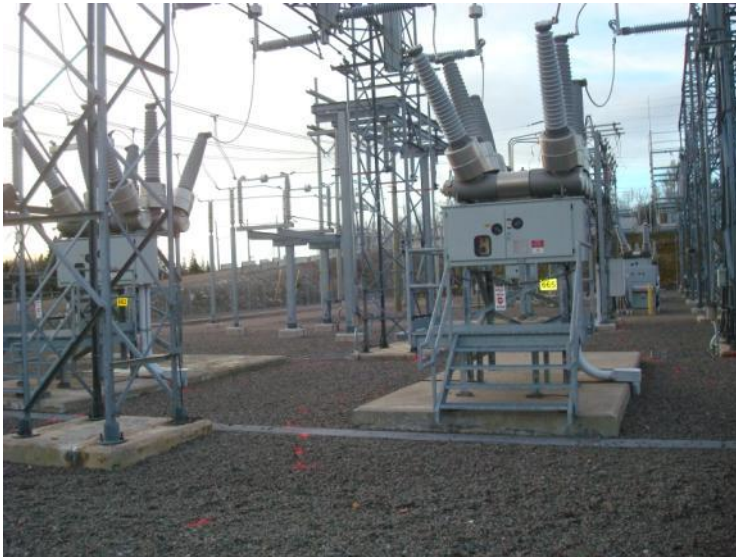
The MacKay station is one of the two major transmission stations in the GLPT system. It is located on a private road off Highway 17 roughly half way between Sault Ste. Marie and Wawa. It has a 115 kV section that serves mainly to connect generation on the Montreal River into the bulk power system. Lines MacKay 1 and 2 connect to the MacKay generating which is several hundred meters from the transmission station.

Lines Gartshore 1 and 2 connect the Gartshore generating station several km away. In addition, there is the Sault 3 line that runs roughly in parallel to the 230 kV line K24G to the Third Line station in Sault Ste. Marie.

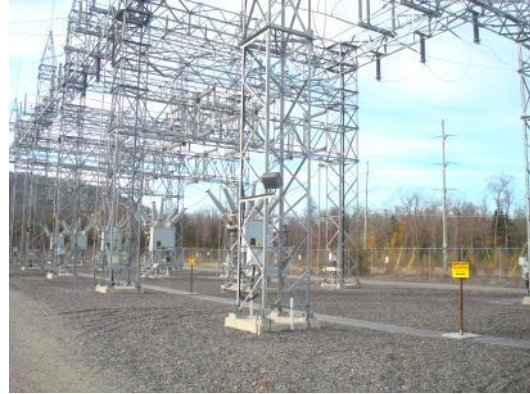
Figure 7-1: Gartshore TS

The Gartshore station is a 115 kV station that connects generation from the Gartshore, Hogg, and Andrews generating stations, all on the Montreal River, to the GLPT bulk 115 kV transmission system at MacKay TS through the Gartshore Lines 1 and 2. The station is an outdoor 115 kV station configured in a 115 kV vertical ring.

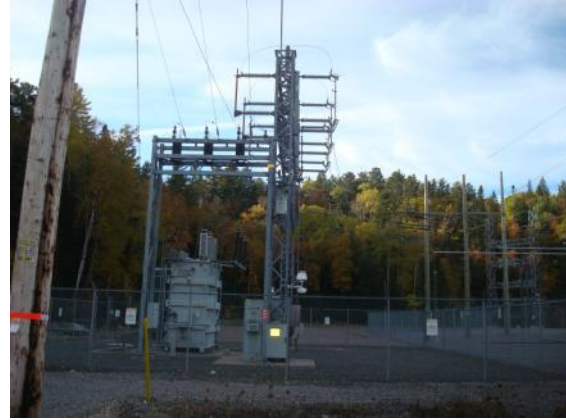
Figure 8-1: Andrews TS

The Andrews distribution station is a very small station, tapped to the Andrew 115 kV line, which connects to Gartshore TS in a small extension to the generation owned Andrews switching station. The station is an outdoor 115 kV station configured as a radial 25 kV distribution supply feeder to local distribution. It basically consists of two sets of disconnect switches, a set of power fuses, a 115 kV/25 kV transformer and metering.

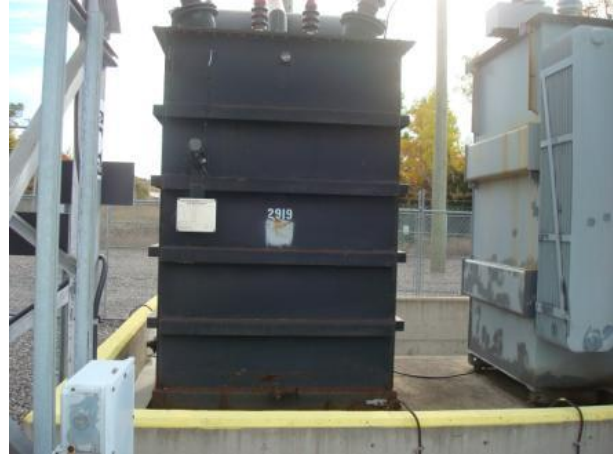
Figure 9-1: Batchawana TS

The Batchawana TS is a small station, tapped to the Sault 3 line. The station is an outdoor 115 kV station configured to supply two radial 12 kV distribution feeders to local distribution in the Batchawana Bay area. It basically consists of an in and out arrangement through two 125 kV circuit switchers connected to the Sault 3 Line. The single phase transformers are fed through 115 kV power fuses.

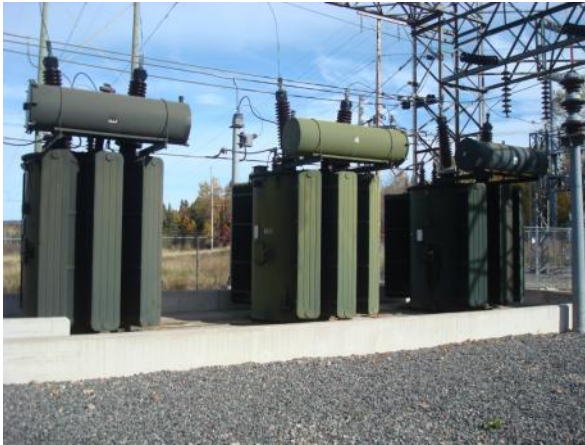
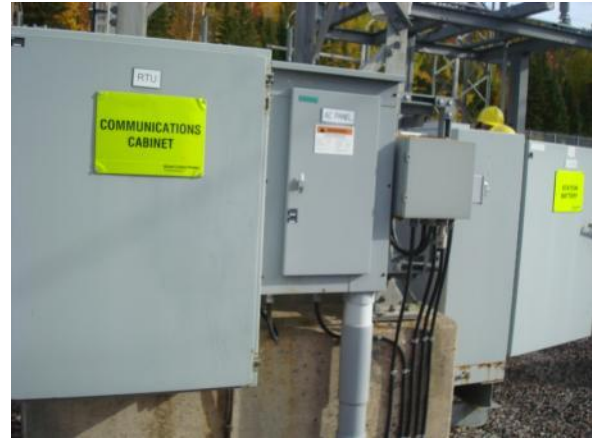
The Goulais TS is a relatively small station connected to the Sault 3 line. It has a load of approximately 7 to 8 MW. The station is an outdoor 115 kV station configured to supply two radial 12 kV distribution feeders to local distribution in the Goulais Bay area. It also supplies a 25 kV feeder through a 12/25kV step up transformer to the Searchmont area to the east of the highway.

The station basically consists of an in and arrangement through two 125 kV circuit switchers to the Sault 3 Line. The circuit switchers date to the 1980s. The single phase transformers are fed through 115 kV power fuses.

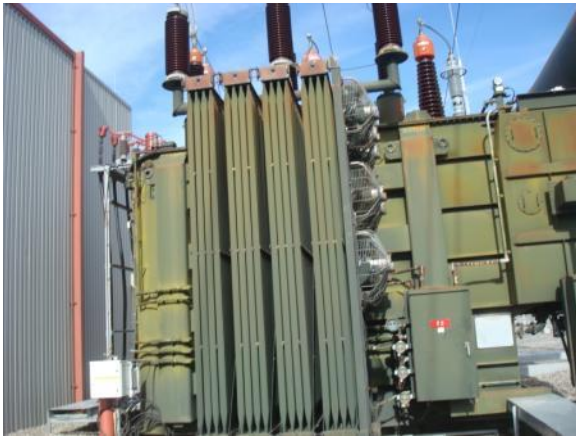
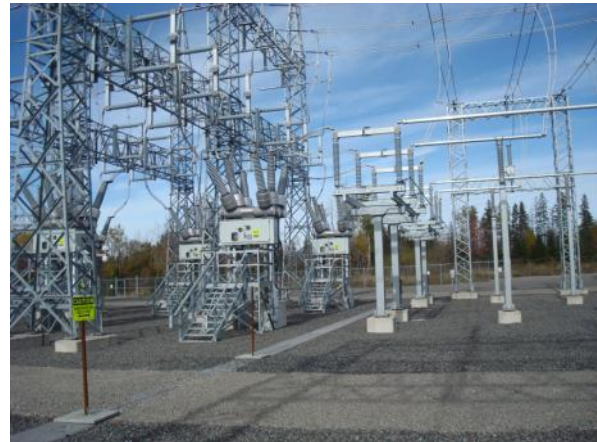
The Third Line station is the largest and most important transmission station in the GLPT system. It is located in the City of Sault Ste. Marie, not far from the GLPT engineering office. It is configured in a one and one half breaker arrangement in the 115 kV section that serves mainly to connect to load in the Sault Ste. Marie area. Other, non-load, 115 kV connections are the connection to the Sault 3 line from MacKay and the two connections to the 230 kV portion of the station.

There are 17 circuit breakers of 115 kV class in the station and eleven 115 kV circuit connections.

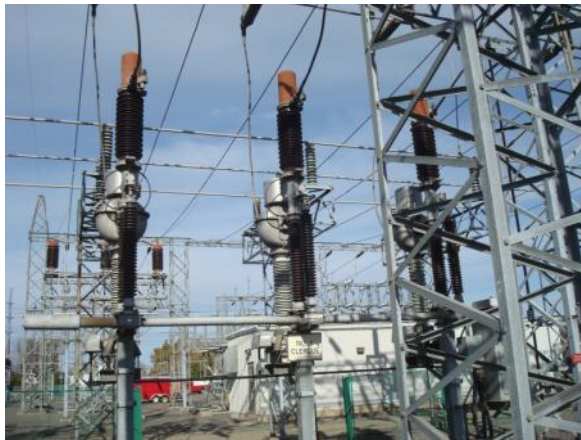
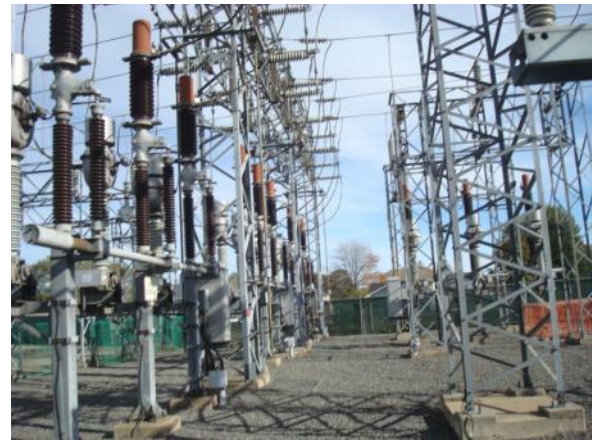
The Steelton station is the 115 kV station that connects the Sault steel plant to the GLPT system. In addition, it connects the Clergue generation station into the GLPT system through the Clergue 1 and 2 115 kV lines. There are two 115 kV lines (Algoma 2 and 3) that connect the Steelton station to the 115 kV portion of the Third Line station. Two bus connections from the Steelton station connect to the steel plant owned Patrick Street station 115 kV transformers.

The Patrick Street station is within the same fence as Steelton, but these are in the portion of the total complex that is owned and operated by the steel plant. Furthermore, an additional line, Algoma 1, also connects to the Patrick Street station; however, this again is also not part of this discussion. The Steelton station is in effect an outdoor 115 kV station configured in as a ring bus.

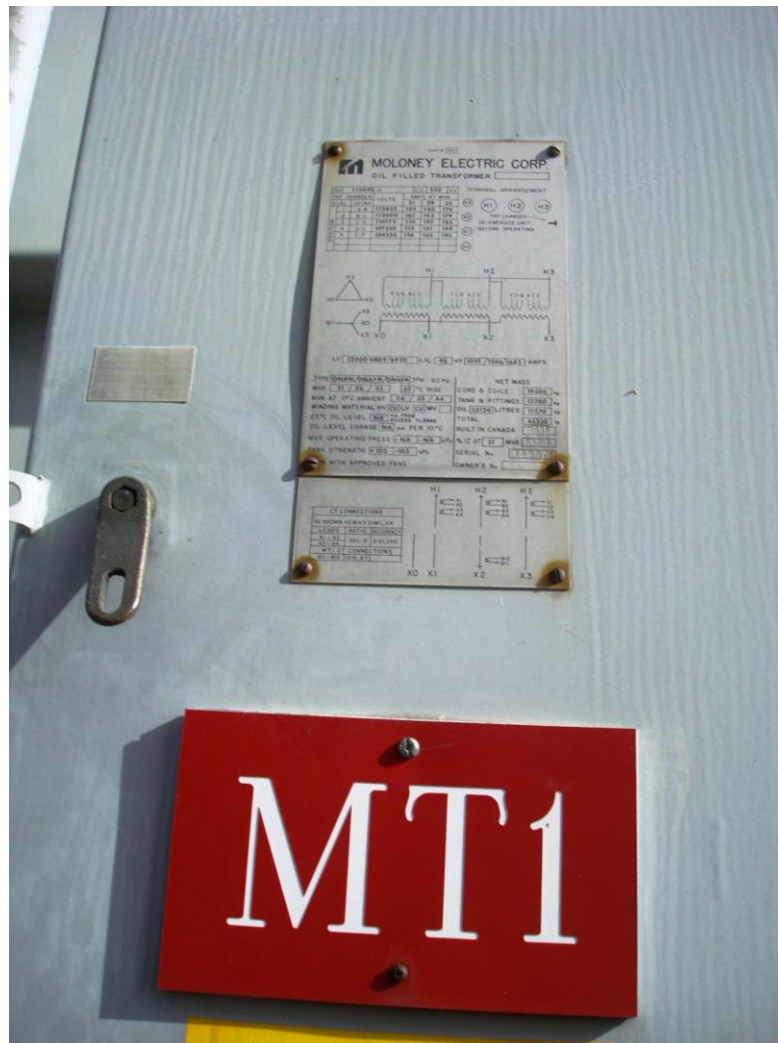
Figure 13-1: Clergue TS

The Clergue transmission station connects generation from the Clergue generating station on the St Mary's River, on the riverfront in Sault Ste. Marie, to the Steelton substation through the Clergue 1 and 2 lines. In addition, facilities exist at an entity named Lake Superior Power to connect natural gas fired generation, in the same area as the Clergue transmission station to the Clergue lines; however, this facility is presently not in use.

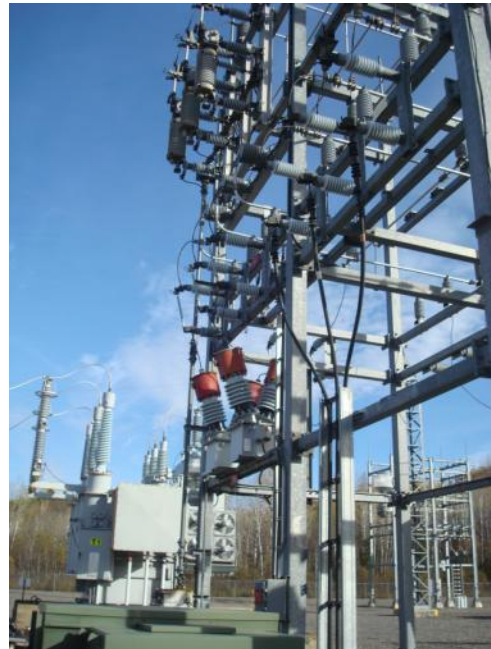
Figure 14-1: Echo River TS

The Echo River station is a 230 kV transmission station located to the east Sault Ste. Marie installed to serve local distribution requirements in the area. The station is tapped into line P22G by diverting the line into and out of the station.

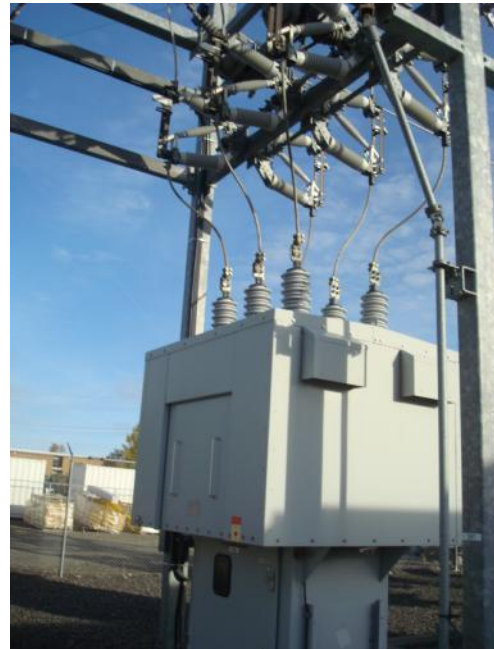
Figure 15-1: Northern Avenue TS

The Northern Avenue station is a 115 kV transmission station located in Sault Ste. Marie, behind the Great Lakes Power office building and control centre. It serves to provide 34.5 kV as a local feeder and 12 kV distribution power to the GLPT building as well as to the Bonniferro welded beam steel plant. The station is served by the single Northern Avenue 115 kV line from the Third Line Station slightly over a km away.

T1 is a Dy1 connected transformer with a voltage ratio of 115 – 34.5 kV, rated 20/26.7 MVA, manufactured by Maloney in 1978. This transformer is very old, but isn't significantly stressed given its load level. It is understood that at one time this transformer contained PCBs but it is understood this is no longer the case. It had been subject to a leak recently, but this has been fixed. Some oil staining from the leak was noted in the rock in the containment pit.

T2 is a Dy1 connected unit with a voltage ratio of 34.5 – 12 kV, rated 5 MVA, manufactured by Northern Transformer in 2003. This unit is a replacement to the previous duplicate unit, which was destroyed by a fault caused by a racoon in the substation.

The transformers were observed to be in good condition, especially given the age of T1. The transformers appear properly connected on the HV and LV sides, suitably grounded and with foundations in good condition, suitable fitted with spill containment and with

Imbiber oil leak prevention.
