### AIRD & BERLIS LLP

Re: Application by Toronto Hydro-Electric System Limited; EB-2012-

0064

ICM Visual Support Booklet

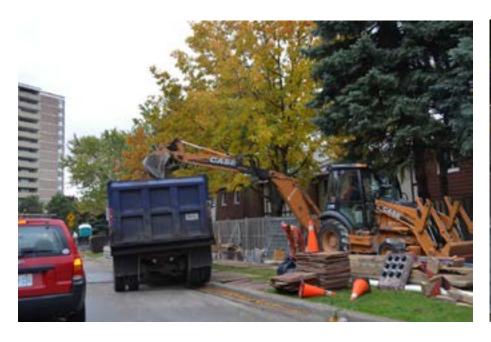
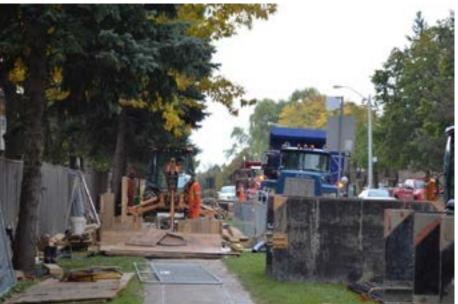
## **DIRECT BURIED CABLES** - REBUILD project midway

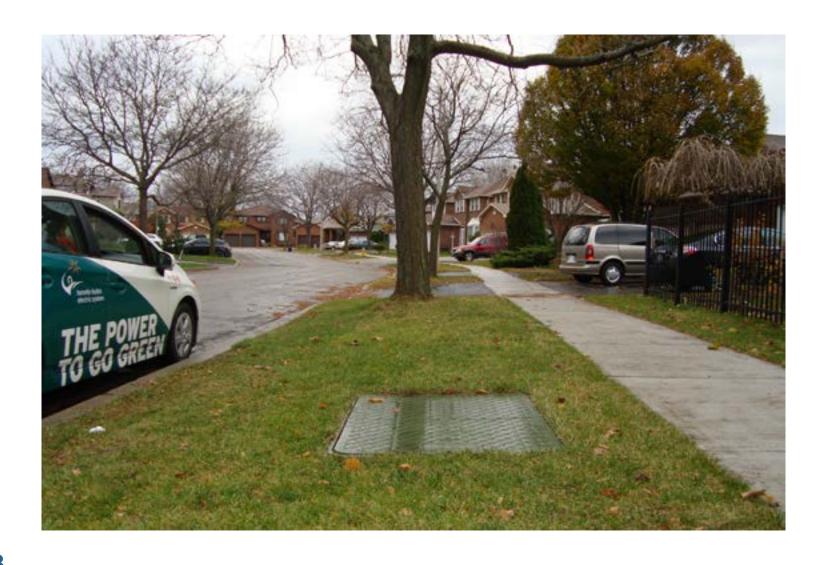
# **DIRECT BURIED CABLES** - Project post completion

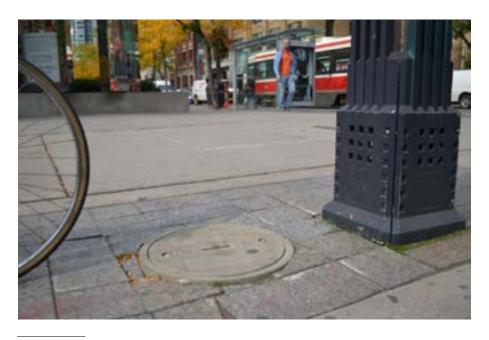
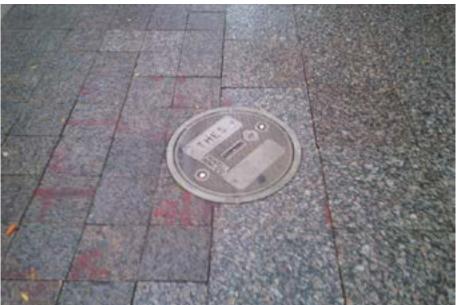
New non-conductive lids

### **HANDWELL REPLACEMENT** - New installations

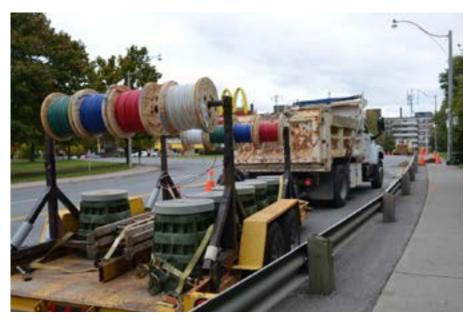
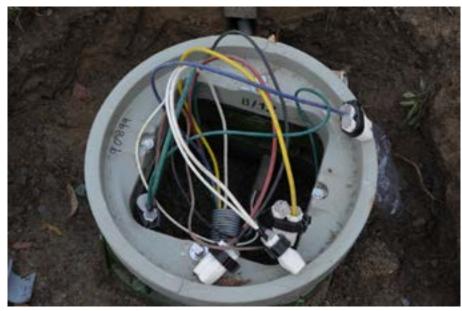
Crew working on installations

New connection

### **HANDWELL REPLACEMENT** - New connections

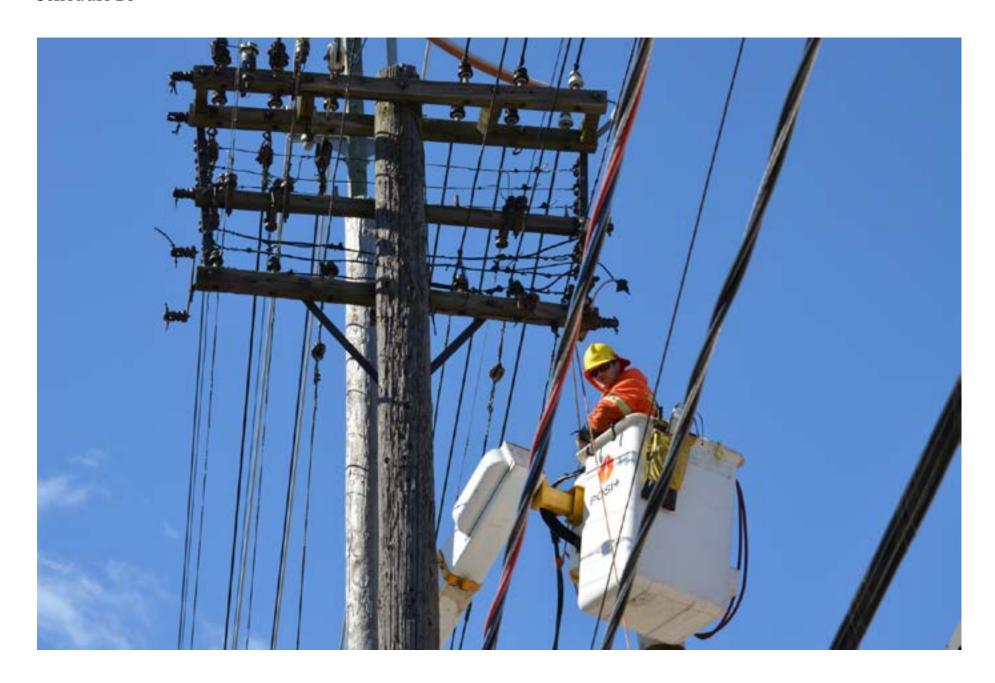
# **BOX CONSTRUCTION** - Crews working on box construction Schedule B5

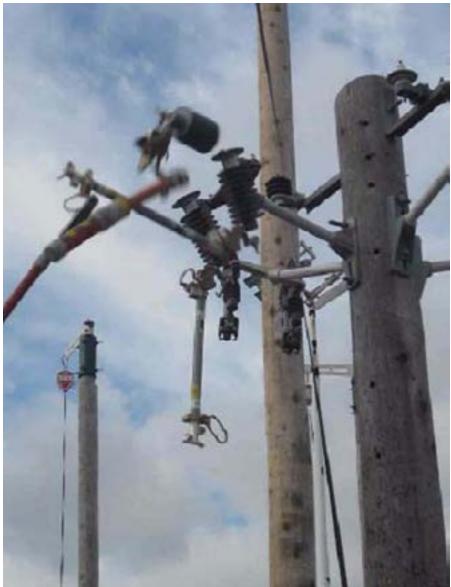
**SMD 20 SWITCHES** – Demonstration of how switch breaks Schedule B7

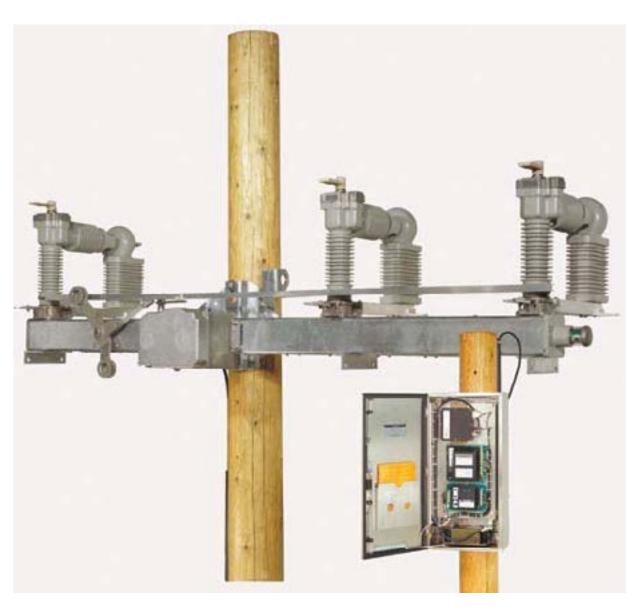
B8 - Fig 1

# **SCADA-MATE R1** – Typical switch Schedule B8

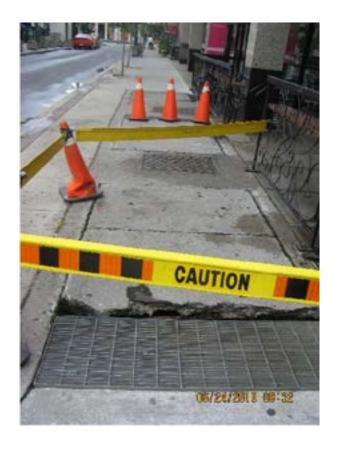
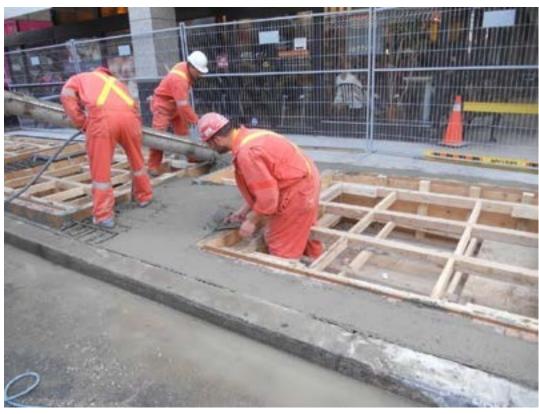
### **NETWORK VAULTS AND ROOFS** - Before and after

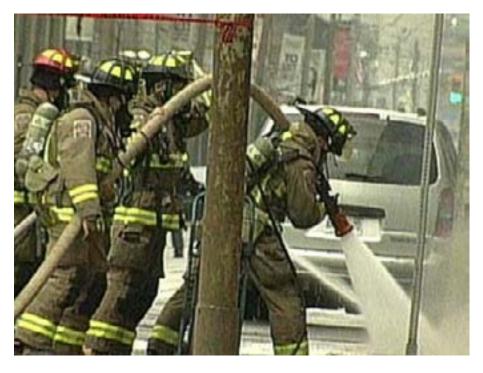
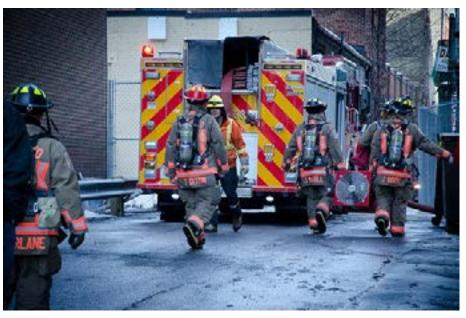
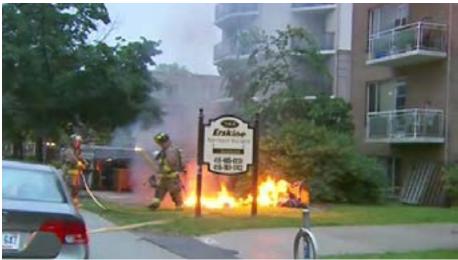
### FIBERTOP NETWORK UNITS - What can happen...

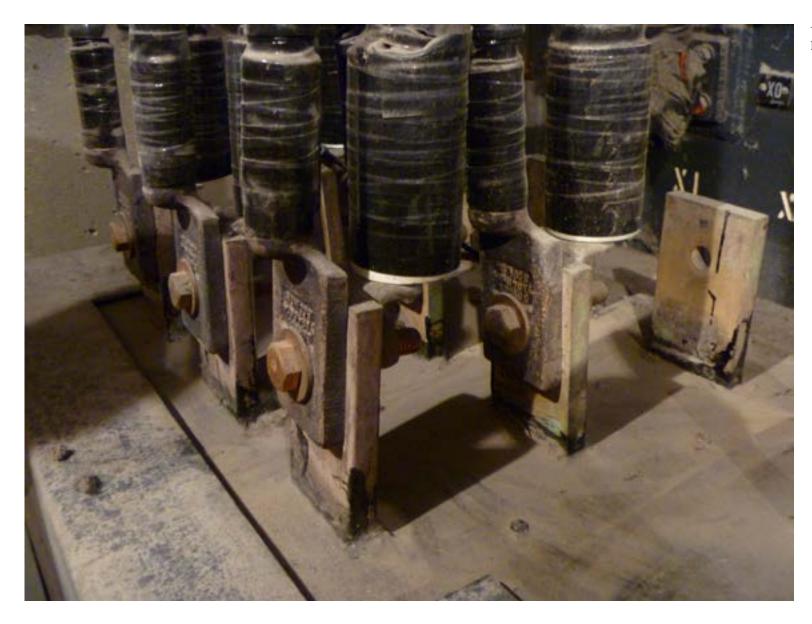
B10 - Fig 2

### **FIBERTOP NETWORK UNITS**

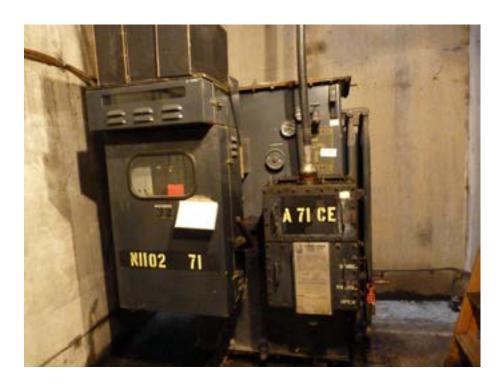
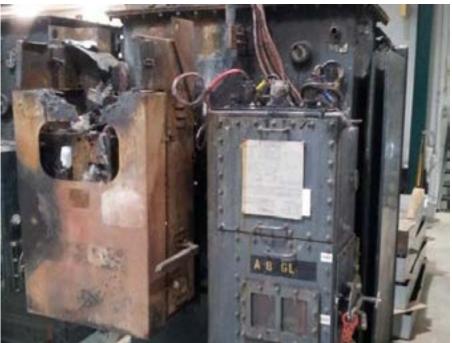
### FIBERTOP NETWORK UNITS - Before and after the fire

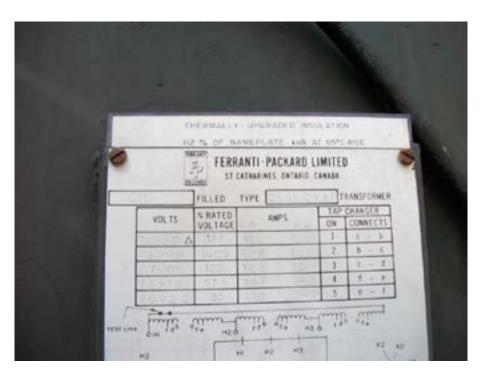
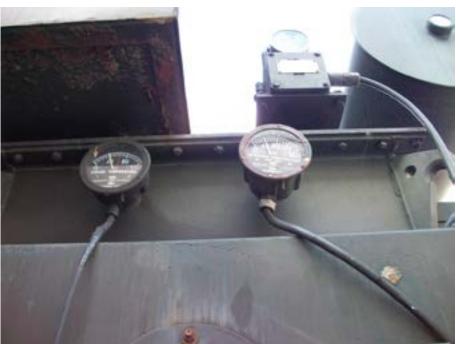
# **STATION POWER TRANSFORMERS** – Albion MS – station transformer TR2 Schedule B12

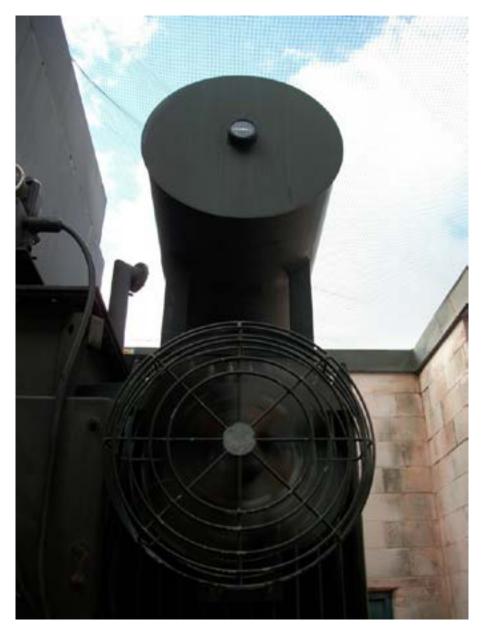
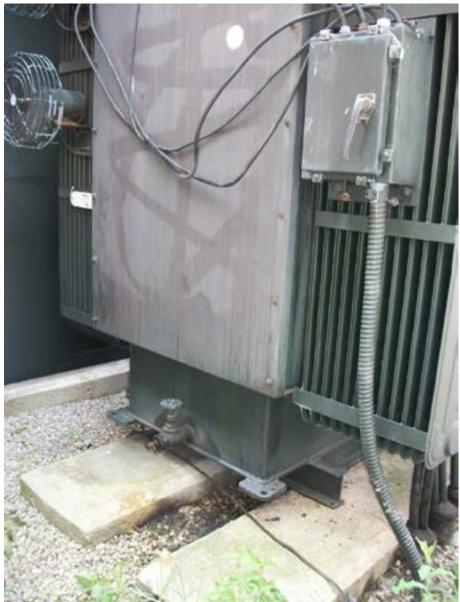
# **STATION POWER TRANSFORMERS** – Albion MS – station transformer TR2 Schedule B12

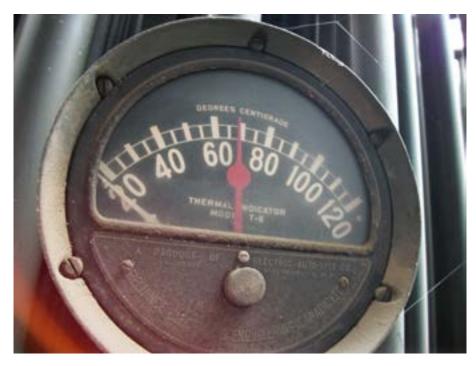
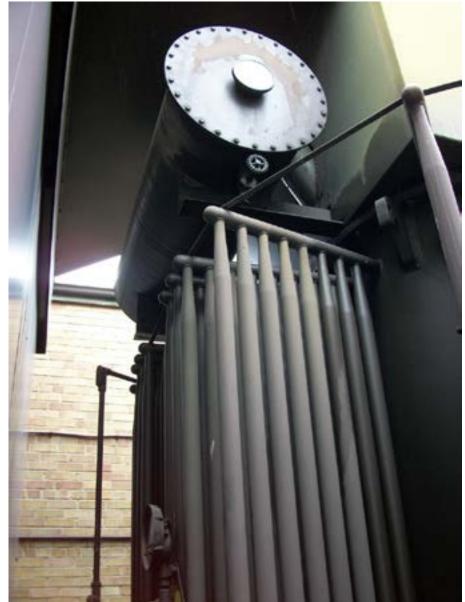
# **STATION POWER TRANSFORMERS** – Thistletown MS – station transformer TR2 Schedule B12

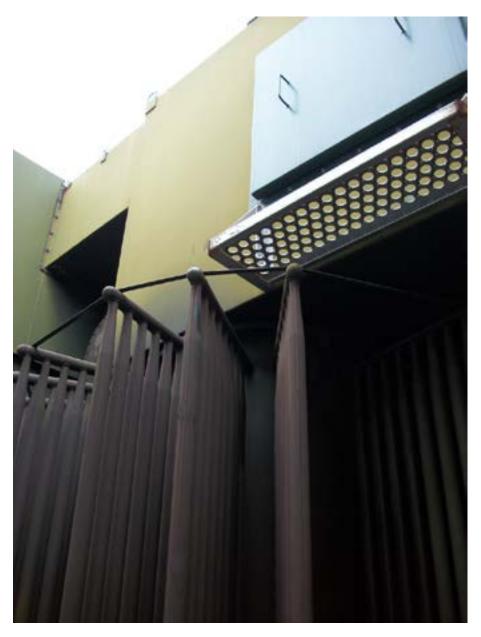
**STATION POWER TRANSFORMERS** – Thistletown MS – station transformer TR2 Schedule B12

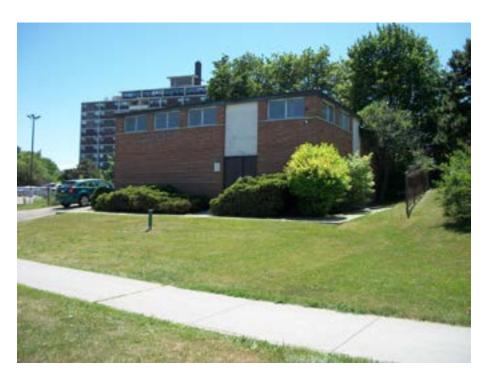
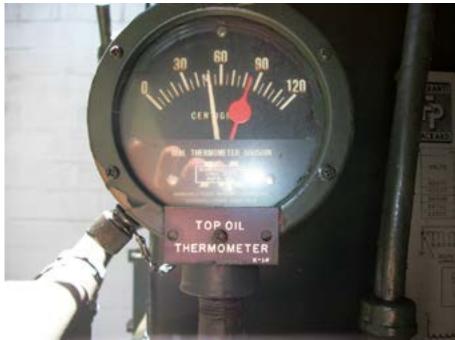
# **STATION POWER TRANSFORMERS** – Edenbridge MS – station transformer TR1 Schedule B12

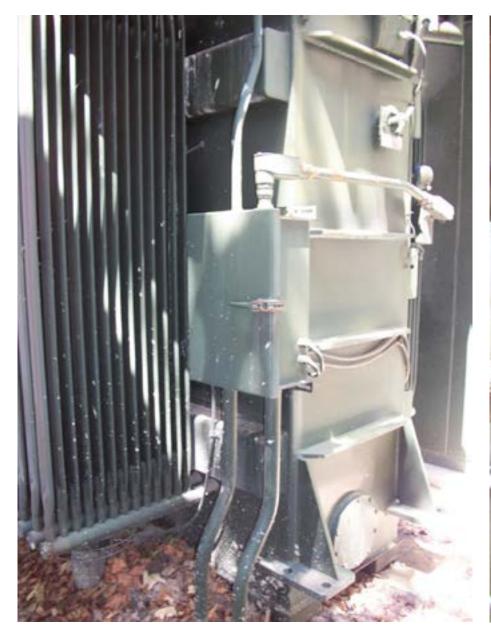
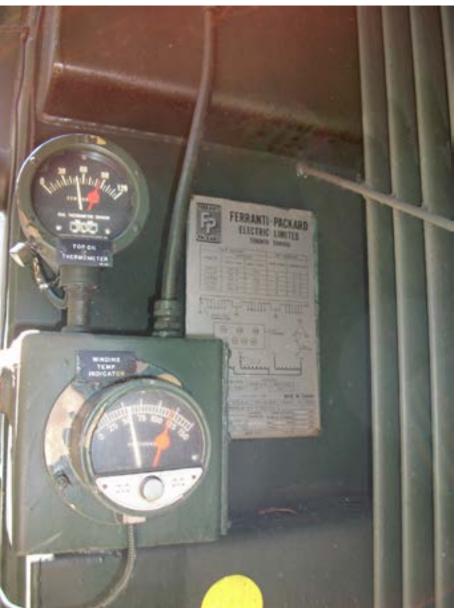
# **STATION POWER TRANSFORMERS** – Edenbridge MS – station transformer TR1 Schedule B12

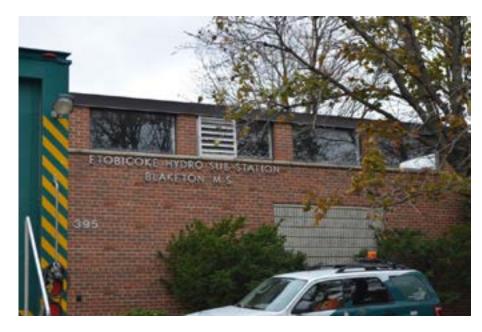
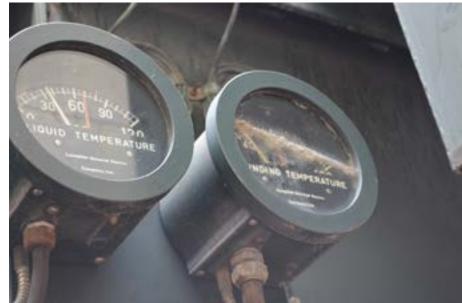
# **STATION POWER TRANSFORMERS** – Blaketon MS – station transformer Schedule B12

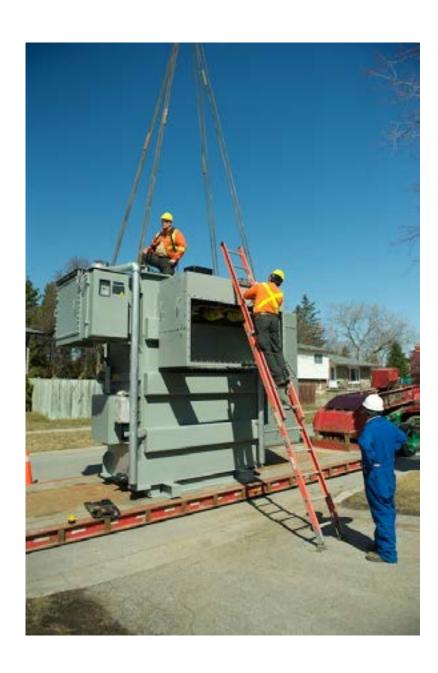
# **STATION POWER TRANSFORMERS** – New station transformer Schedule B12

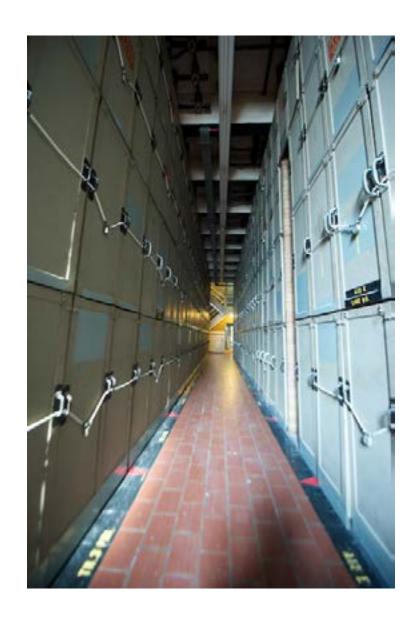
Schedule B13 / B13.1 / B13.2

### **STATION SWITCHGEAR** - Old vs. new

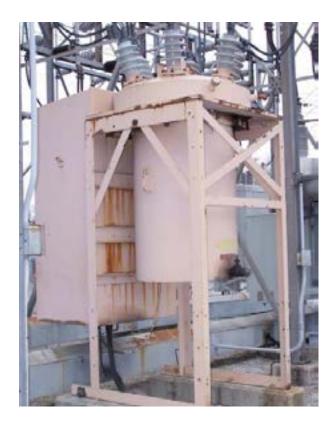
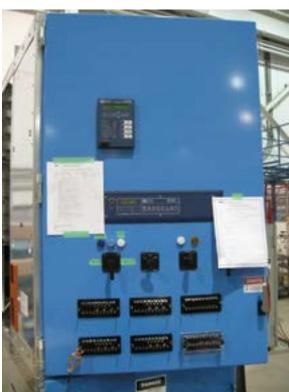
### **STATION CIRCUIT BREAKERS** - Old vs. new
